Laboratory Testing of Handpumps for Developing Countries,  
World Bank Technical Paper #19 from the Rural Water  
Supply Handpumps Project

# Rural Water Supply Handpumps Project

## Laboratory Testing of Handpumps for Developing Countries: Final Technical Report

Consumers' Association Testing and Research Laboratories

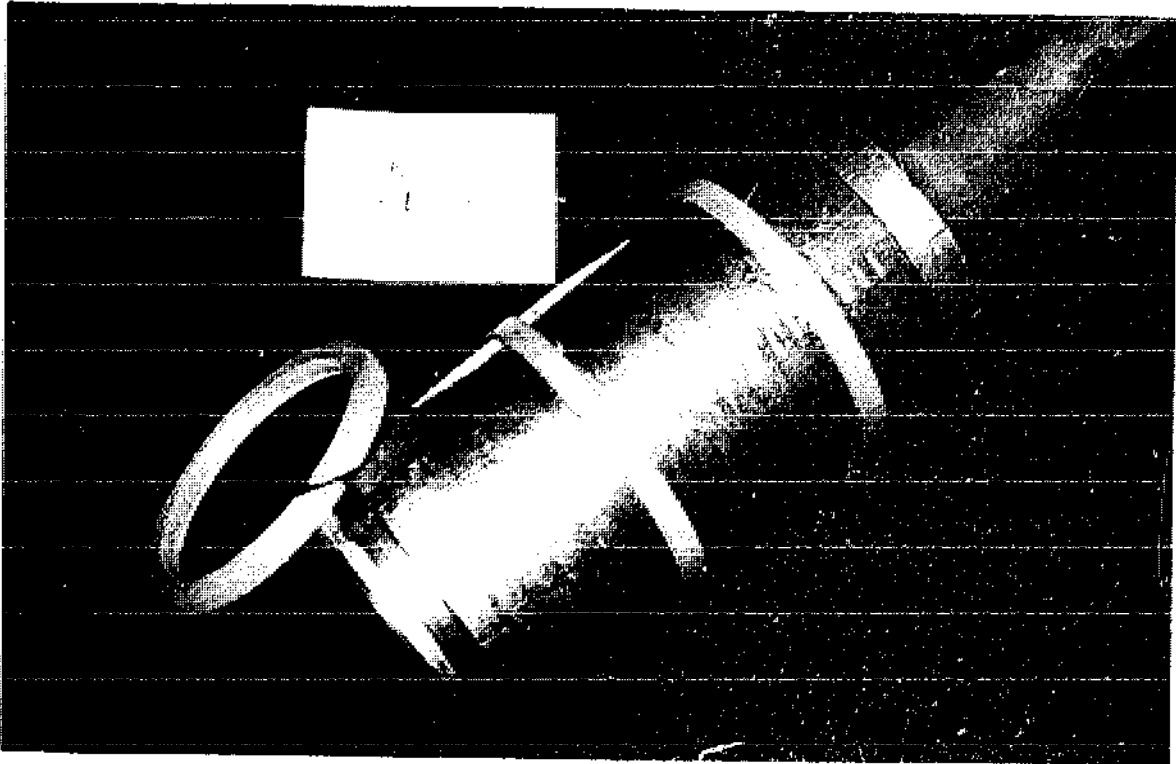
Polyethylene seals made to replace the original leather seals

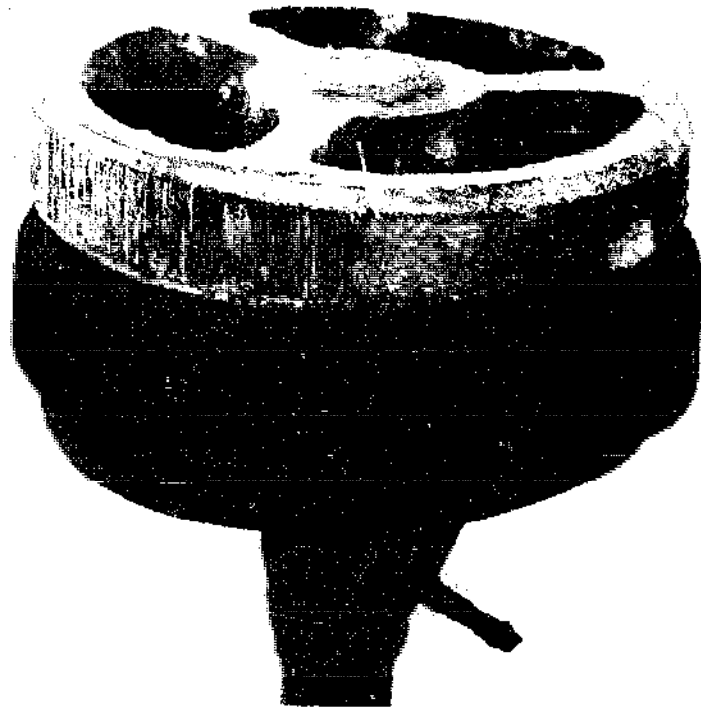
Plunger at end of endurance test

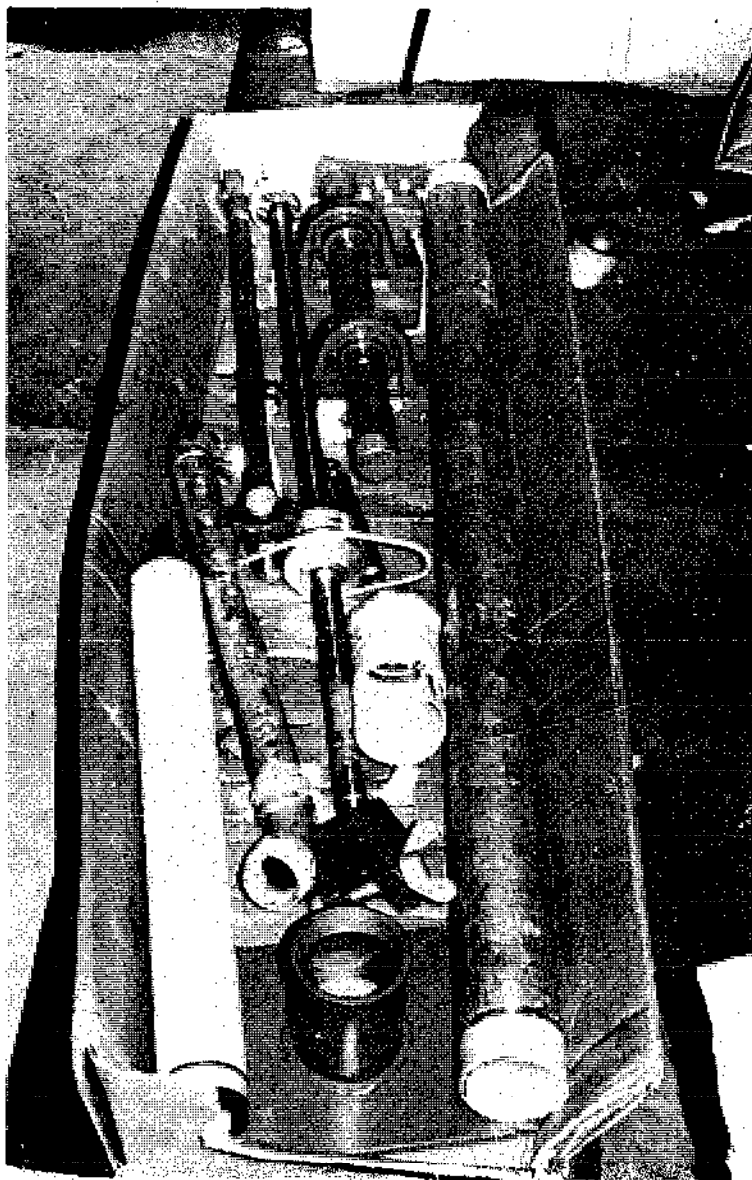
Although the wooden case was satisfactory, the cardboard boxes were unsuitable for the amount of weight put in them, and the components were loose inside. Several components were broken or damaged. The packaging of the pipes was completely unsuitable, four of the six pipes bundled together were damaged in transit.

Inadequate Packaging in Cardboard Boxes

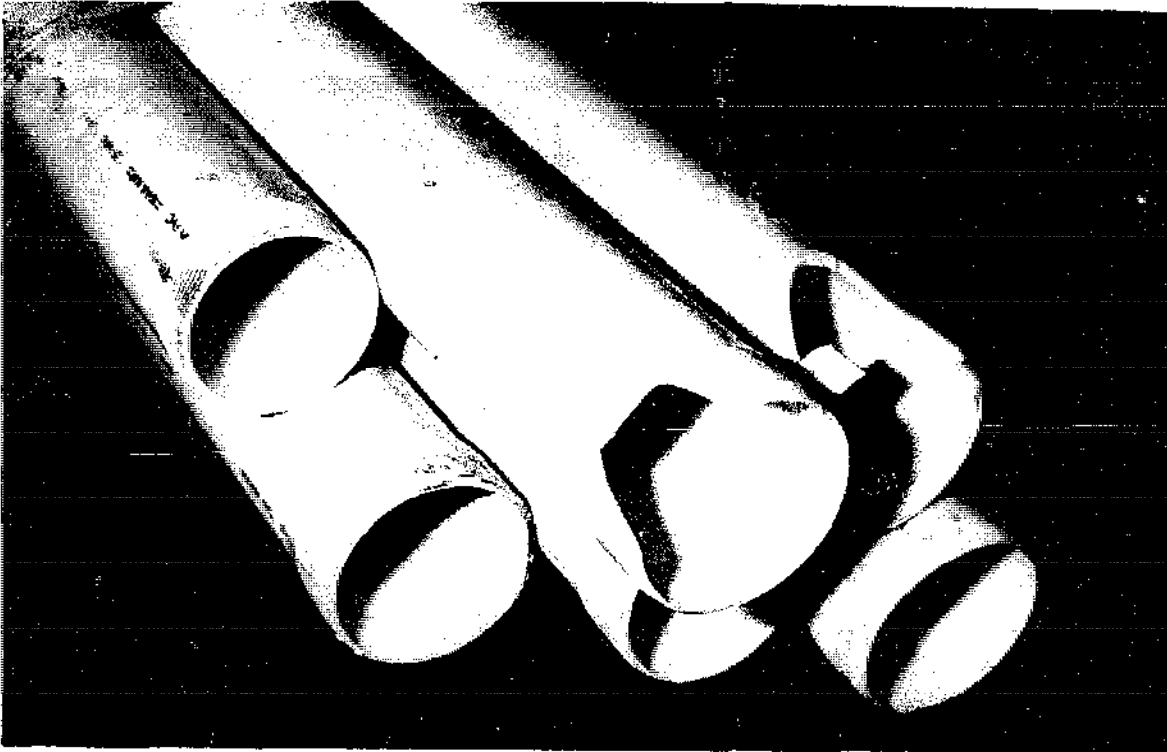
### Broken Pipes

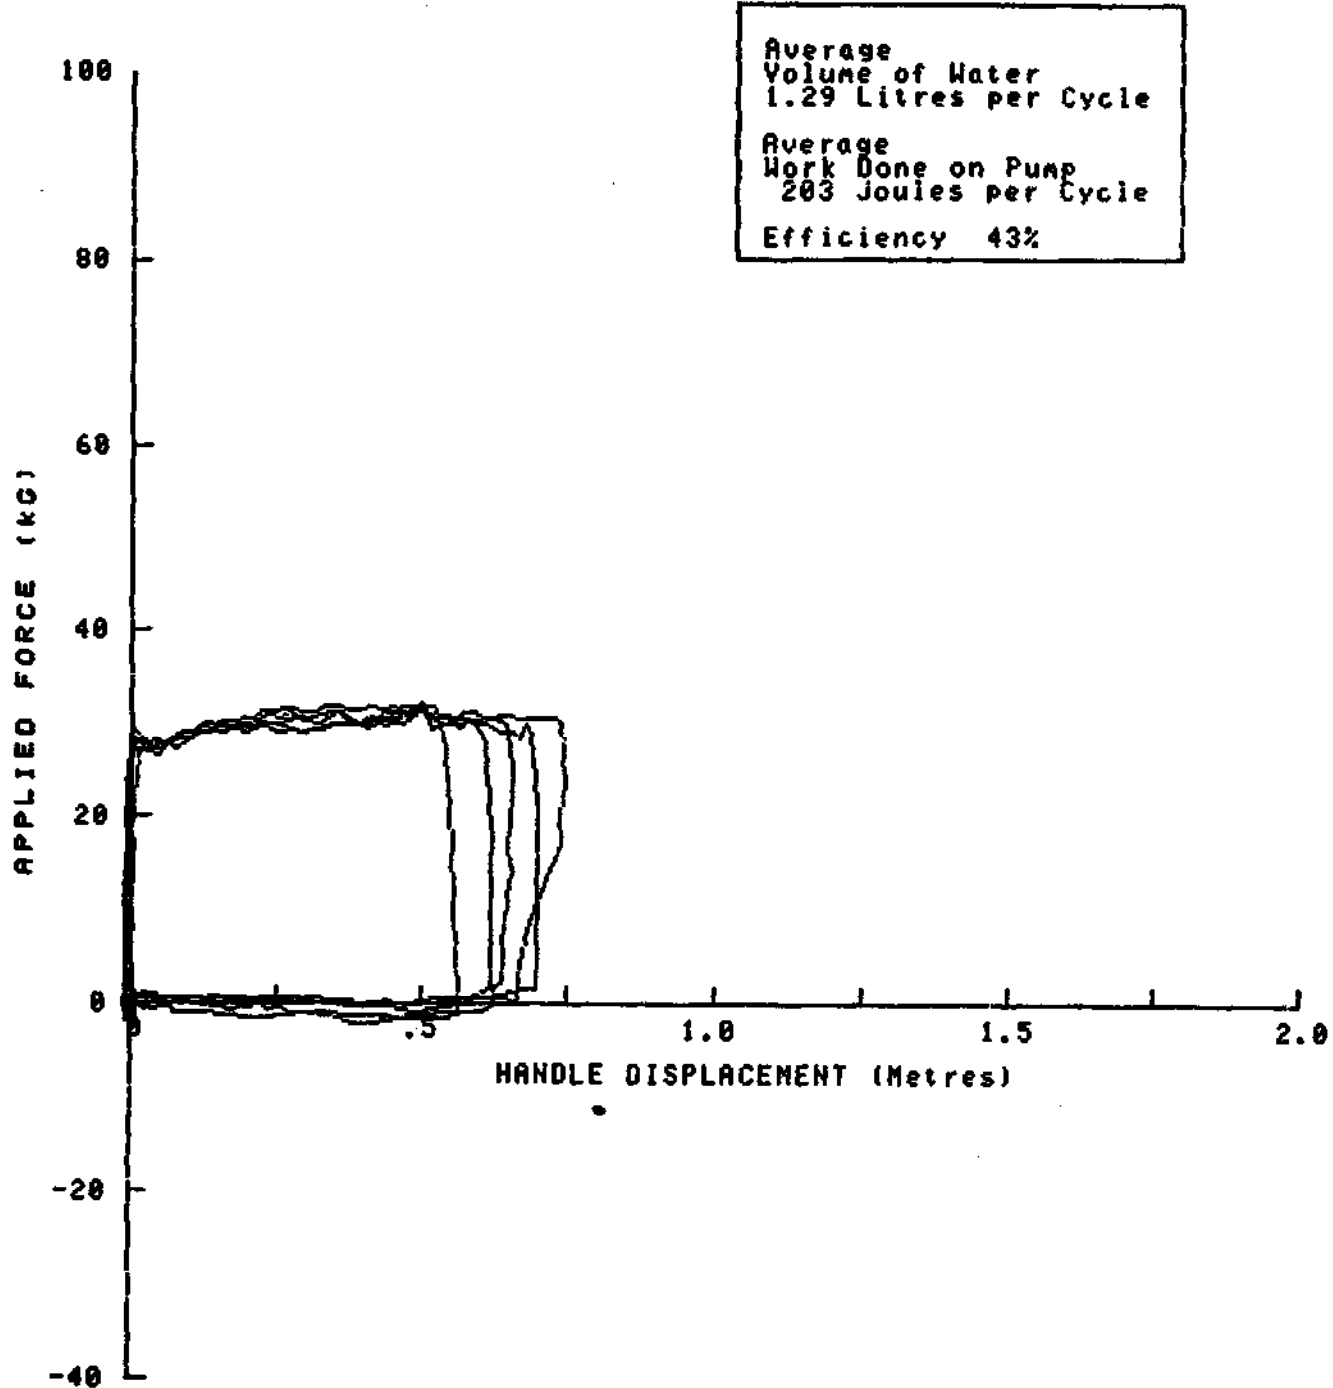
Considerably higher efforts were noted after endurance, possibly due to increased friction between the cup seal and cylinder bore.

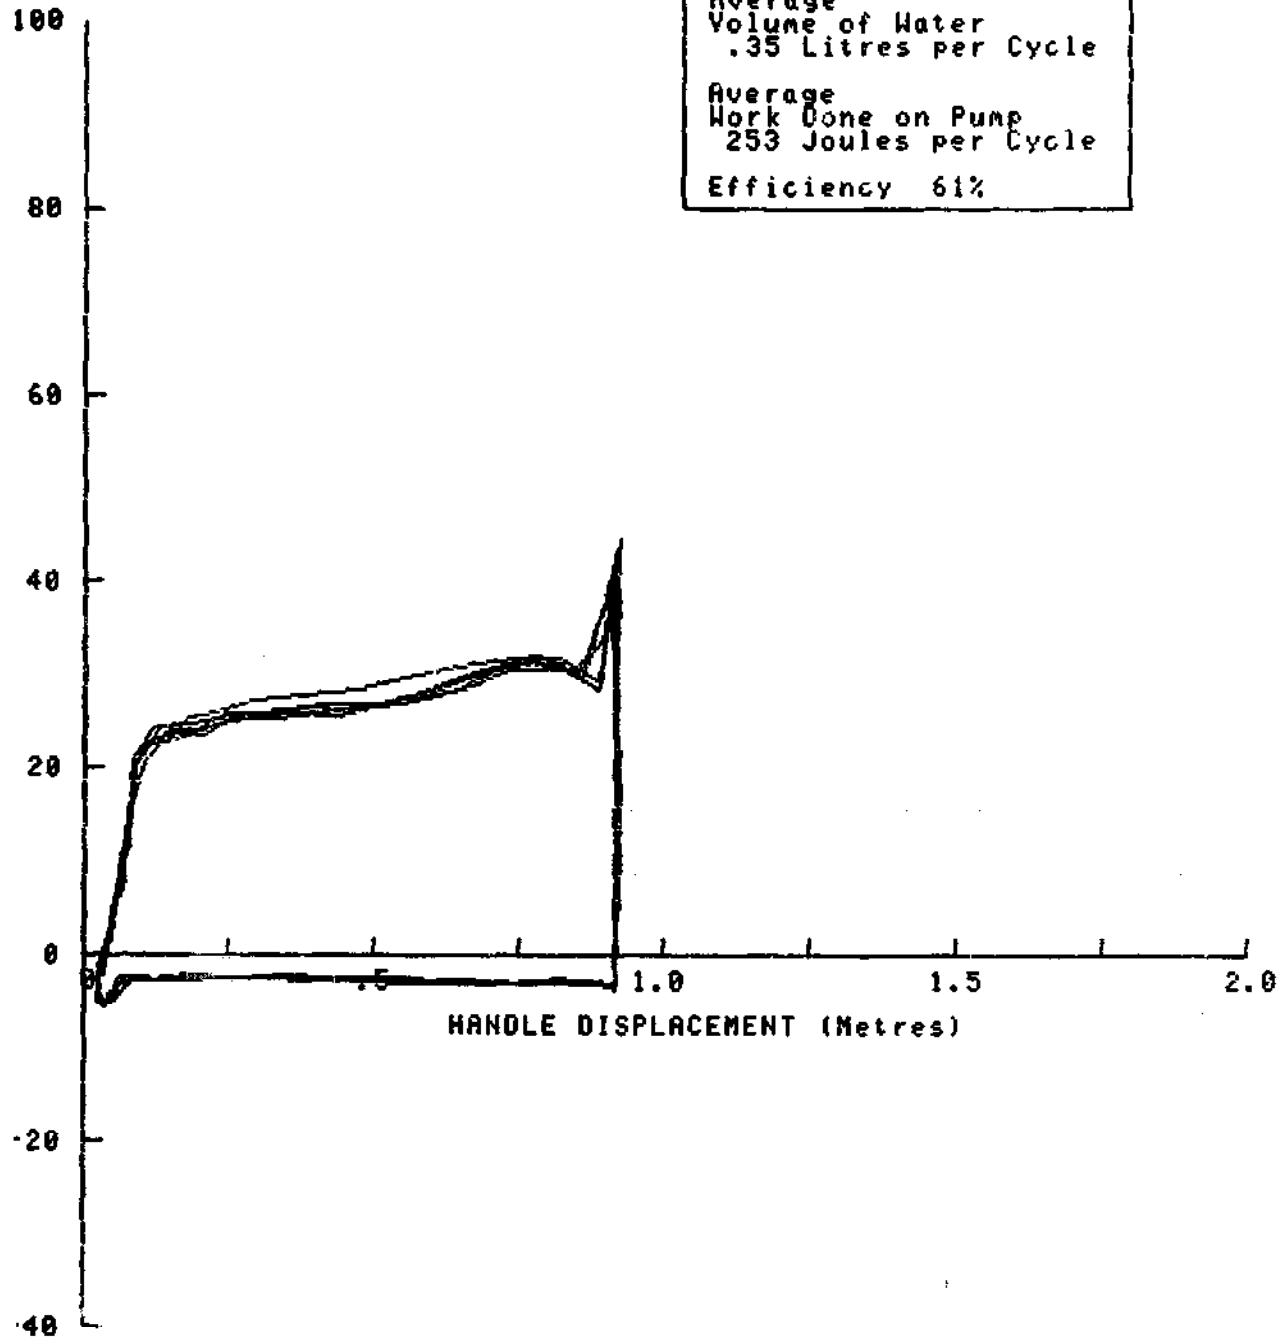
The diagrams illustrate the effects of wear in the pumpstand rack and quadrant:  
(a) greater handle displacement for the same volume flow  
(b) increased frictional losses, particularly at the start of the return stroke.

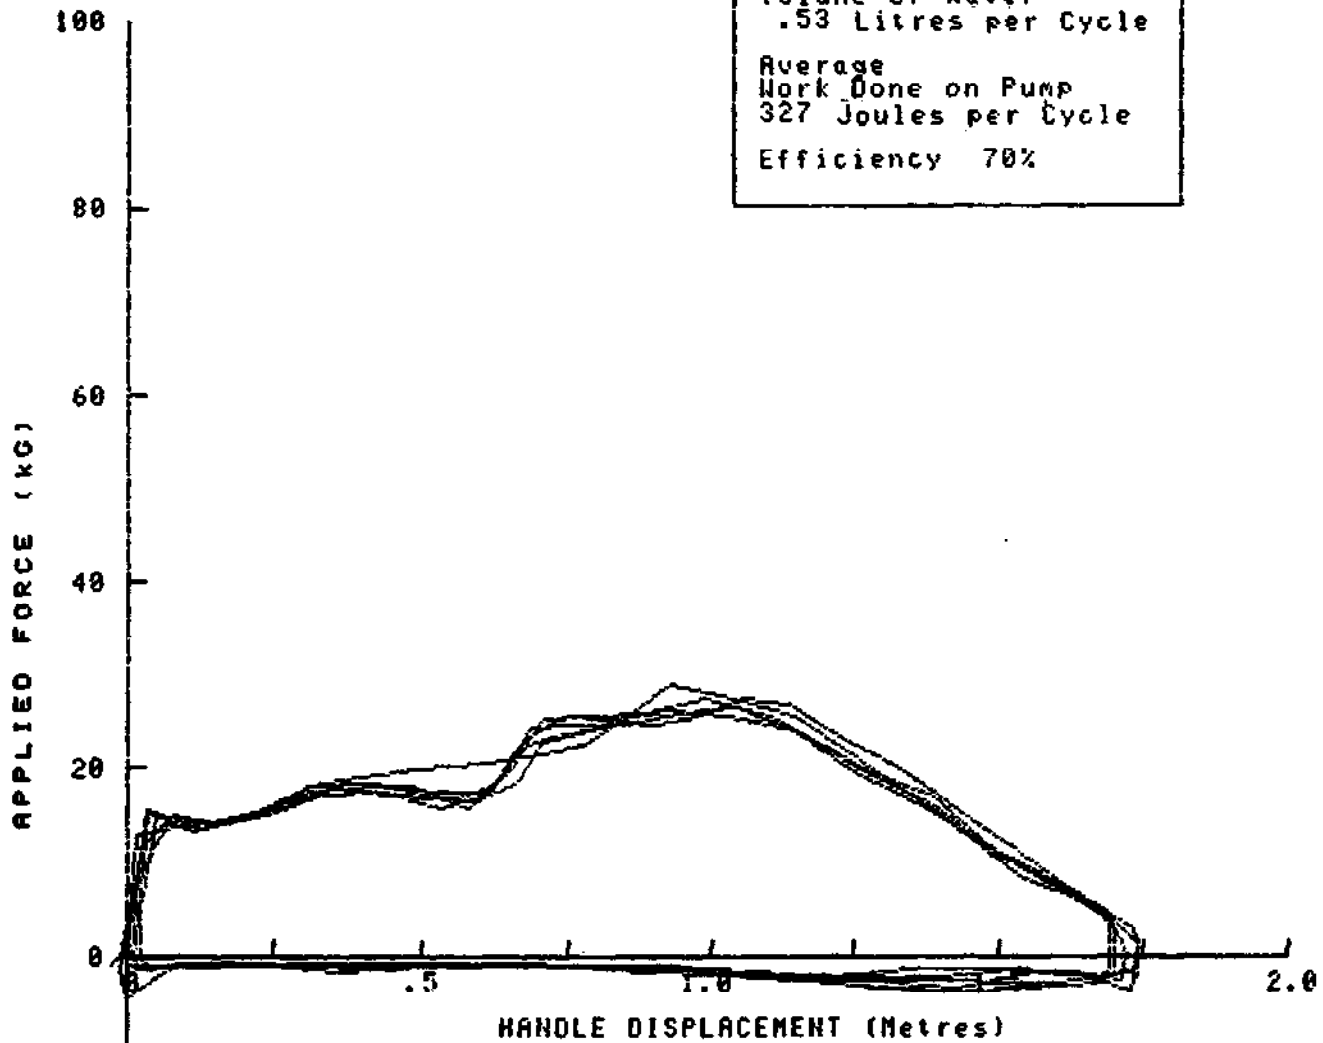
The irregularities on the power stroke are probably caused by variations in the linkage friction due to the wear which has taken place in the linkage mechanism.

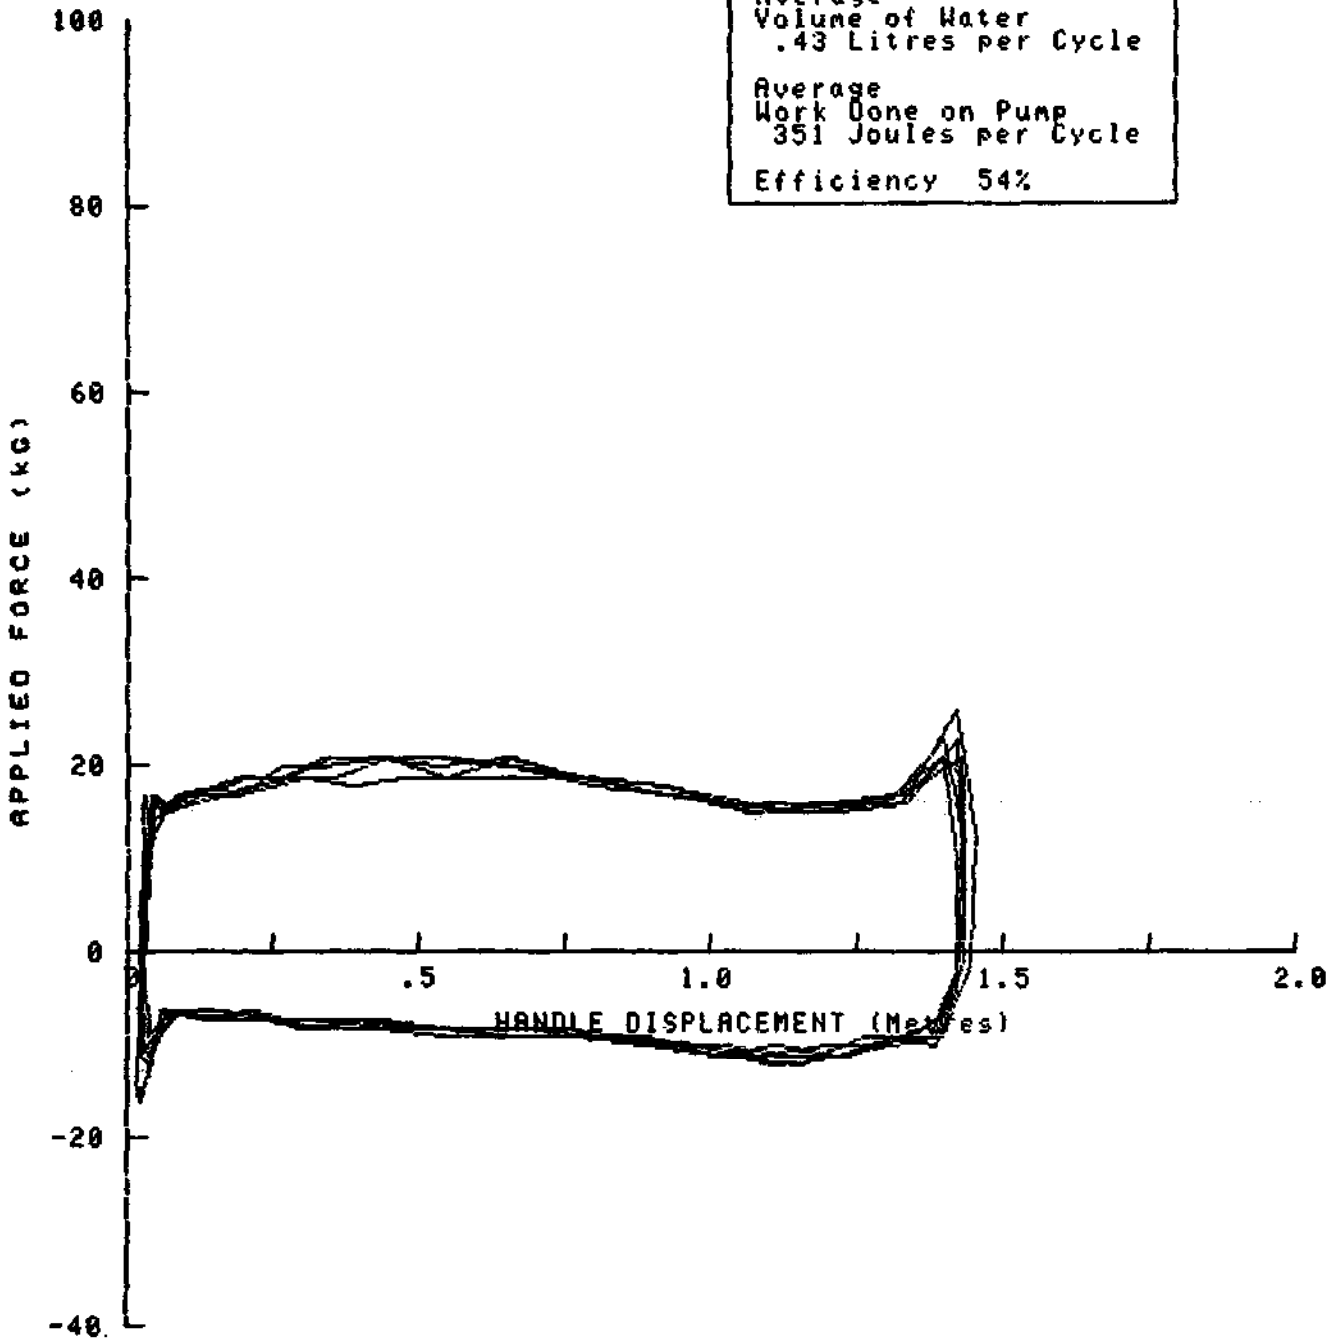
The results show that the work done on the handle increased by over 50% after endurance, with a small increase in volume flow. Friction had therefore increased considerably, probably as a result of the failure of the upper plunger seal.

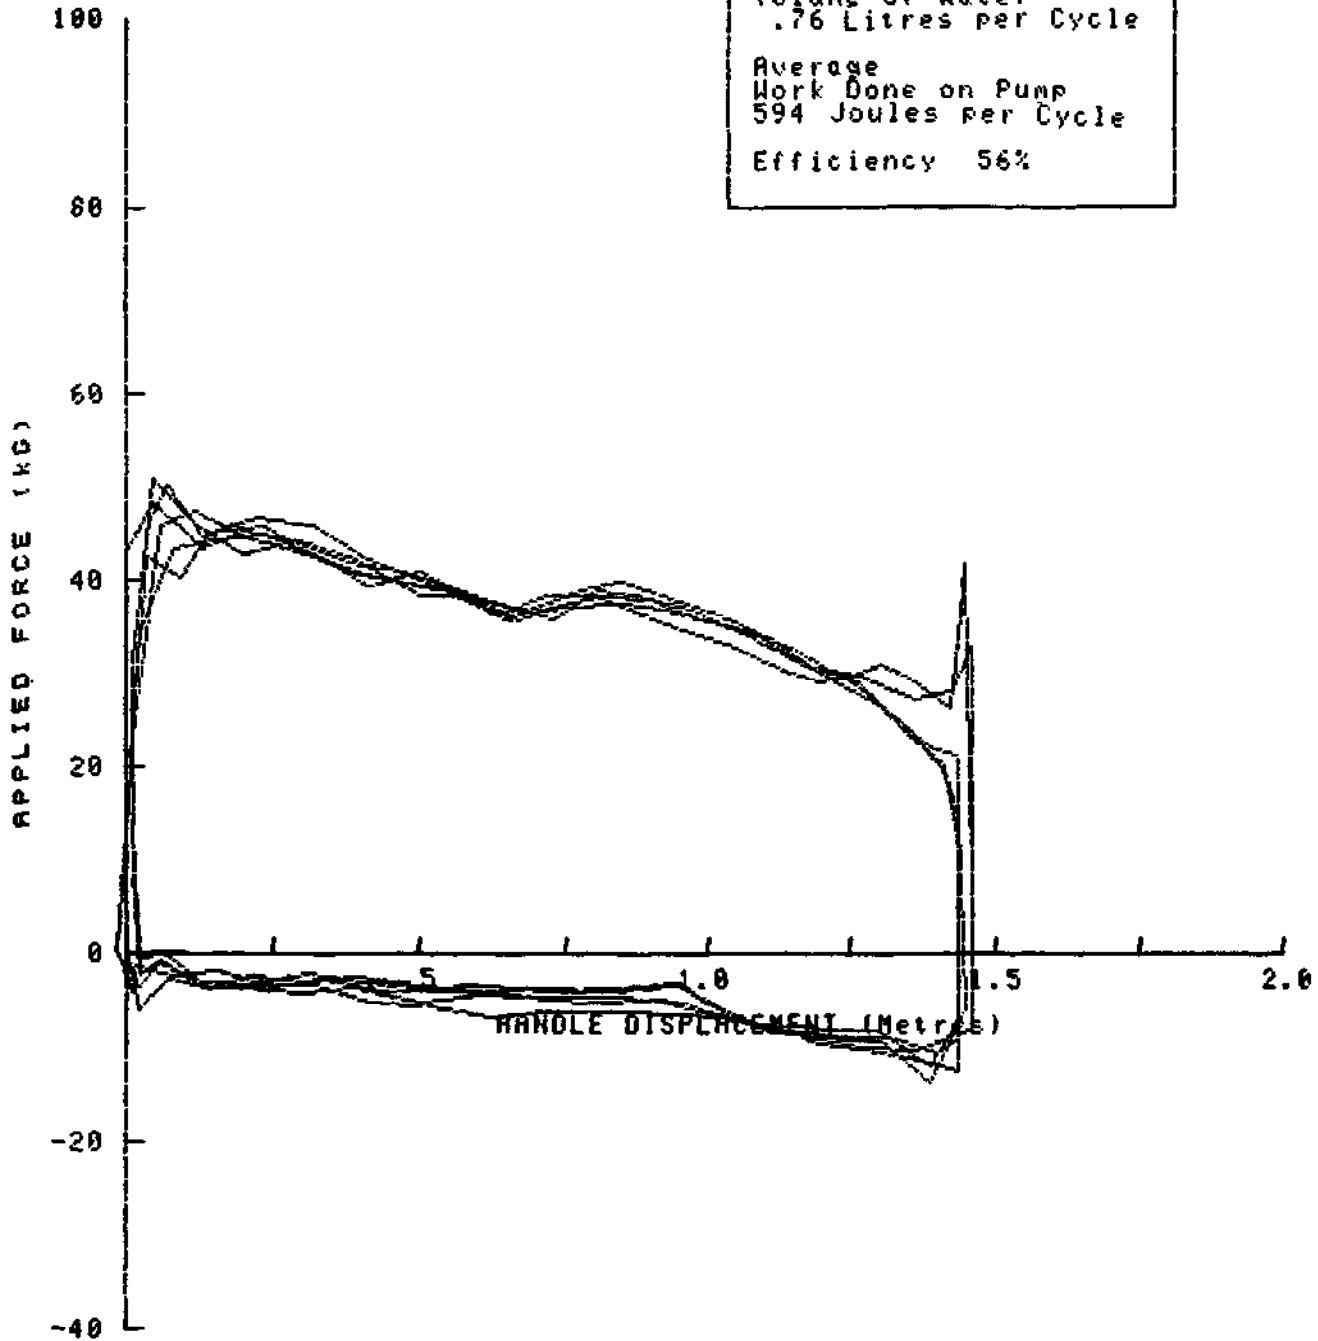
Differences between the profiles of the curves before and after endurance are the result of severe wear at the handle pivot.

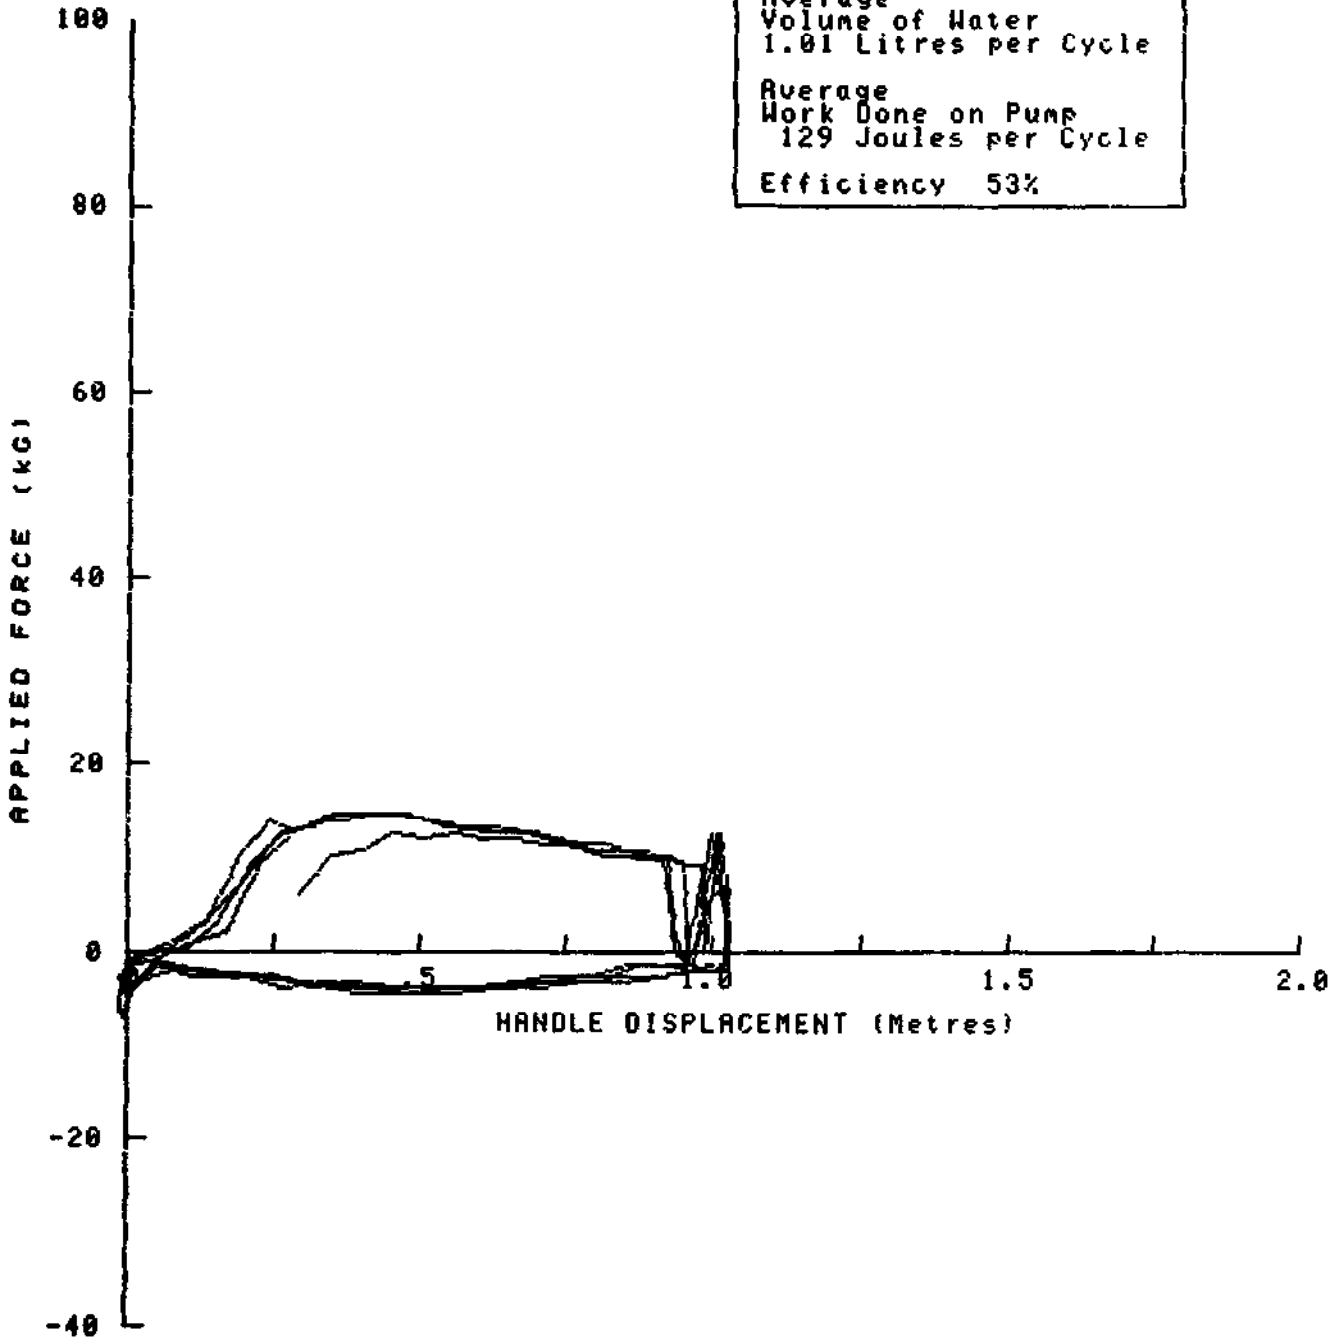
Differences between the profiles of the curves before and after endurance illustrate increased lost motion in the handle pivots.

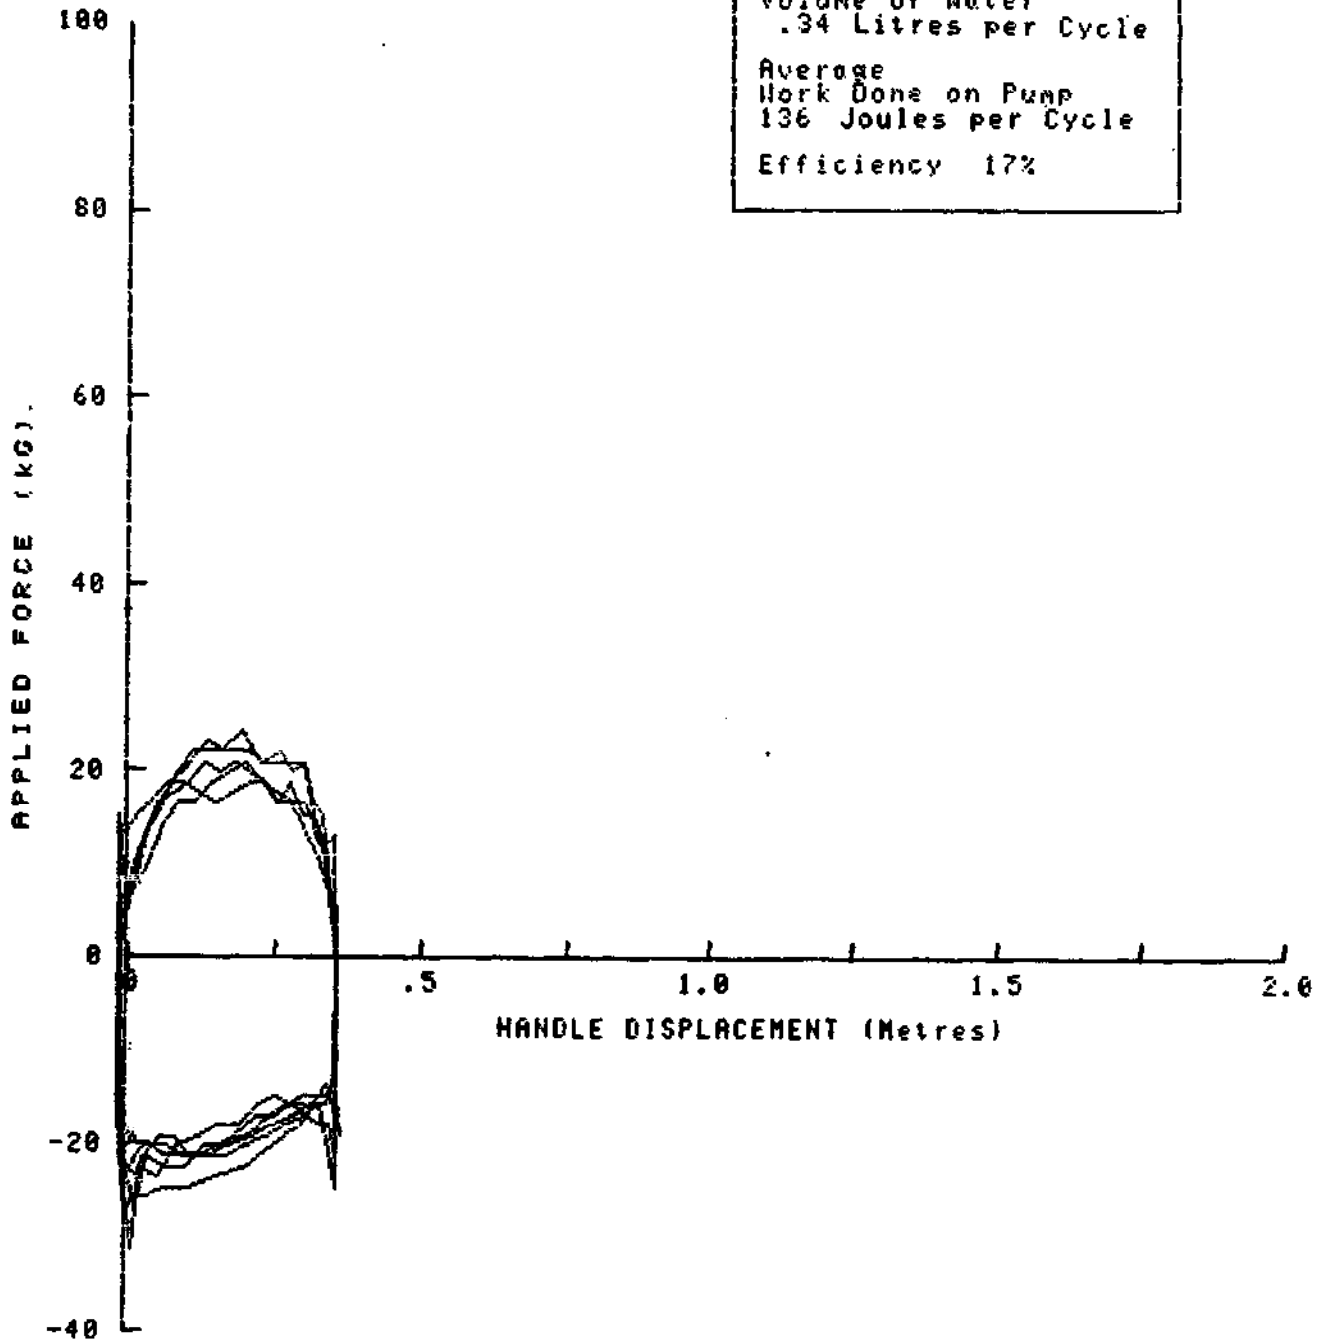
As this pump discharges on the lifting stroke, the power stroke is below the horizontal coordinate. The reduction in force on the power stroke after endurance shows the leakage past the plunger.
