Evaluation of the Bissa--An Indigenous Storage Bin

RPDC Report N° 5/78  
May - 1978

**EVALUATION OF THE BISSA - AN INDIGENOUS  
STORAGE BIN**

**RICE PROCESSING DEVELOPMENT CENTRE  
(FAO - UN Assisted Project)  
ANURADHAPURA - SRI LANKA**

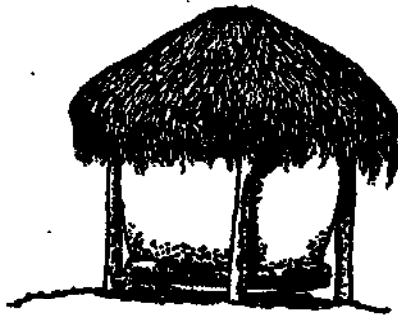
Fig. 2 - External view of a Bism

Figs : 2,3, show the external appearance of the completed structure of capacity 5 tons. The main stages of construction were as follows:

The function of the 4 supporting posts (diameter 6") of the cylindrical wall (Fig.2) is to prevent the structure from displacement due to loads imposed by the grain mass and loads imposed by rain and wind.

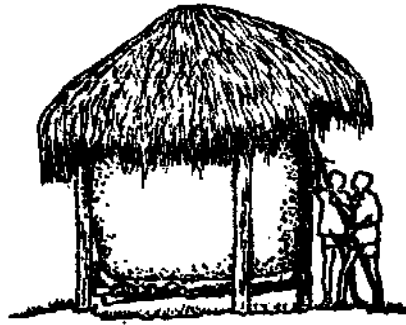
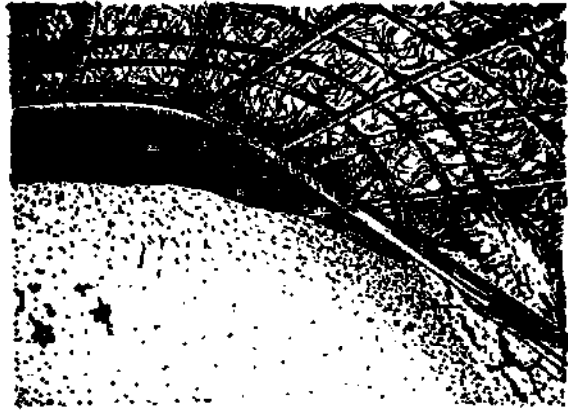
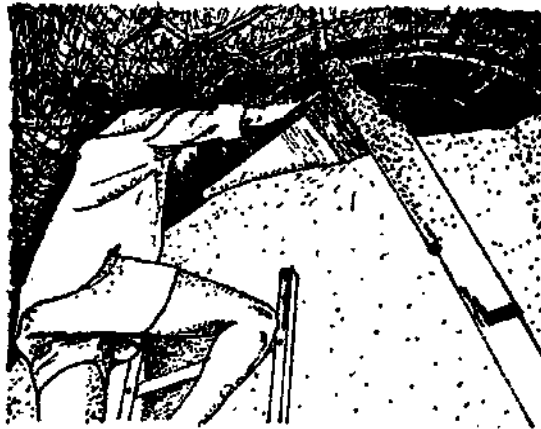
**Fig. 8 - Loading & Unloading operation**

A serious problem encountered in these operations was that, when lifting the roof it tend to shift from the original position due to which damage can be caused to the roof structure.

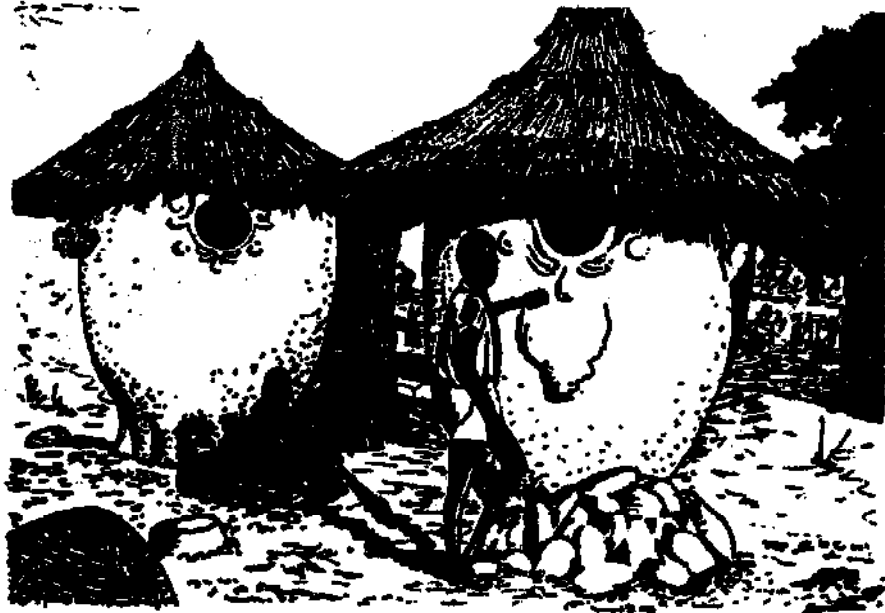
Fig. 11 - A Bissa in Africa

(vi) Fig. 11 shows a Bissa in Africa. No information could be obtained regarding its construction, operation and performance. Probably loading is done through the opening found on upper part of the wall. One disadvantage of having an opening of this nature is that, unless strict security measures are taken paddy could be pilfered.
