INSTALLATION OF A SOLAR DISTILLATION PLANT
ON ILE DE LA GONAVE, HAITI

May 1970

Internal Report No. I.67

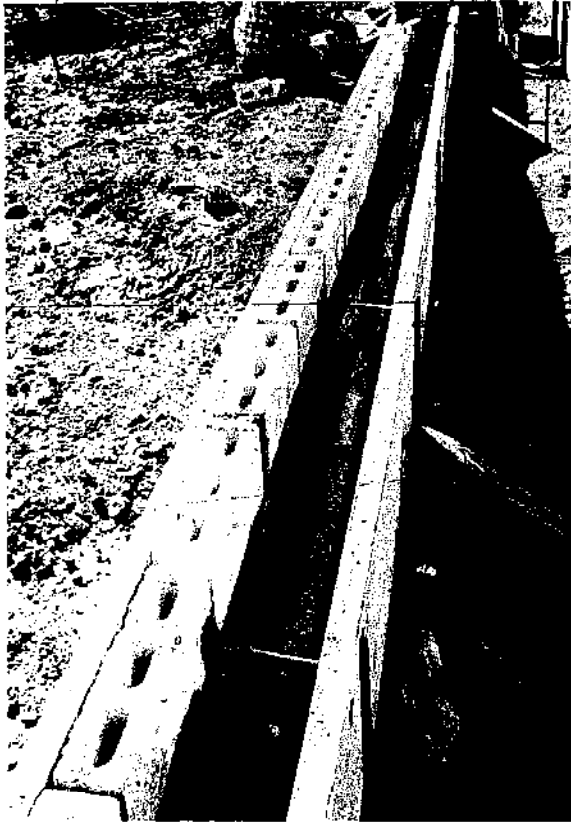
Fig 3: General view of partially completed curb wall, illustrating wood form work, rough gutters and concrete blocks. Note that at each tie wire, a bottom portion of the concrete block had to be chipped away. As noted in text, subsequent courses of concrete blocks were placed after tie wires had been removed

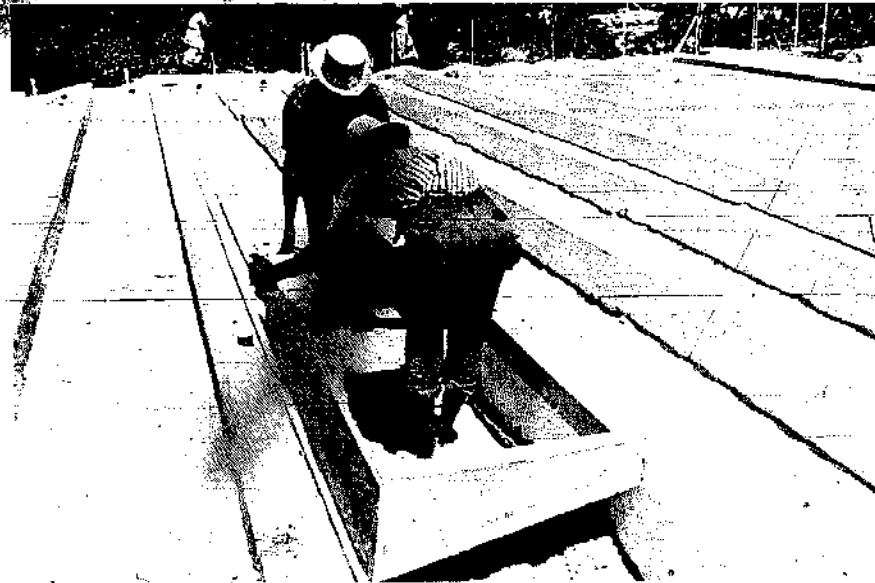
Fig 6: Finished curb and end walls with basin fill. The wooden frame is the guide used in levelling the basin fill in each of the twelve 6 foot long ponds that form one bay

The area between the curb walls was covered with a layer of beach sand up to a depth of four inches below the proposed level of the butyl rubber liner. The length of each Basin was then split up into a number of six-foot sections. A large wooden frame (see Figure 6), some 7 feet in length, was built with appropriately sloping guides such that the sand in each of these six-foot sections could be levelled. This first layer of beach sand was well tamped and on top of this went a two-inch layer of dried coffee husks to act as insulation. This layer was levelled using the same wood frame with the levelling boards raised two inches. A second two-inch layer of beach sand was placed on top of the insulation, and again the area was well tamped. A series of two-inch high weirs were built from the sand, at the end of each six-foot section.

These weirs were installed to keep a uniform, shallow depth of water in a series of ponds down the length of each basin.
