## Milestone A3

**‘Completion of one externally reinforced brick tank, two brick test cylinders, one partially below ground tanks and five thin-shell ferrocement tank covers’.**

**University of Warwick**

**September 1999**

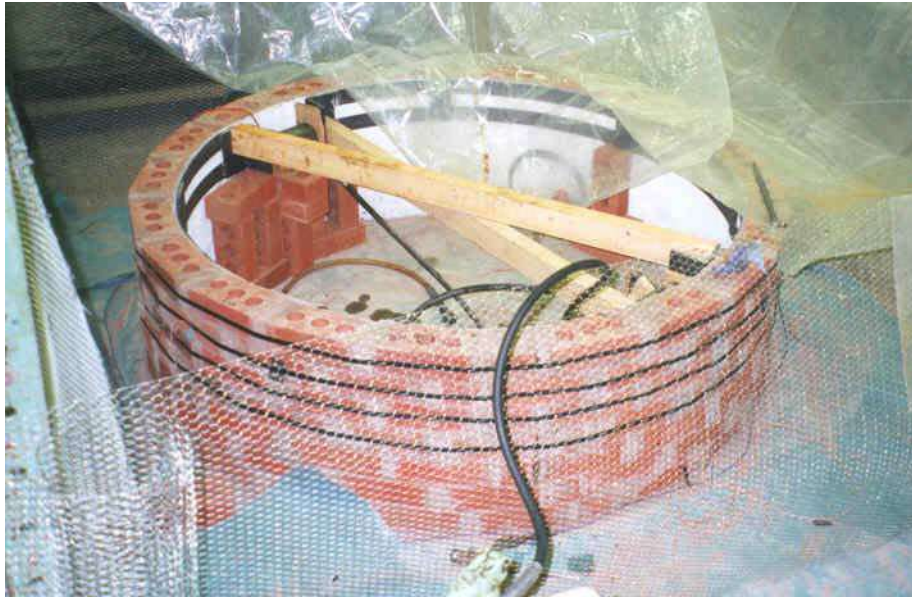
Figure 1 – Tests arrangement for externally reinforced brick cylinders

Figure 1 below shows one of the specimens under test, showing the internal expansion ring used to apply pressure. Figure 2 shows the steel strapping with a strain gauge that was used to measure the hoop stress generated. For fuller details of the tests, please refer to the Milestone A2 report.

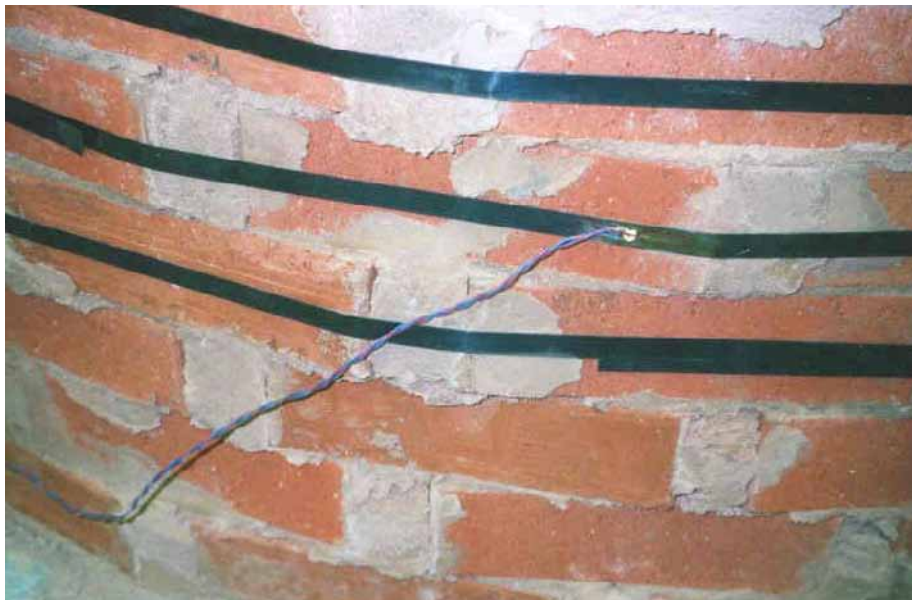
Figure 2 – Strain gauge used to measure hoop stress generated in steel strap during testing.

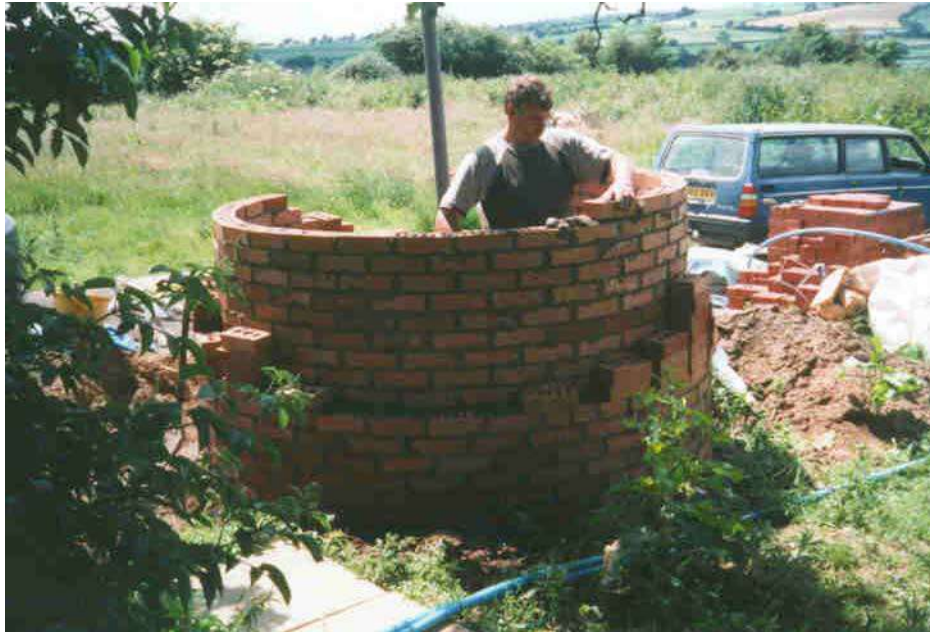
Figure 3 – Full-size experimental tank under construction at field site.

Further work has since been carried out on the construction of a full-sized tank for rainwater storage at a field site in Herefordshire. The tank has a capacity of approximately six cubic metres, with a diameter of 2m and a height of 2m. The tank is at present complete, but without instrumentation as yet. The aim of the experimental tank (shown under construction in Figure 3 below), is to further investigate the behaviour of the tank with particular regard to induced stresses under real conditions and also to investigate the feasibility of a number of peripherals designs.

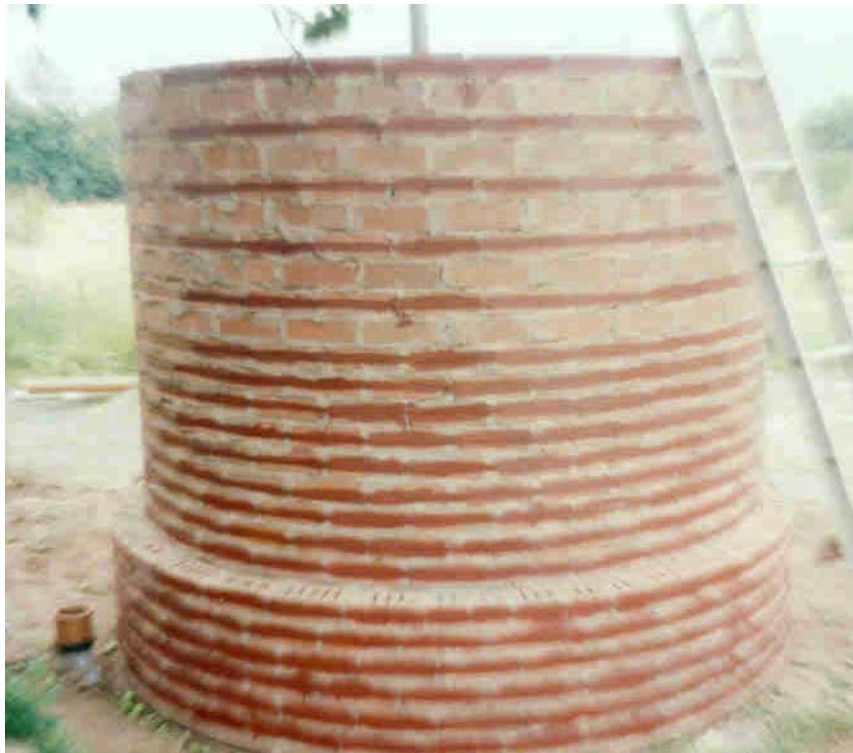
Figure 4 – Strapping applied to experimental tank.

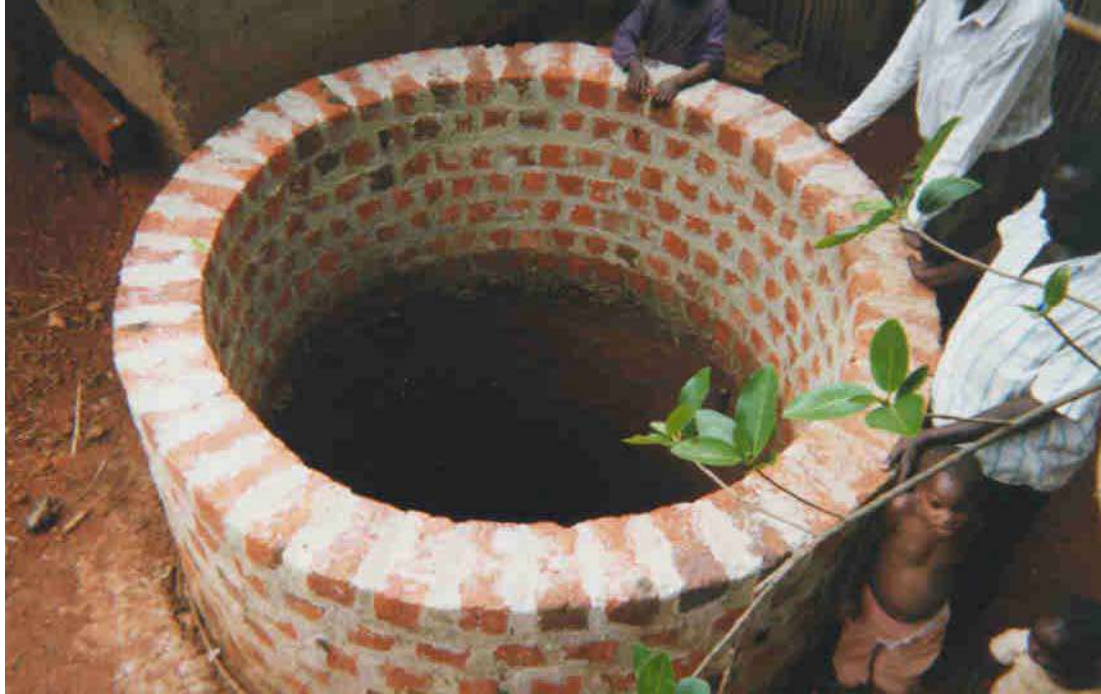
Figure 7 – Bird's eye view of the partially below-ground tank under construction.

Figures 7, and 8 below, show the partially below ground tank under construction, while Figure 9 shows the thin shell ferrocement cover being manufactured.

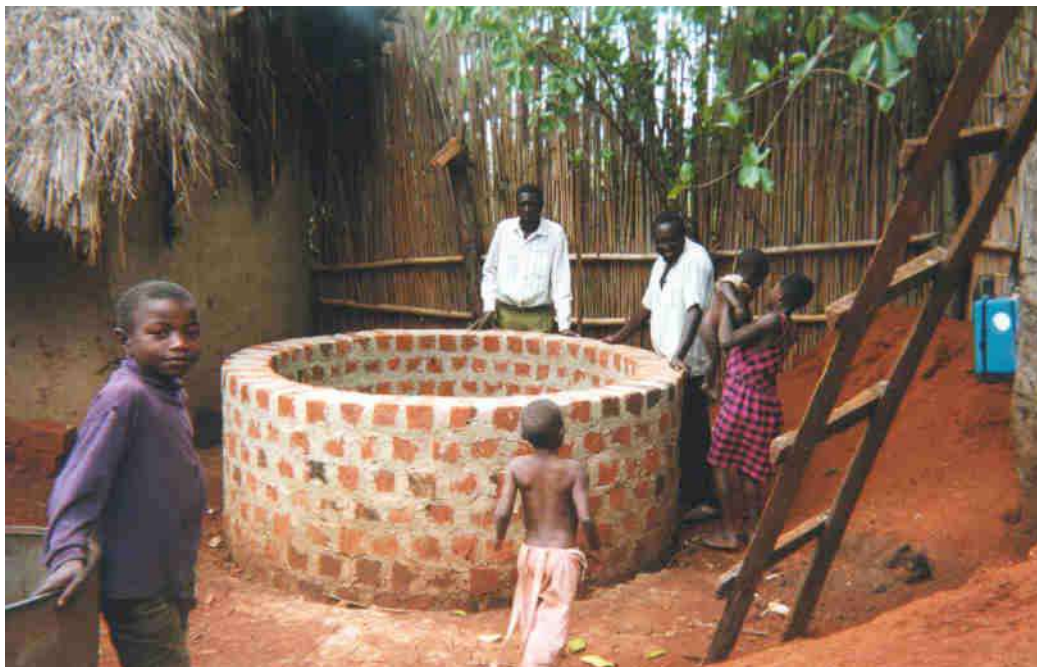
Figure 8 – Partially below ground tank under construction in western Uganda, showing parapet wall.

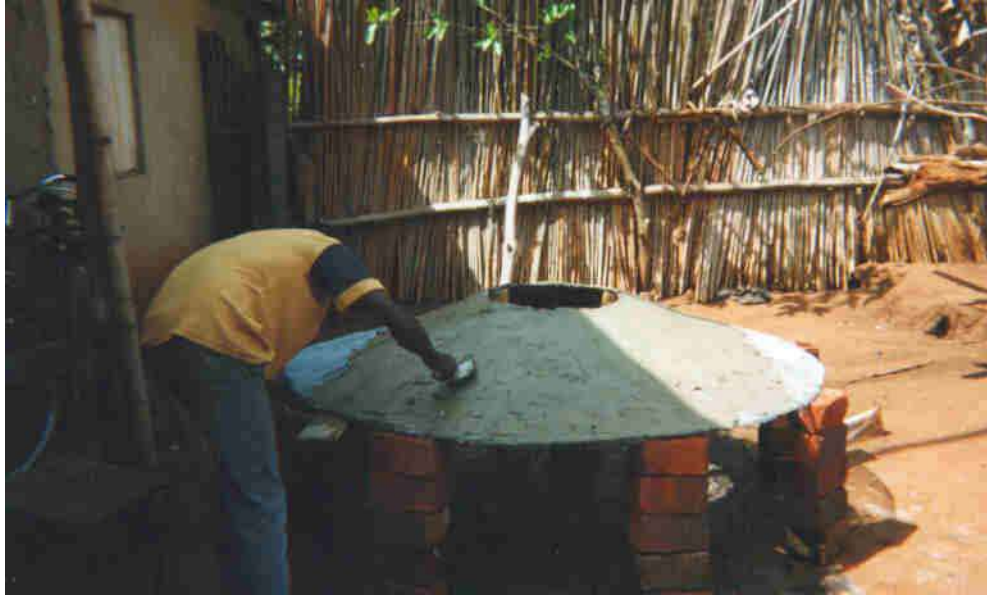
Figure 9 – Thin-shell ferrocement cover being manufacture for partially below-ground tank in western Uganda

Five of these covers have been produced to date, 3 for testing purposes and two that have been fitted to tanks. One has been made in Uganda by local masons (see Figure 9 above and Figures 10 and 11 below) with no complications.

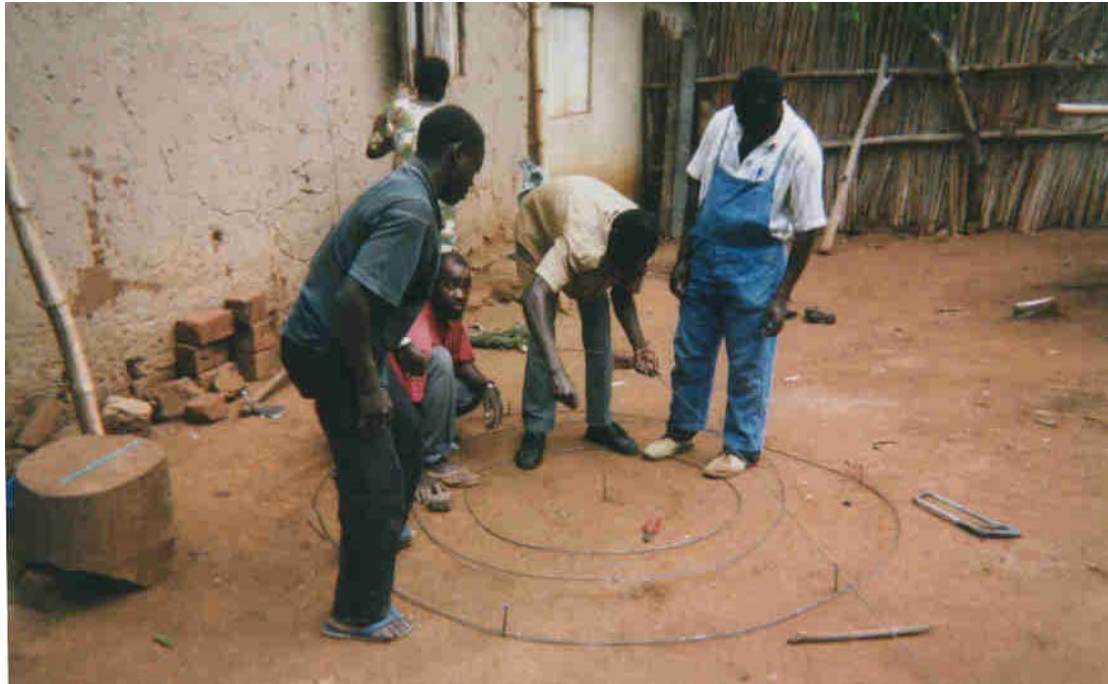
Figure 10 – 6mm steel framework being formed by local masons in western Uganda for the TSF tank cover.

The design is based on a frame known as a reciprocal frame, that has spokes that, when loaded, put little radial loading onto the structure on which it sits. The frame is covered with a wire mesh that is then rendered with a sand cement mix.

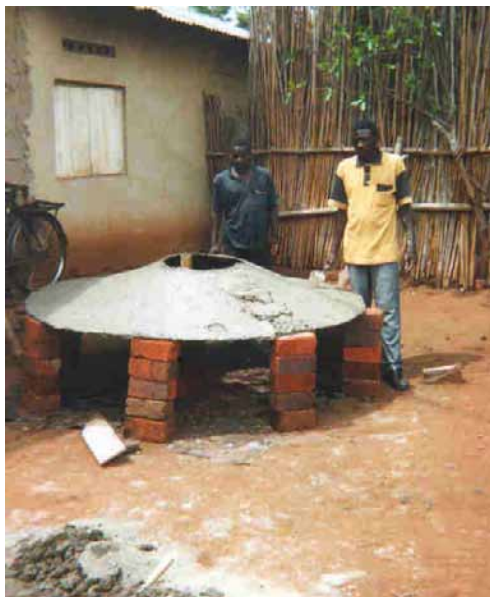
Figure 11 – TSF cover being completed by local mason in western Uganda. This cover was fitted to a partially below-ground tank.
