Milestone A4

Completion of three partially below ground tanks, 2 rammed earth tanks, eight cement jars and two stabilised soil block tanks.

Development Technology Unit (DTU)

University of Warwick

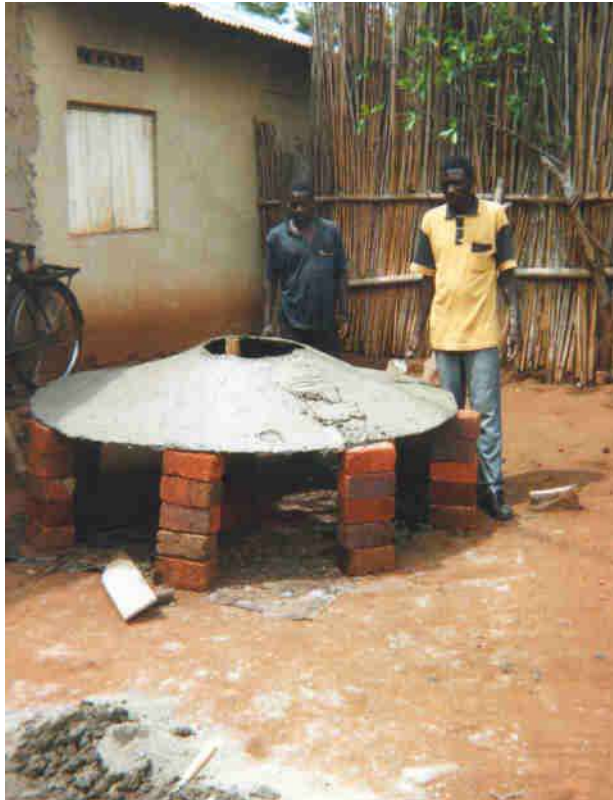
Figure 2 – A thin shell ferrocement cover near completion and ready for fitting to a PBG tank

Each of the PBG tanks was fitted with a thin shell ferrocement cover, described in a previous report and developed under this programme.

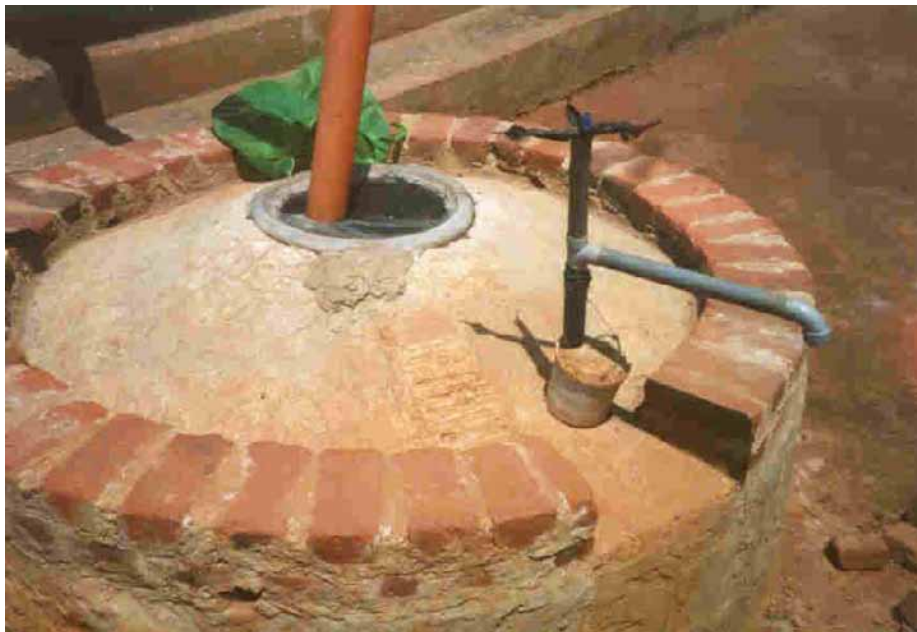
Figure 3 - A completed PBG tank showing inlet pipe and handpump for extracting water

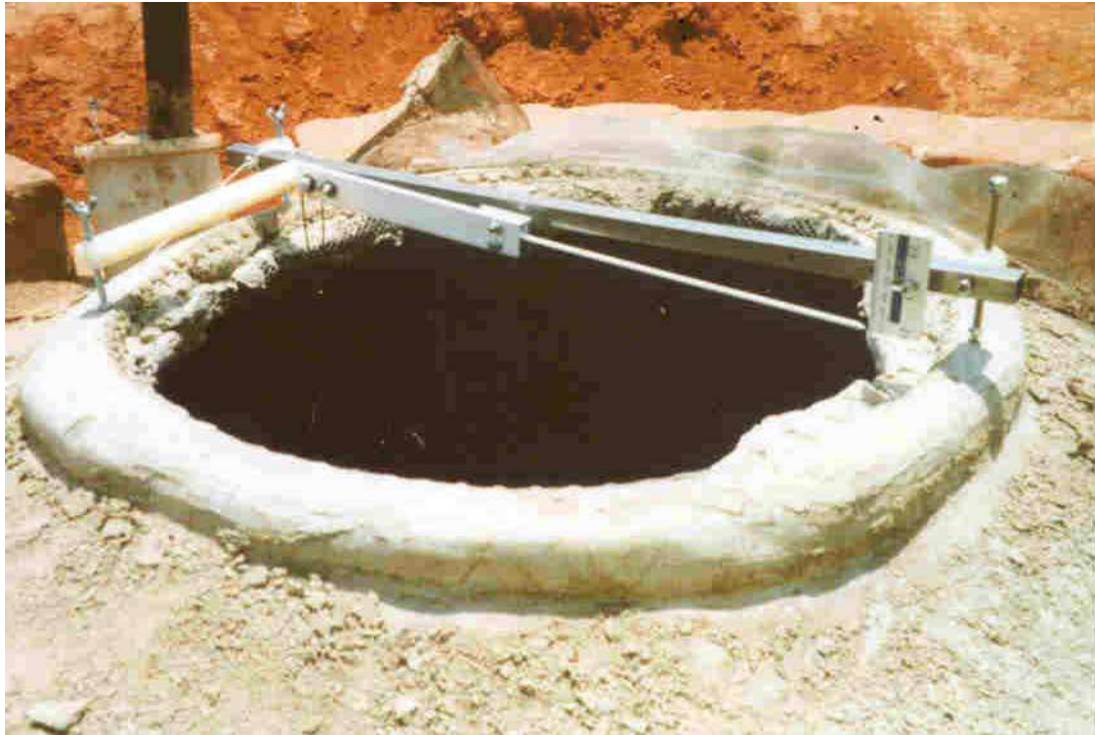
Figure 4 – Leakage test apparatus being tested in the field on a PBG tank

Initial leakage tests were carried out on a number of tanks using a device developed at Warwick (see Figure 4). These tests are continuing at present and will be reported later.

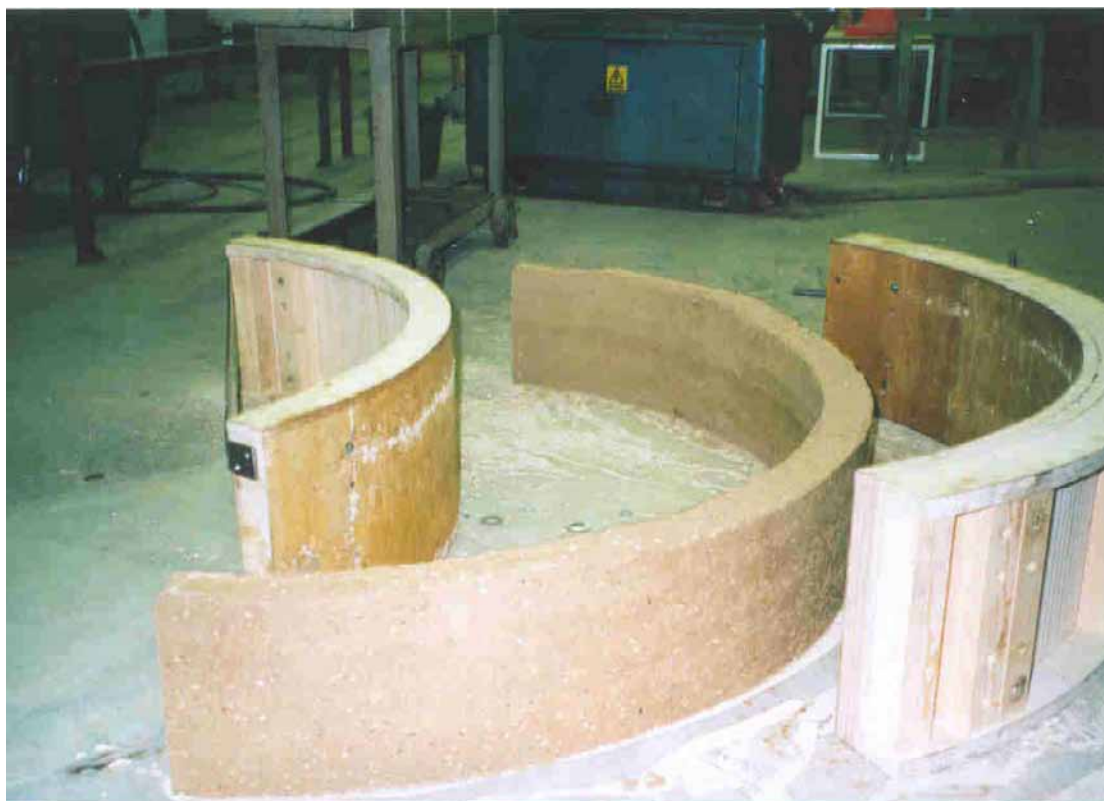
Figure 5 – A section of wall rammed between the wooden shuttering shown after removal of the shuttering

The direction of the experimental work at the University has shifted from reinforced brick tanks (reported in Milestone A3) to a more radical design of tank – the rammed earth tank. The aim is to adopt a low-cost technique commonly used for house building in areas of the world such as North Africa, North and South America and the Middle East. The technique uses a mixture of sand and clay, sometimes with a small amount of stabiliser such as cement, which is rammed, either manually or pneumatically, between wooden shutters. To use rammed earth as the structural material in a water storage vessel a waterproof liner is required. This can be provided by employing one of a number of possible options, such as cement render or a plastic sheet liner (as mentioned earlier, this latter is being developed for this application at the University). It is a technique that is relatively simple in essence and requires little in the way of imported material.

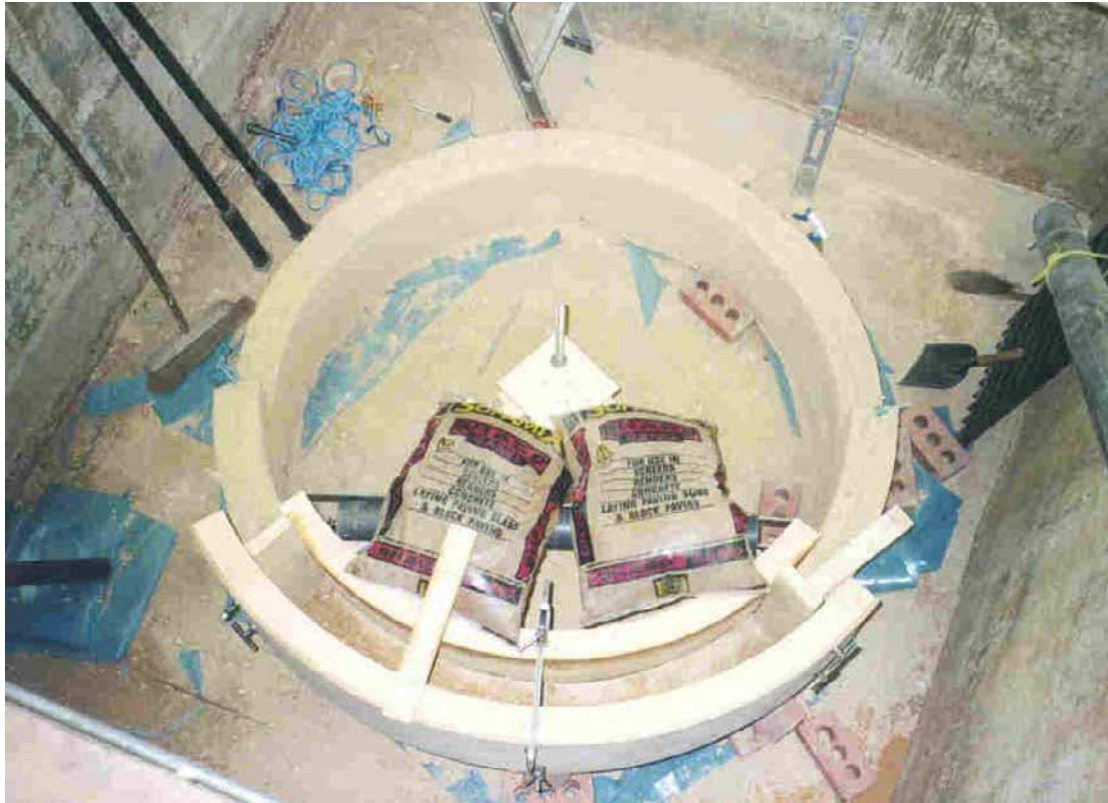
Figure 6 – Bird's eye view of the rammed earth tank under construction in the test pit at the University

A tank, of radius 0.7m and depth 0.7m, has been constructed in a test pit at the University, and fitted with a plastic liner. The tank has been fitted with steel straps to give added hoop strength, but these will be removed after initial tests. The straps will be fitted with strain gauges and will be linked to computer data logging equipment. Measurements of strain, water depth, and temperature will be taken during tests. It is hoped that full-scale testing will take place within the coming month (May 2000). The aim is to seal the top of the tank with a large wooden disc, which will be pierced with a header pipe. The water pressure head will be gradually increased to a maximum of 5m while logging the variation in strain and water depth. The tank has been designed to fail at about 4m, so the test should be destructive, giving valuable information on the strength of rammed earth as a possible alternative to conventional building materials.

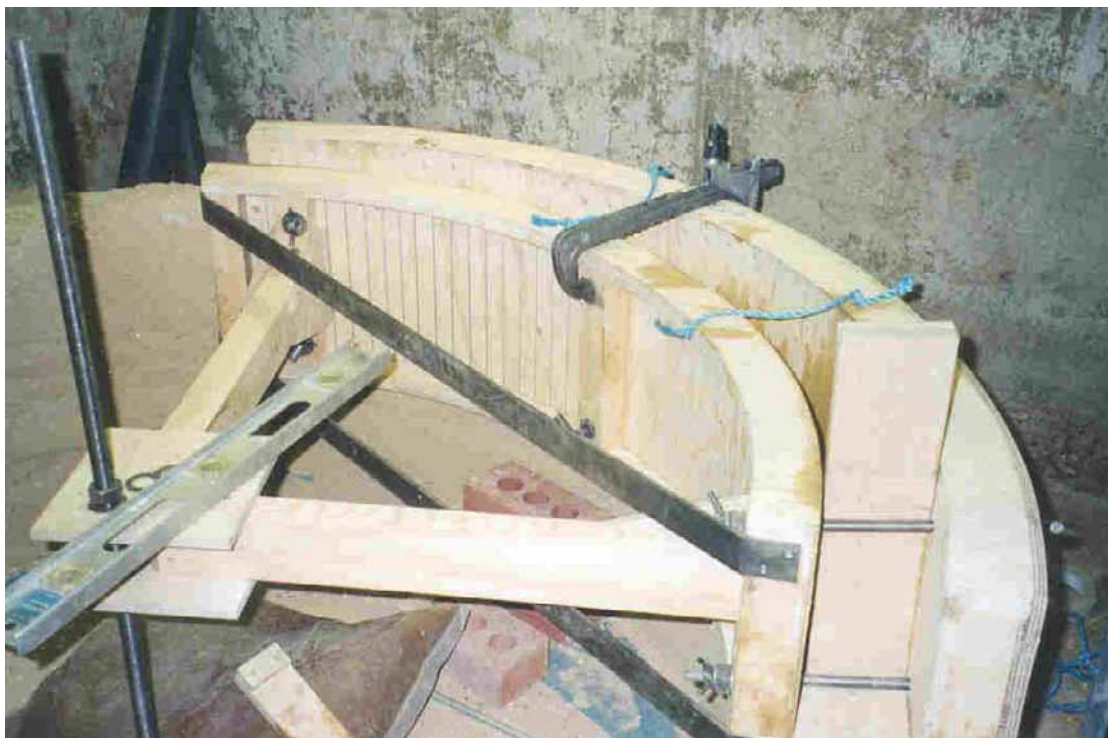
Figure 7 – Revised shuttering arrangement shown during construction of the experimental tank

So far, the work that has been done on rammed earth tanks has been experimental, and mainly focused on adapting the basic technique (generally used for construction of straight walls in the building sector), to the construction of circular walls for water storage tanks. A 0.7m inner radius quadrant shuttering (see Figure 5) was manufactured and a number of test sections were rammed using a locally excavated soil (local to the University). The soil had to be modified somewhat to make it suitable in terms of cohesion. Wall thickness was increased gradually from a starting minimum of 60mm. We eventually opted for a 100mm wall thickness although even this is unsuitable for manufacture in the field. It is ideal, however, for testing purposes.

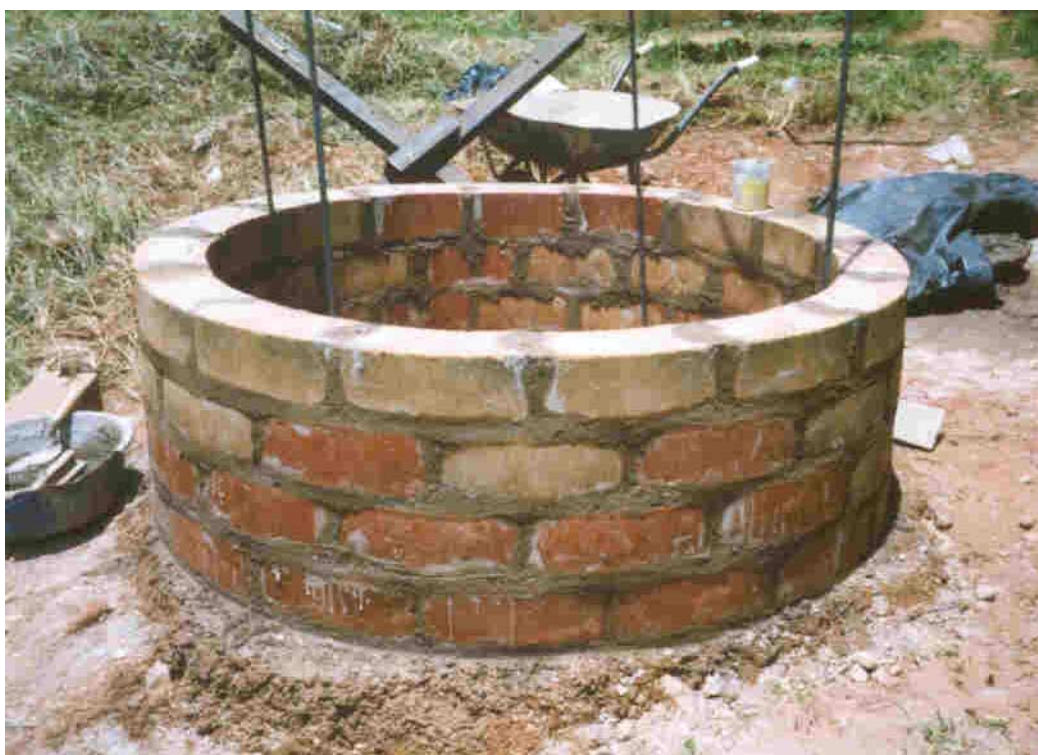
Figure 10 – Showing one of the stabilised soil block tanks under construction

In March 2000, two experimental cylindrical water tanks were built at Kawempwe, Kampala in collaboration with Dr Muses Musaaazi, a lecturer at Makerere University. Both were built above ground of curved stabilised-soil blocks with end interlocking, 280mm x 140mm x 110mm high, made with an Approtec (Kenyan) manual block press. The soil used was a red somewhat pozzolanic local soil previously known to make strong blocks. The tanks were built on concrete plinths, lined with ‘waterproofed’ mortar (3 parts sand, 1 part cement and .02 parts ‘Leak Seal’ waterproofing compound). There was no metal reinforcing.

Tank 1 is 2050mm high, has internal diameter 1300mm, wall thickness 140mm (+ 15mm render) and used $15 \times 15 = 225$ blocks incorporating 6% cement (100 blocks per 50kg bag). It has been filled with water and therefore has withstood a maximum head of 2.05m at the wall bottom. Volume = 2720 litres, max hoop stress = 0.19 MPa

Tank 2 is 1880mm high, has internal diameter 1000mm and the same wall thickness, but used $12 \times 14 = 168$ blocks with only 3% cement (180 blocks per 50 kg bag). It has been filled with water and therefore withstood a head of 1.88m at the wall bottom. Construction is continuing to extend its height up to 4m, testing its ability to resist

pressure forces at both 3m and 4m head. Volume = 1476 litres, maximum hoop stress (so far) = 0.13 MPa.

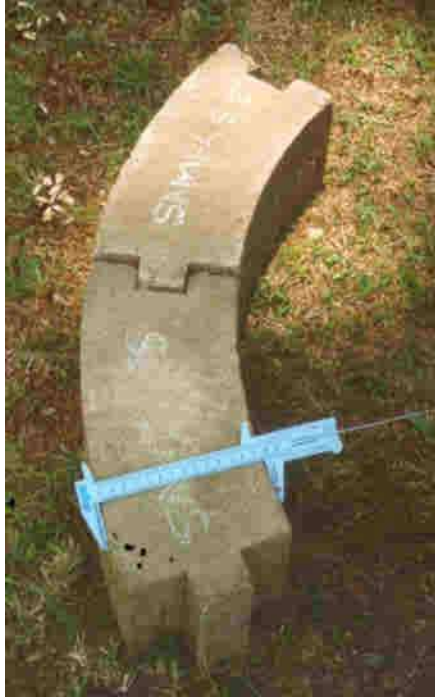
Figure 11 – Showing the interlocking blocks used for the tanks
