Village Handpump Technology: Research and Evaluation
in Asia, Publication IDRC-204e

edited by Donald Sharp and Michael Graham

Village handpump technology : research and evaluation in Asia.
Ottawa, Ont., IDRC, 1982. 72 p. : ill.

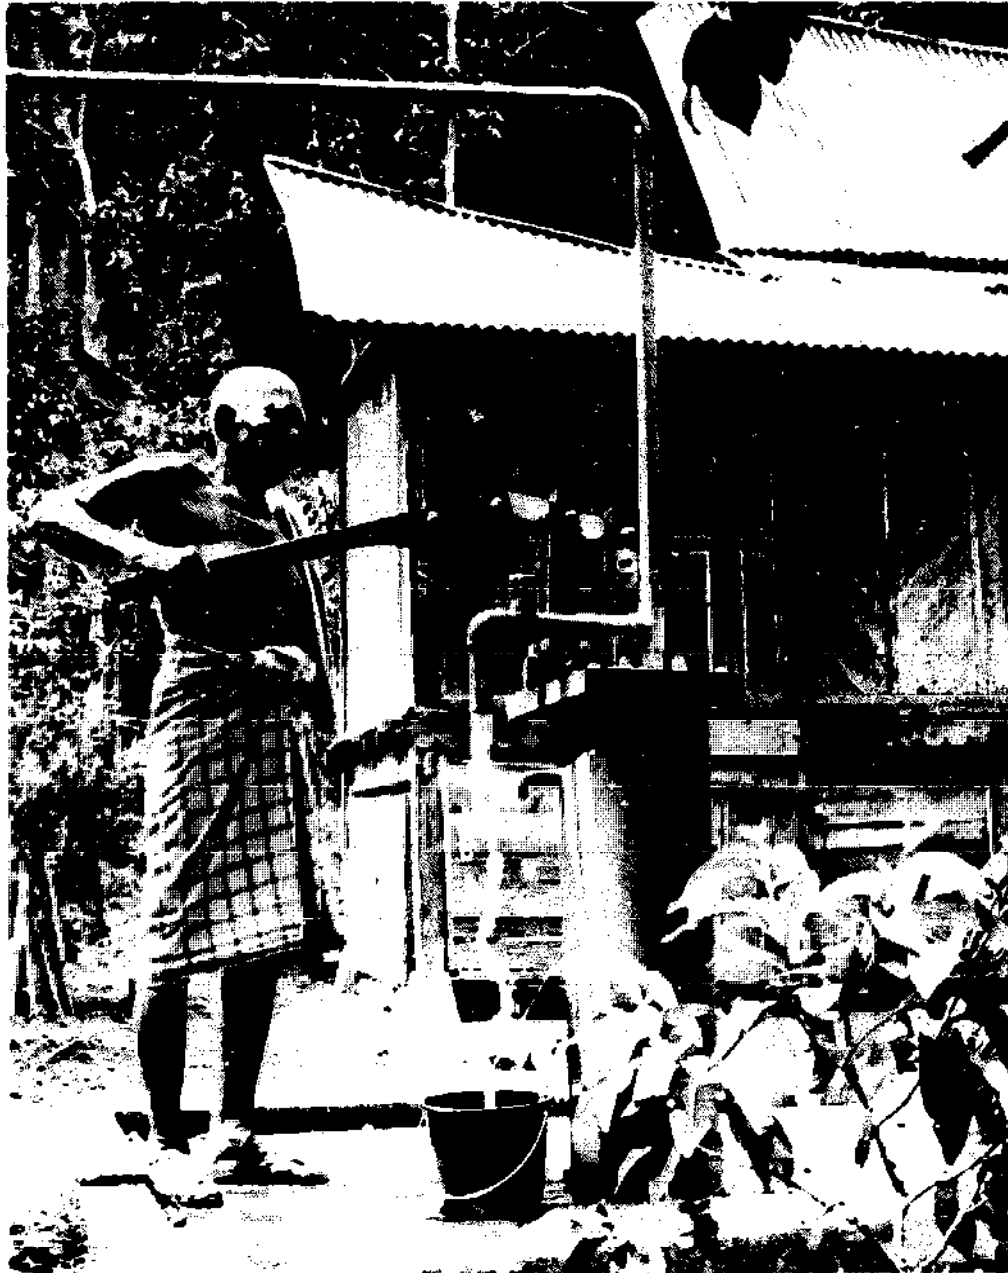
The Waterloo handpump has brought clean water to rural families in Malaysia.
