Laboratory Testing of Handpumps for Developing Countries,  
World Bank Technical Paper #19 from the Rural Water  
Supply Handpumps Project

# Rural Water Supply Handpumps Project

## Laboratory Testing of Handpumps for Developing Countries: Final Technical Report

Consumers' Association Testing and Research Laboratories

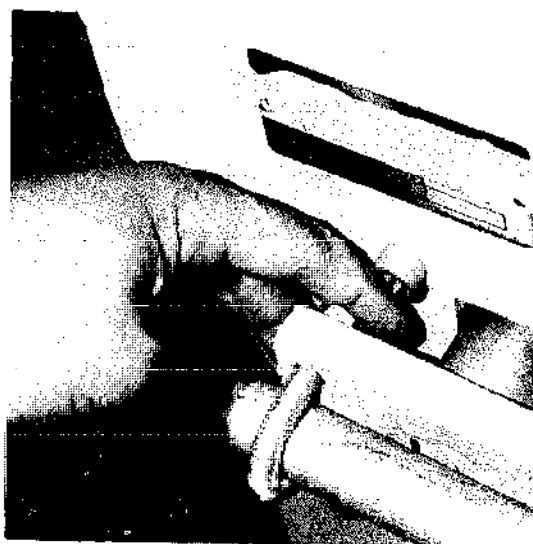
There are a number of potential finger traps between the handle and the pumpstand, see photograph.

Increased clearances would help considerably.

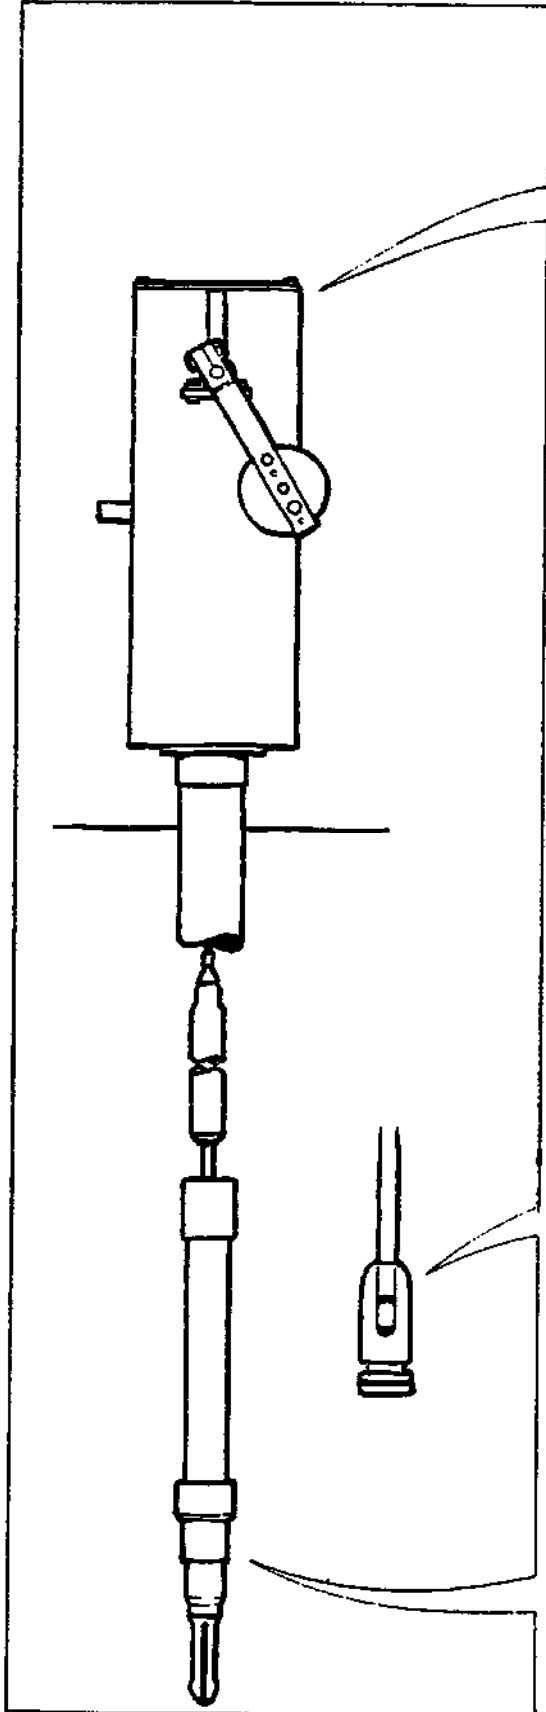
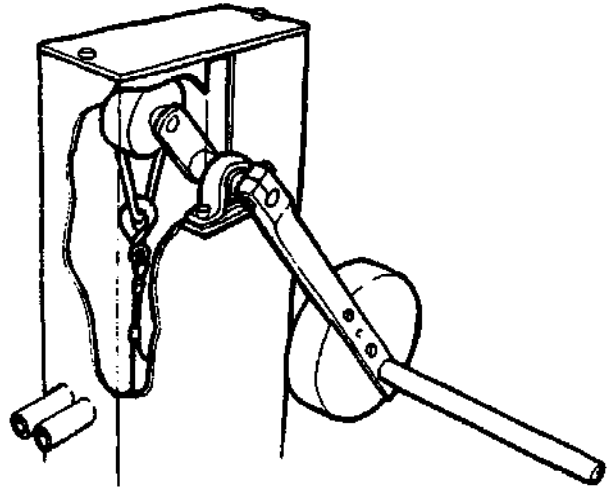
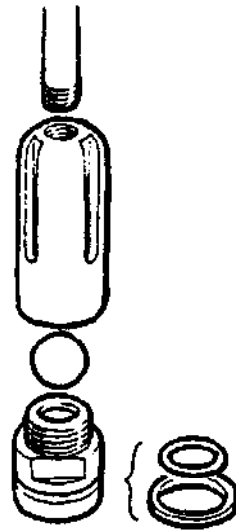
VEW A 18

The pump was tested at 40 revolutions per minute at a simulated head of 45 metres and failed after only 152 hours. The tendency of the operating cable to twist under tension had made the bearing saddle run out of true, causing rapid wear of the saddle and the crankshaft. Both were replaced, and a swivel was fitted in the cable. The handle broke at 277 hours, and the replacement bearing saddle and crankshaft were worn out after 598 hours.

In the final inspection, the plunger seal was found to be worn out, the plunger body was worn and also the plunger rod where it passed through the cylinder top. The cylinder bore was in good condition. There was some play in the big end but in all other respects the pumpstand was in good condition.

61 Bearing saddle running out of true, caused by tendency of cable to twist under tension. Ends of bearing axle pins worn - one split pin and washer replaced.

152 Pronounced misalignment of bearing saddle, severe wear with imminent danger of catastrophic failure. Crankshaft and bearing saddle replaced, swivel fitted between bearing saddle and cable.

277 Handle broken at weld

598 Crank pin severely worn, bearing track much too deep. Bearing saddle replaced by nylon block to continue testing

- (a) Changing the crankshaft plunger blocks to a heavier pattern and redesigning the crankshaft 'big end' assembly.
- (b) Changing the cable to the type designed for hoists and lifts, which will not twist under tension.
- (c) Supplying polished solid handles.
- (d) Attaching the handles more securely to the ends of the crankshaft and repositioning the counterweights.
- (e) Making the cylinder easier to dismantle, to replace the plunger seals.
- (f) Single rigid spout, with slots to prevent faecal contamination.

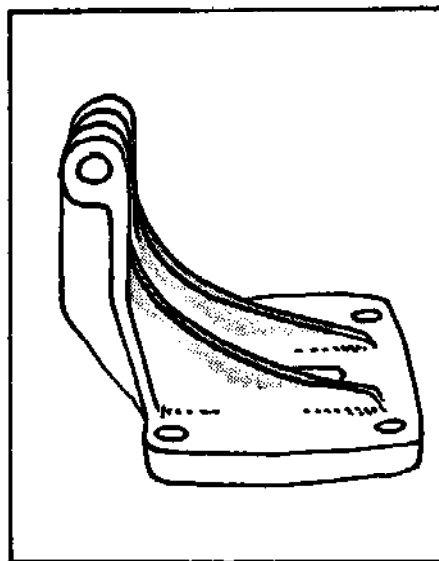
This pump was found to be leaking from the cylinder end caps. One of the castings was found to be porous. All spare castings were also found to be defective. The original castings were therefore fitted for the remaining performance and endurance tests. In subsequent tests, leakage of the end caps was found to be not significant.

The webs on the cylinder top casting should be extended to make it more robust - see illustration.

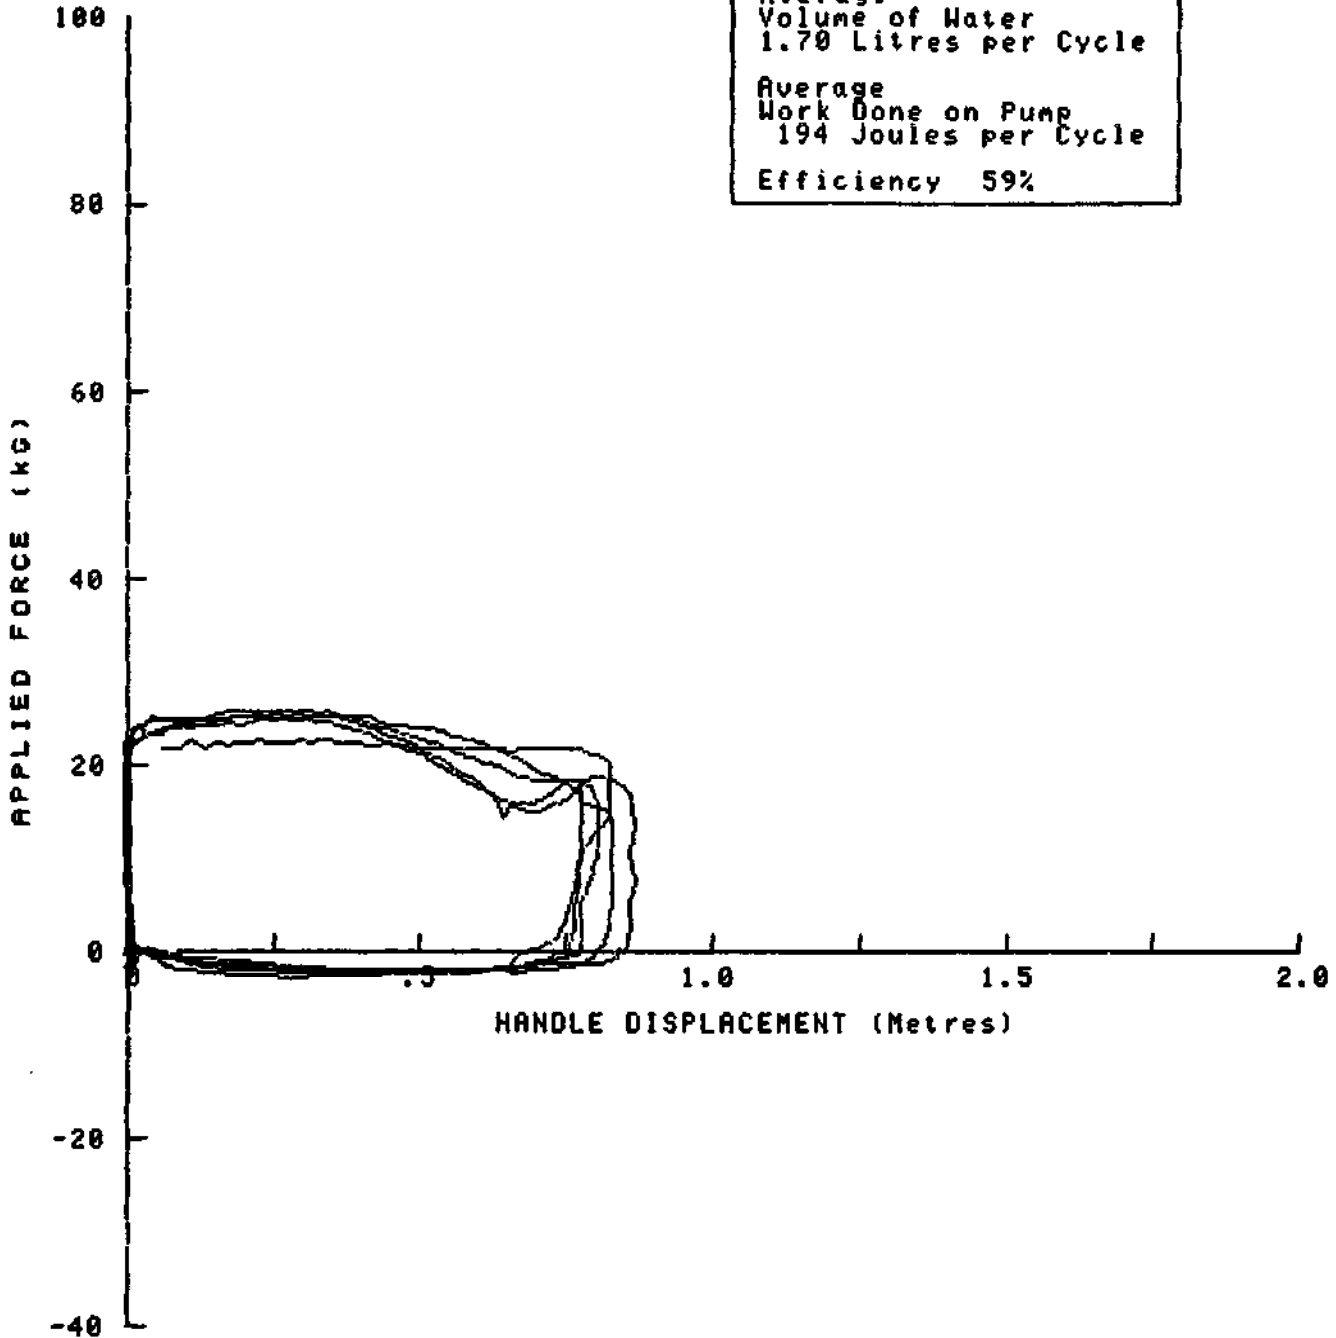
A marginal reduction in efficiency can be seen when the surge chamber is not used.

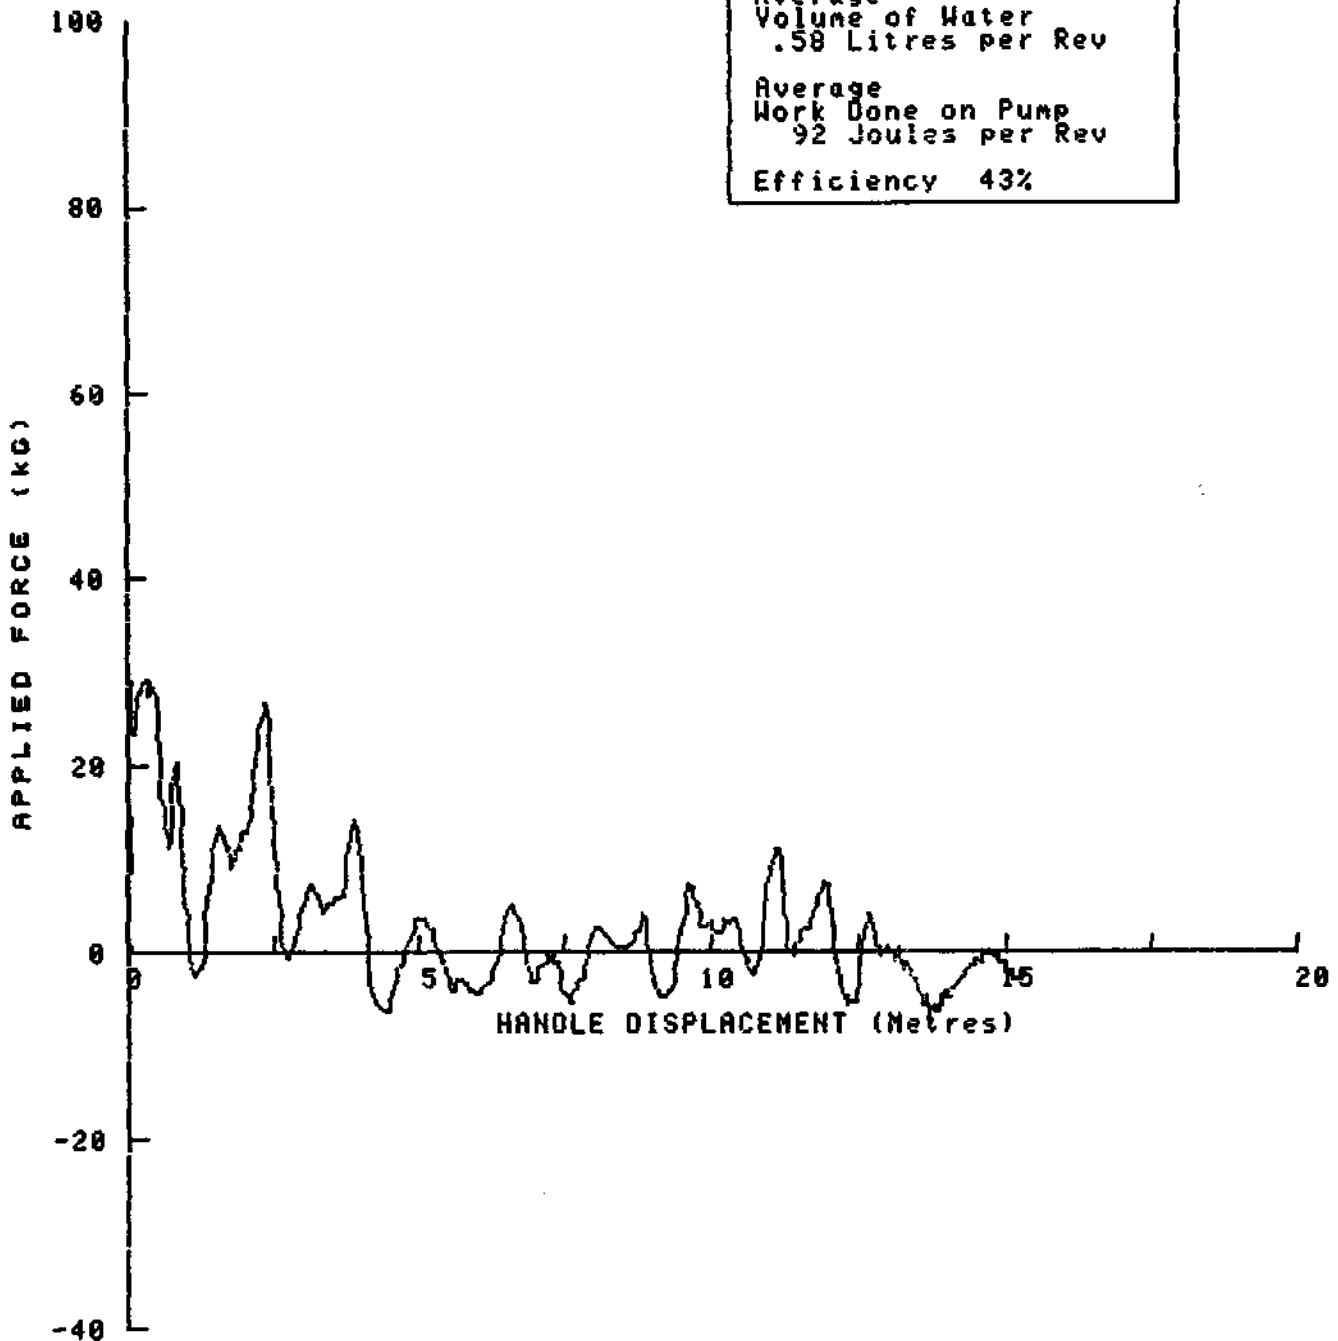
By limiting the test to 9 revolutions the initial effort to start the pump from rest has reduced the average efficiency. This would be higher if the test was carried out over a larger number of revolutions.

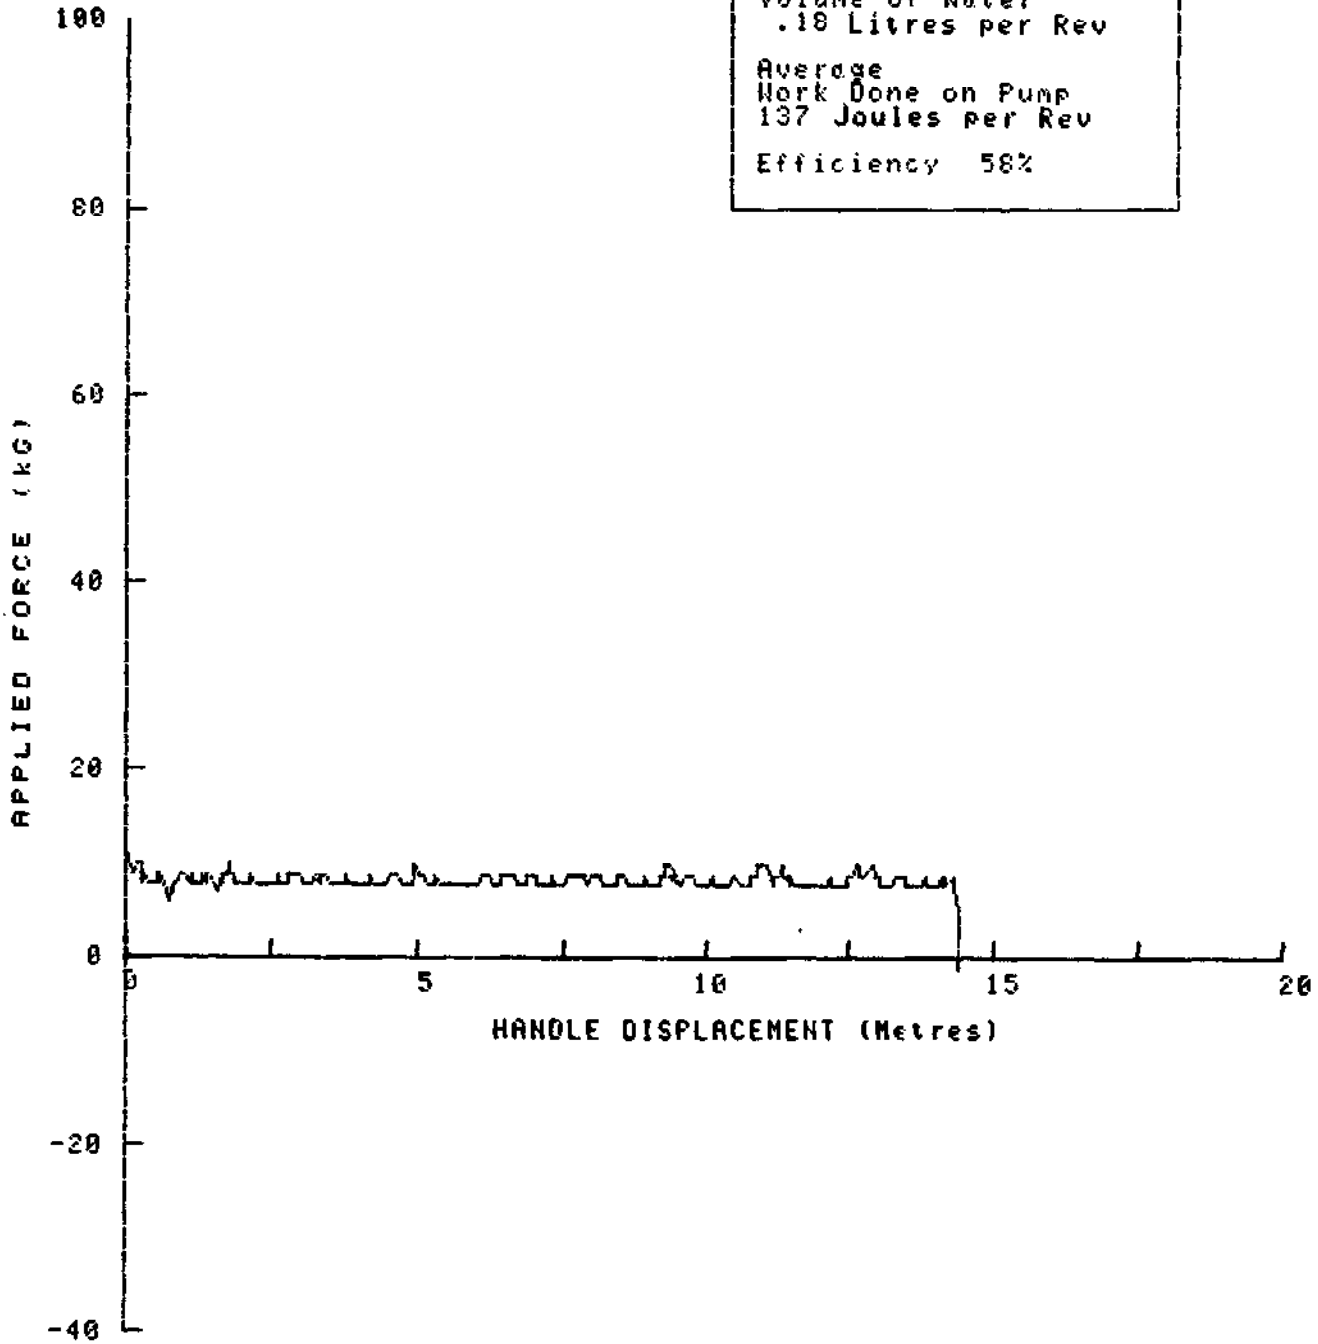
The irregularities on the curves are probably due to system noise.

The diagrams indicate a reduction of friction combined with an increase in volume flow.

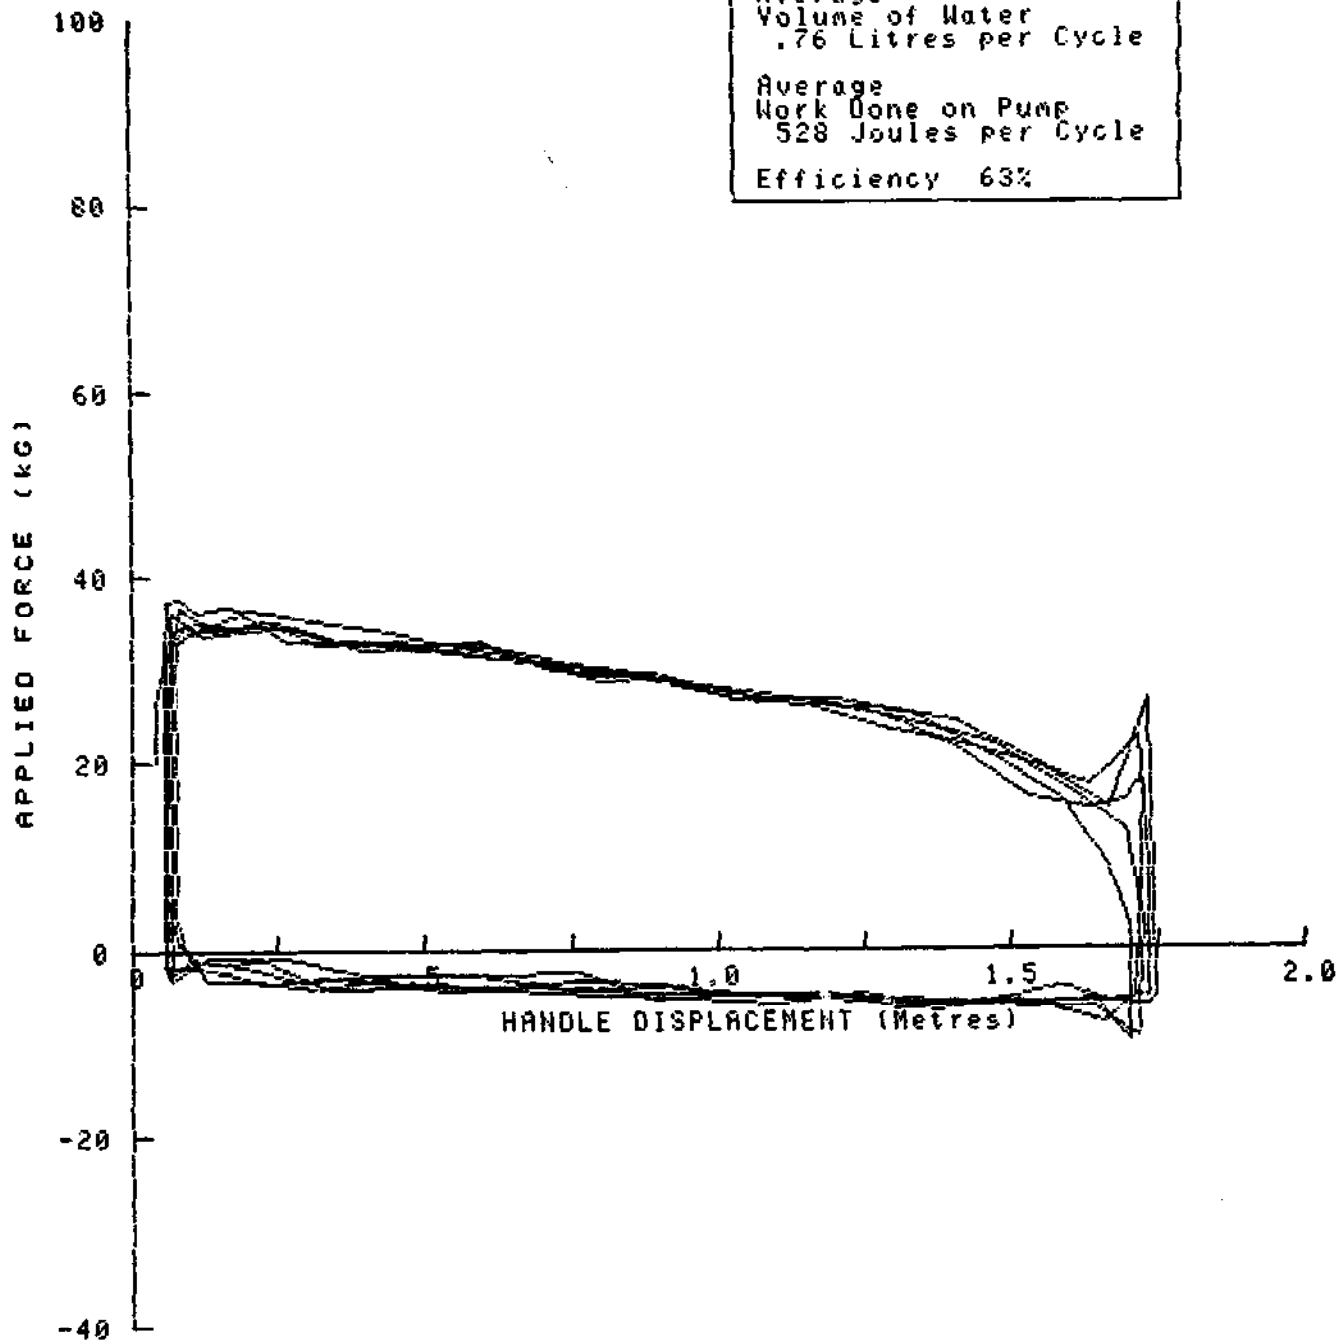
Differences between the profiles of the curves before and after endurance are the result of severe wear at the handle pivot.

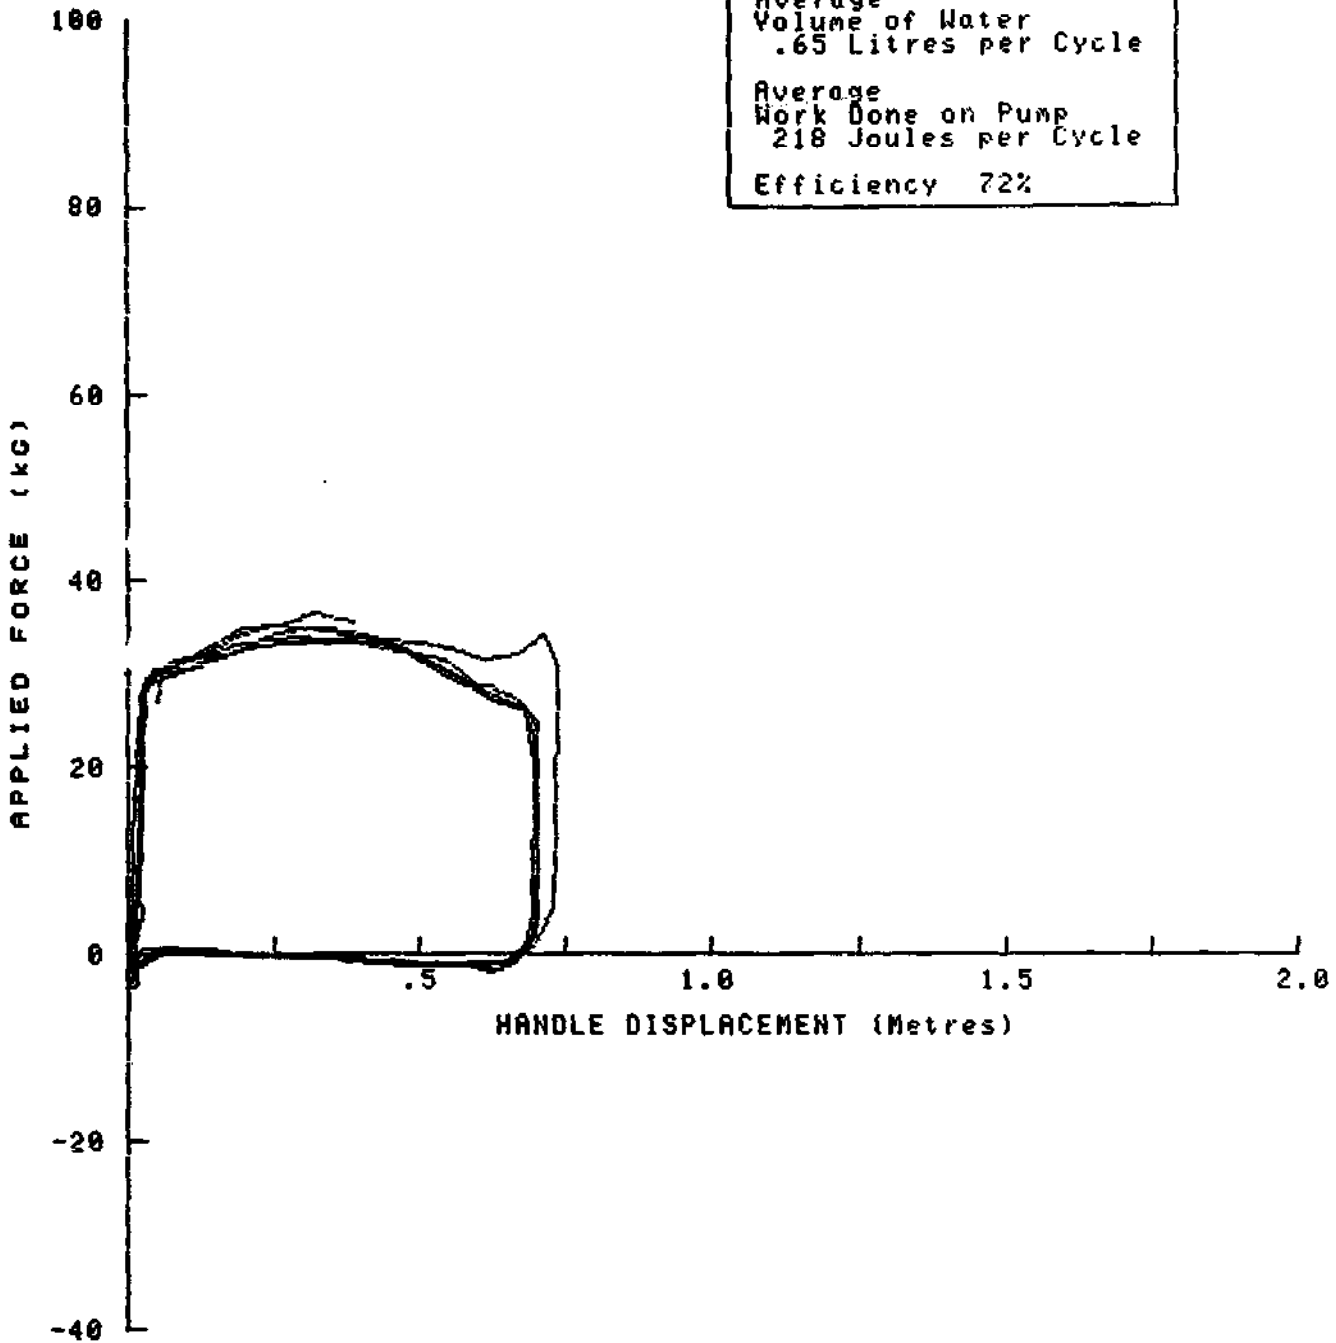
**PUMP PERFORMANCE after endurance  
CODE G Nira AF76**

Differences in the profiles of the curves at the beginning of the delivery stroke, and the reduction of effort on the return stroke, probably illustrate the improved conformity of the rubber cup washer after bedding in.

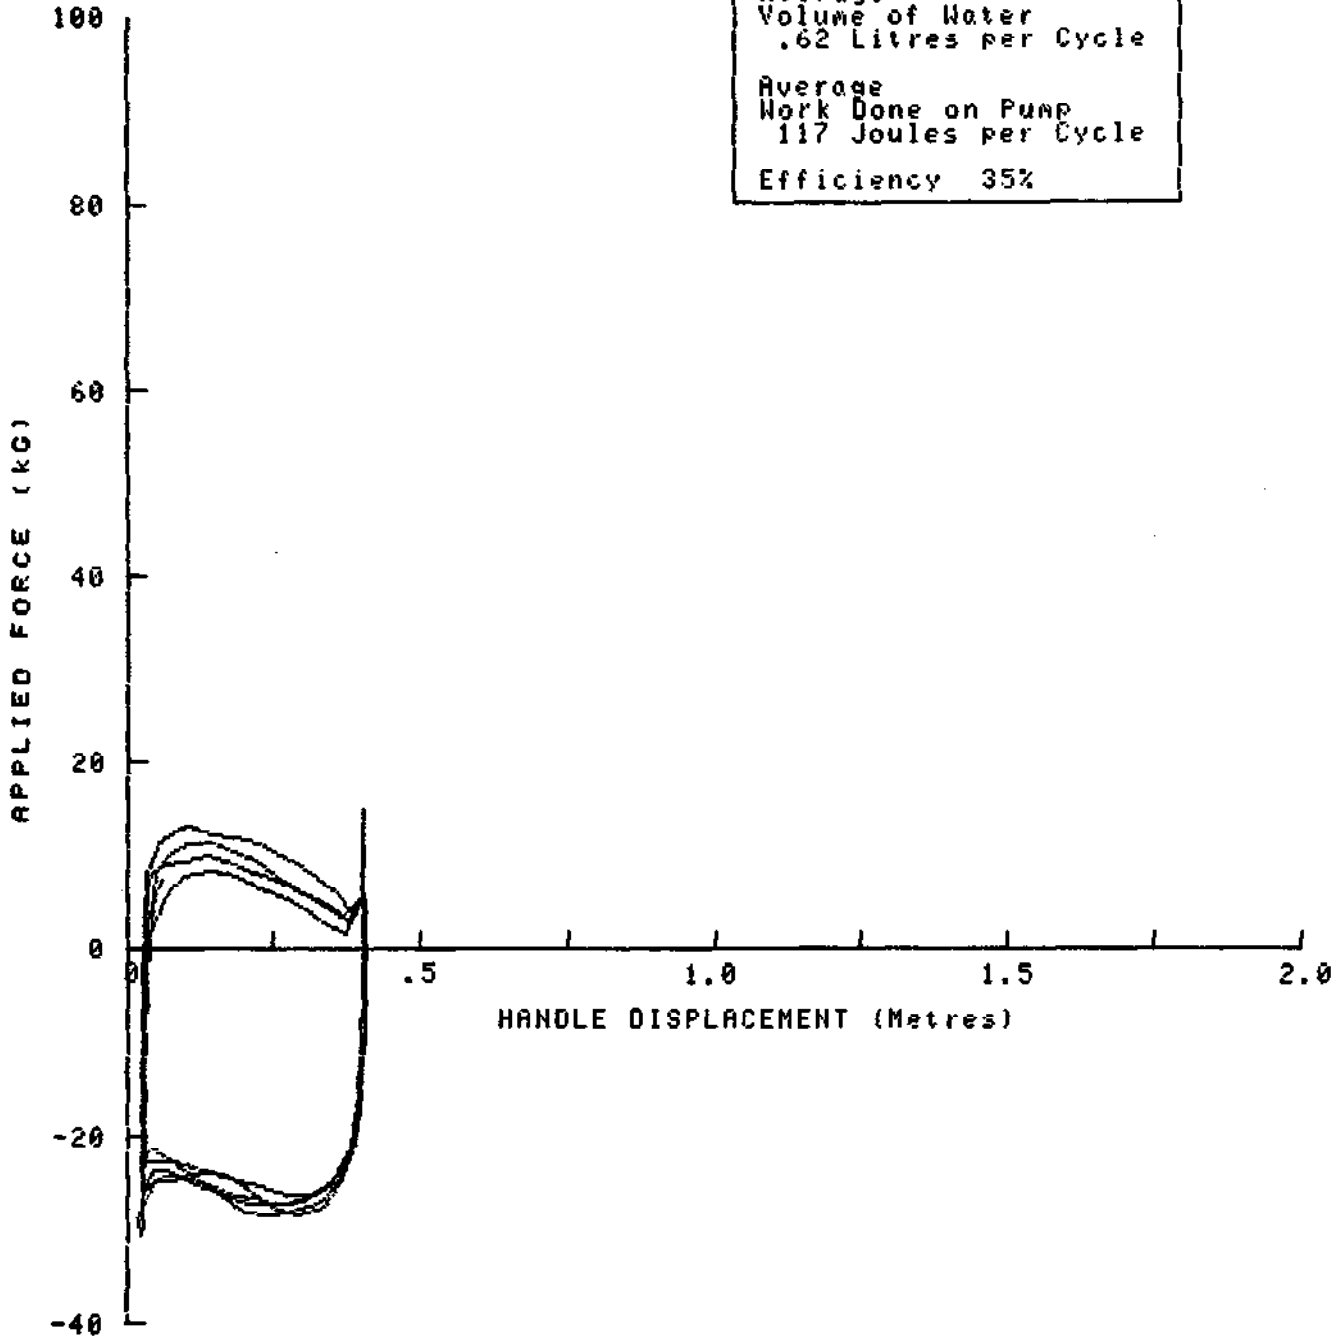
**PUMP PERFORMANCE after ENDURANCE**  
**CODE H Ethiopia Type BP50**

As this pump discharges on the lifting stroke, the power stroke is below the horizontal coordinate. The reduction in force on the power stroke after endurance shows the leakage past the plunger.

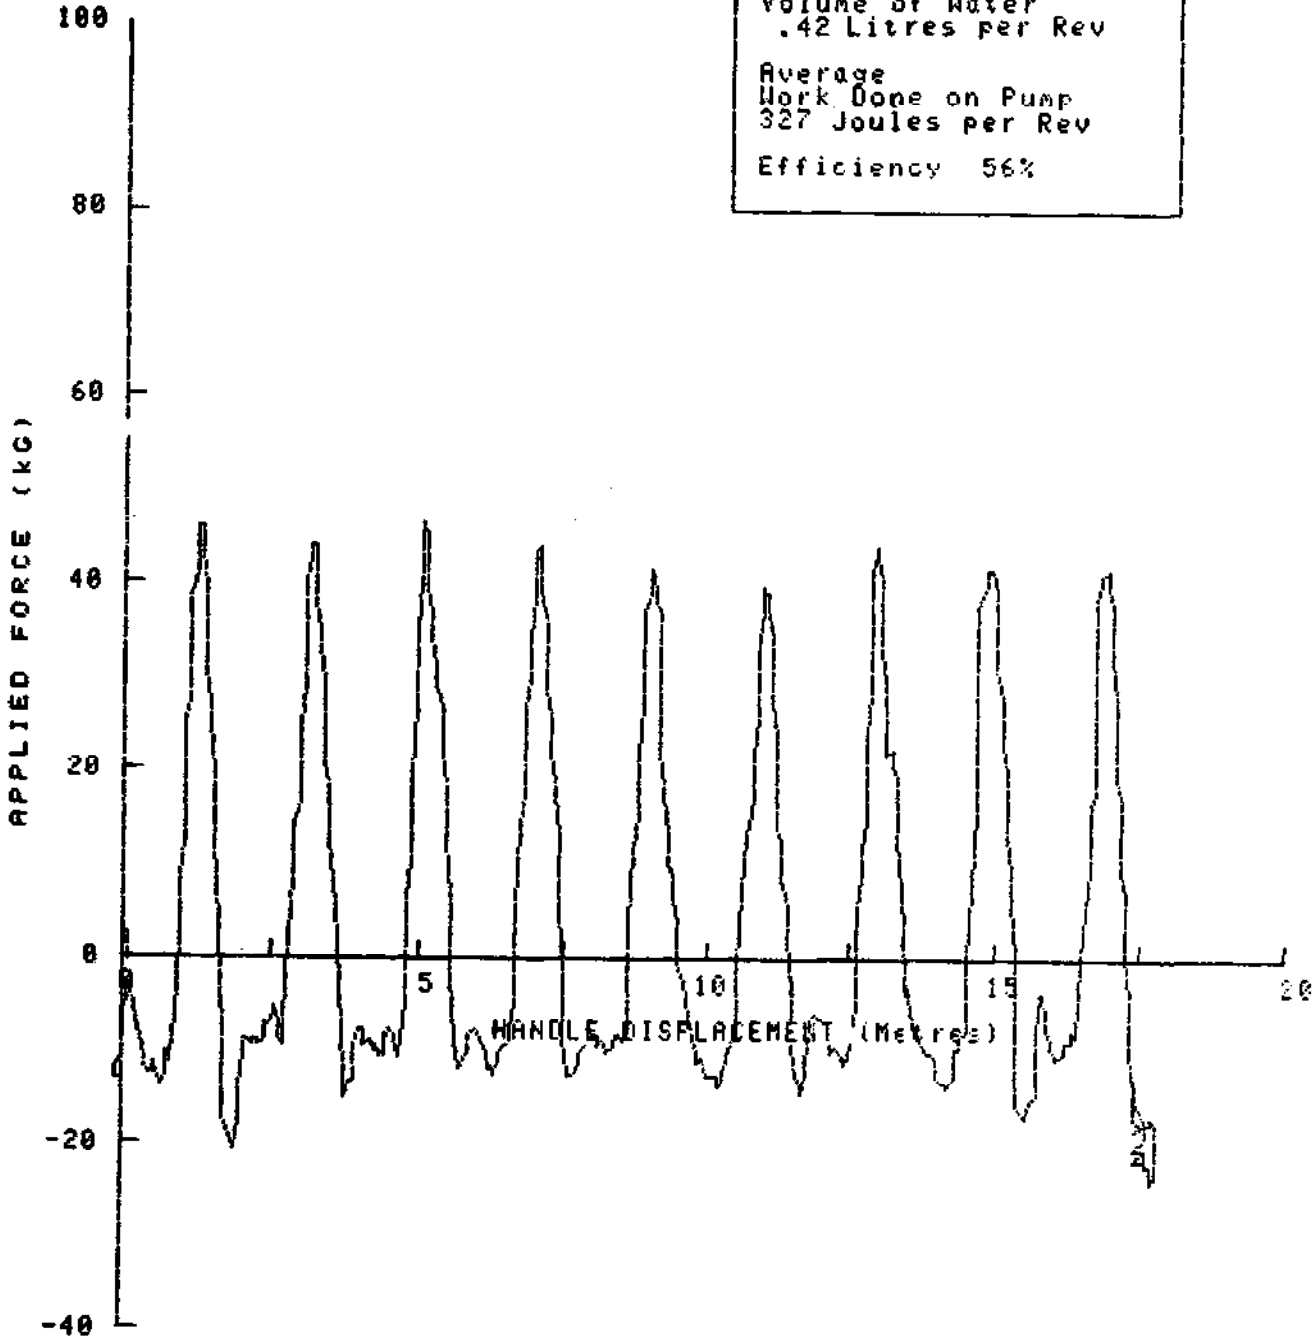
**PUMP PERFORMANCE after ENDURANCE**  
**CODE J VEW A18**

The results before and after endurance should not be directly compared because the plunger seal was replaced during the endurance test. Differences in the profiles of the curves may also reflect the changed position of the handle counterweights.

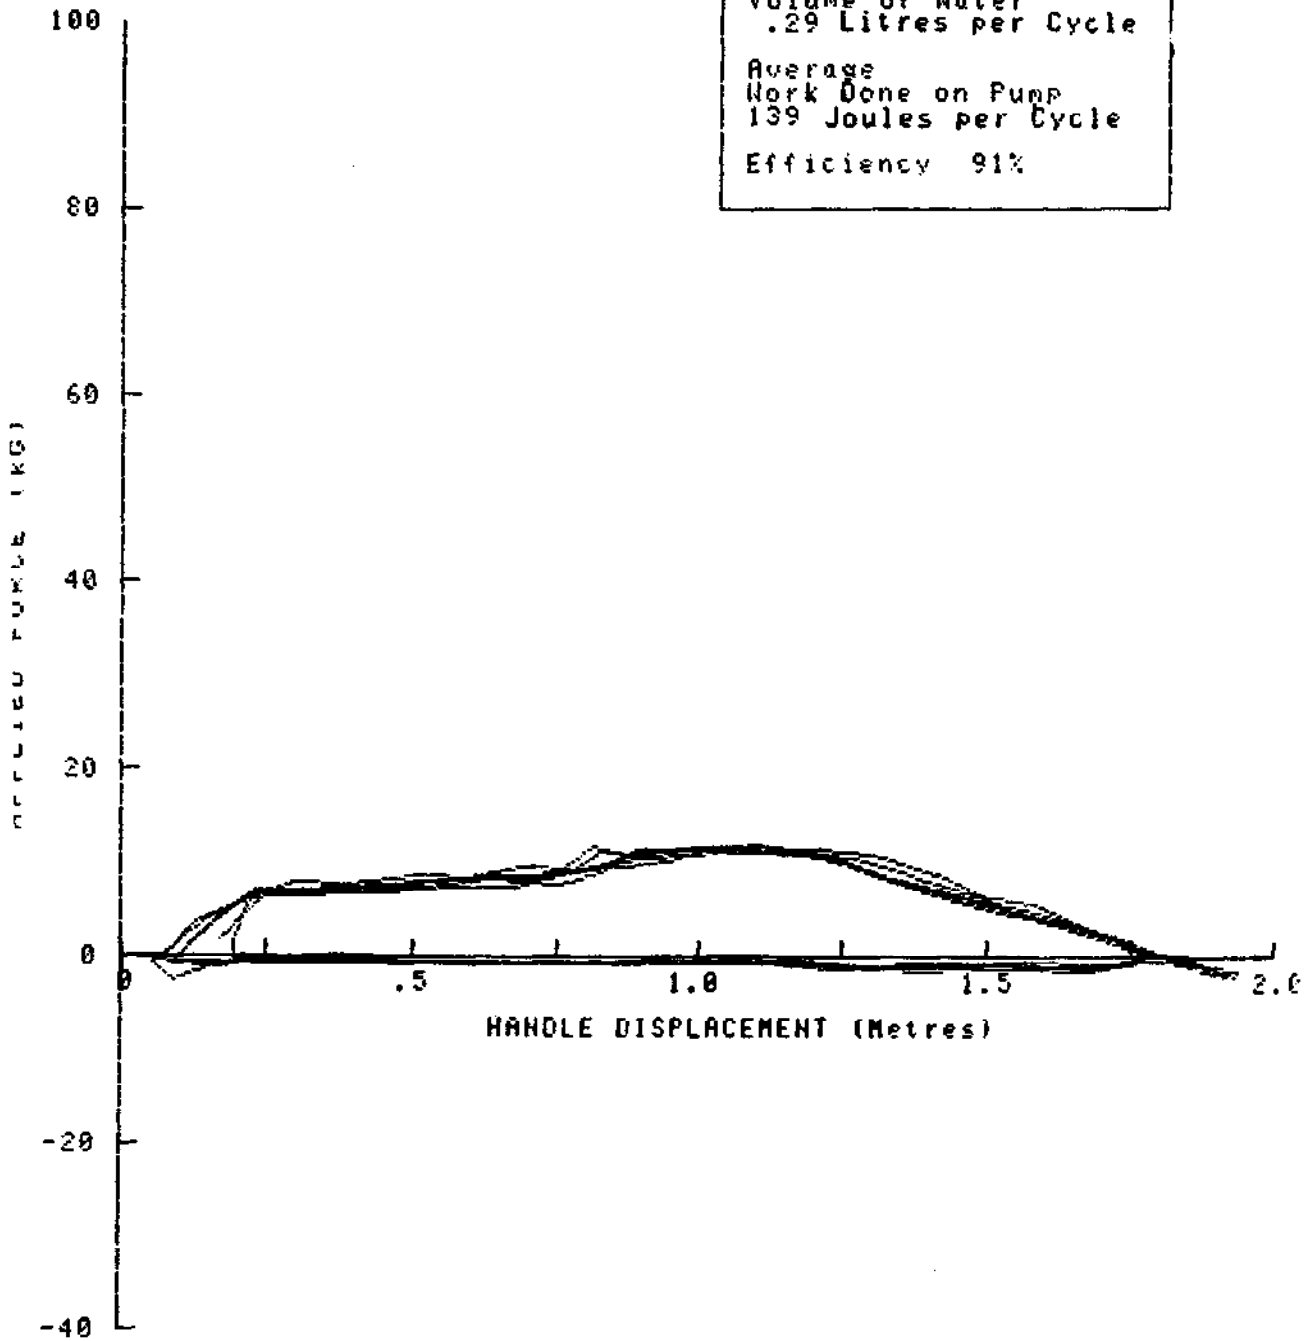
# PUMP PERFORMANCE after ENDURANCE CODE K Jetmatic

The results illustrate reduced friction after endurance testing.

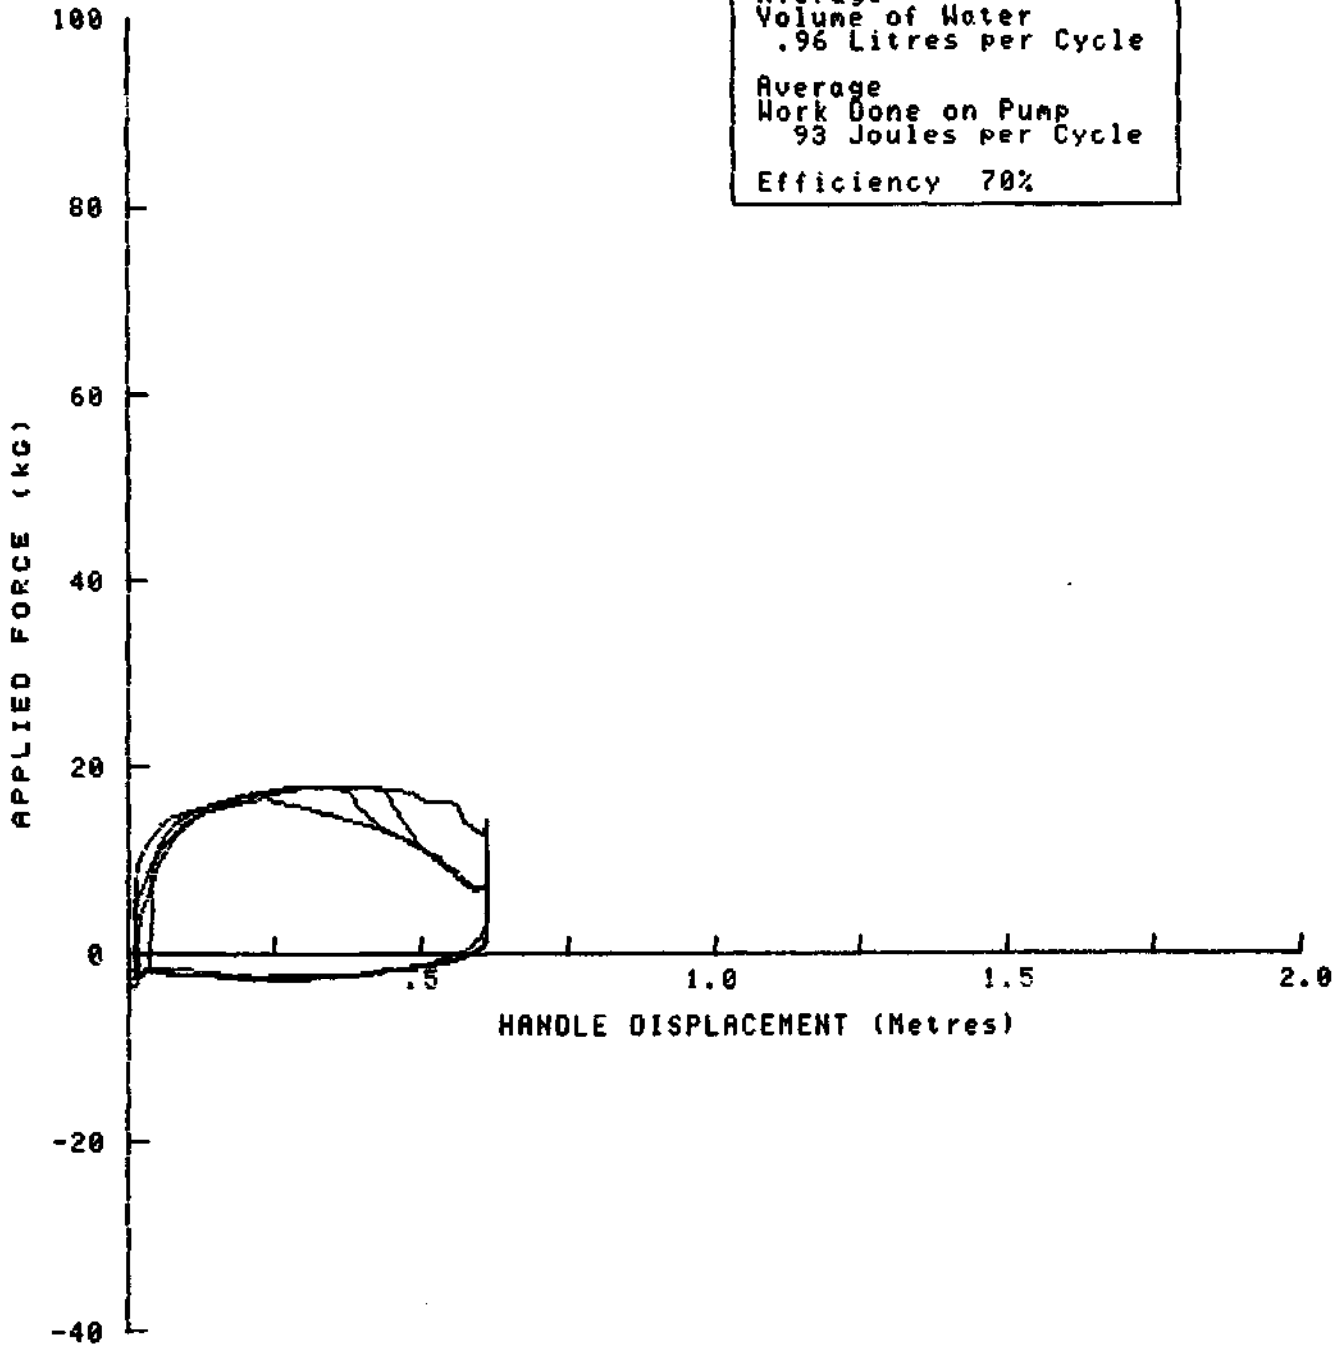
The results before endurance testing suggest some irregularities in the performance of the plunger seal or valve.

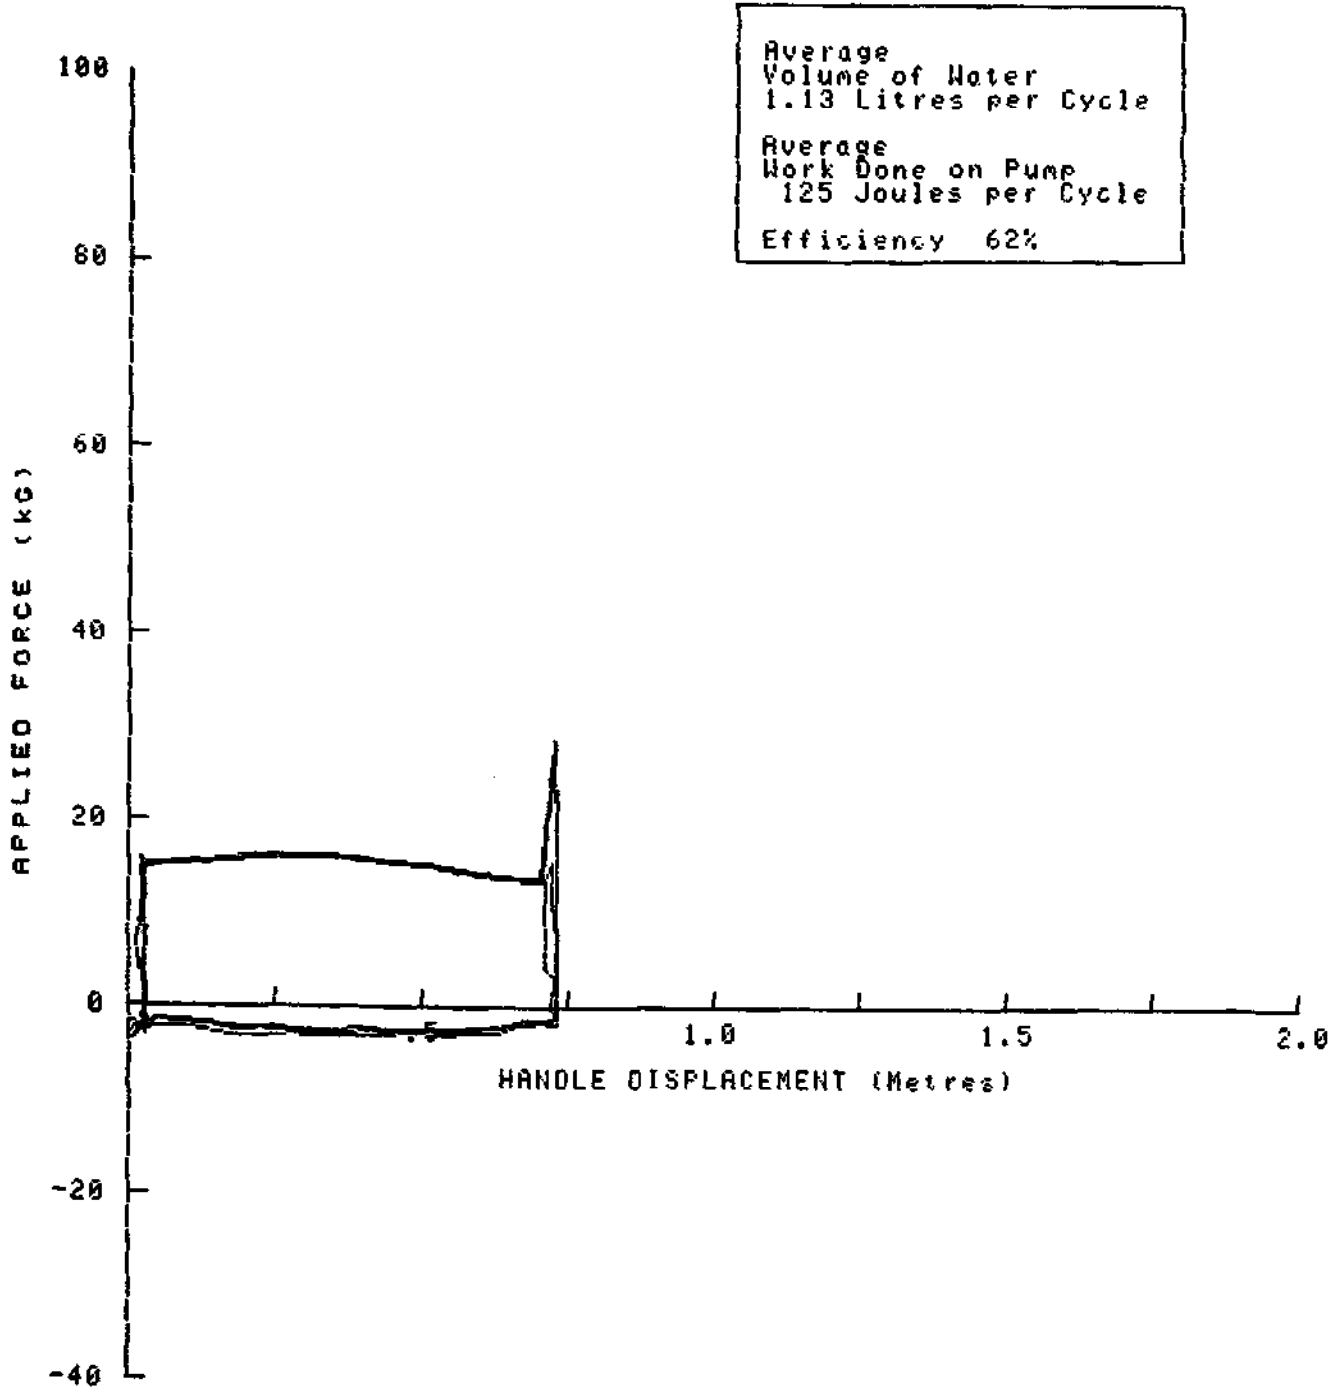
### PUMP PERFORMANCE after endurance CODE L Bandung

No irregularities are indicated, suggesting that the plunger seal and valve were working satisfactorily during this test. Note that the plunger seal was replaced three times during the endurance test.

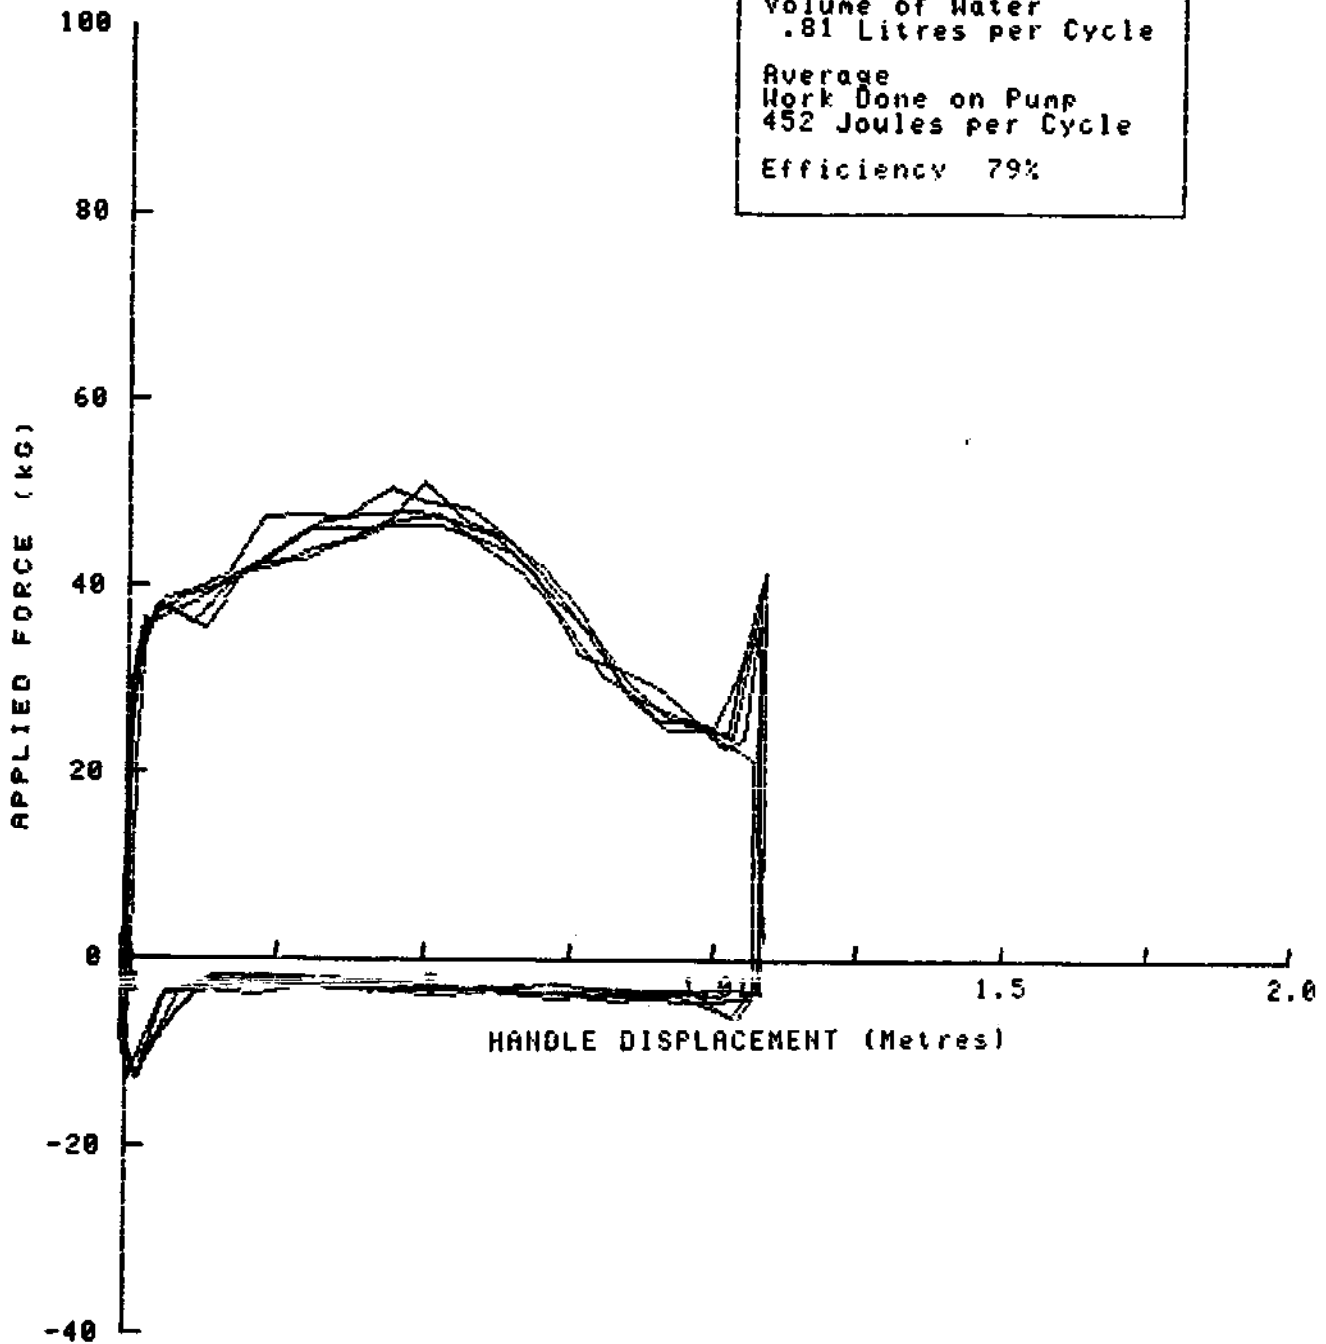
### PUMP PERFORMANCE after ENDURANCE CODE M Sumber Banyu

The results before and after endurance should not be directly compared because the cylinder components were replaced during the endurance test.
