Capacity Loss in PV Batteries and Recovery Procedures

Tom Hund

Photovoltaic System Applications Department
Sandia National Laboratories*, Albuquerque, NM 87185-0753

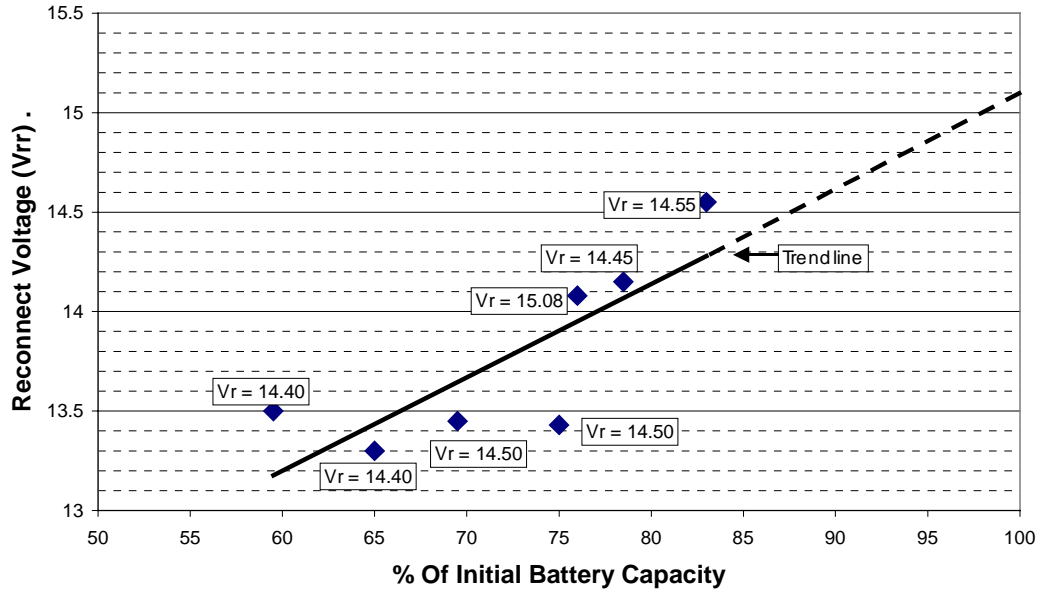
Initial PV battery testing [3] using vented (flooded) thin plate deep-cycle lead/antimony batteries and PV charge controllers purchased using the charge controller manufacturer's recommended regulation voltage resulted in significant battery capacity losses, in most cases due to under charging. Figure 1 summarizes the results from this work and plots the charge controller array reconnect voltage (V_{rr}) vs. percent of initial battery capacity. The associated array disconnect voltage or regulation voltage (V_r) is also included for comparison purposes. The plot of V_{rr} vs. percent of initial battery capacity provides a much stronger relationship to battery capacity than V_r and battery capacity. When a constant voltage or pulse width modulated (PWM) charge controller is used, the V_{rr} and V_r are the same or nearly the same value. The best example of the strong effect that V_{rr} has on capacity is shown by the third data point from the top where V_r is 15.08 volts and V_{rr} is 14.08 volts. Even though this battery used the highest regulation voltage, it did not result in an improved battery capacity relative to the other V_{rr} values. Also the trendline projects that a V_{rr} voltage over 15.0 volts (2.50 vpc) is required for maintaining 100% of initial battery capacity. This is consistent with the manufacturer's (Trojan Battery) recommendation for a full charge or an equalizing charge. Trojan Battery recommends that 15.5 volts (2.58 vpc) for 2 to 4-hours be used for equalization. The full or equalization charge is usually not recommended in PV systems every cycle because of the dramatic increase in water consumption and resulting maintenance. Usually Trojan Battery will recommend an equalization charge about every 10th cycle in deep-cycle service to 80% depth of discharge. In PV systems a compromise between battery capacity and maintenance is reached by using a temperature compensated regulation voltage that maintains the battery to at least 80% of its initial capacity.

Array Reconnect Voltage (Vrr) vs. Battery Capacity
Avg. of 4 and 8 Month Capacity Tests

As suggested by Figure 1, a minimum vented lead/antimony battery regulation voltage of 14.4 volts (2.40 vpc) for constant voltage/PWM charging and 14.7 volts Vr (2.45 vpc) 13.7 volts Vrr (2.28 vpc) for on/off charging at 25°C is required to maintain the battery at about 80% of its initial capacity. In addition to the regulation voltages, batteries in stand-alone PV systems require adequate PV charging current measured in amp-hours (Ah) to ensure adequate battery recovery rates and overcharge. The Tramway PV systems used a minimum PV Ah to load Ah ratio of 1.27. The battery capacity from eight Tramway batteries after 2.5 years of operation indicated that battery capacity was 63 to 90% with an average capacity of 82% of the initial installed value. The batteries using constant voltage charge controllers exhibited slightly higher capacity values between 80 and 90% with an average value of 86% of their initial installed capacity. Additional field tests at the Venice, Florida lighting systems [5] with the same voltage setpoints and system design as the Tramway systems, resulted in batteries operating at 85 to 90% of their initial capacity after 1 year. The above golf cart batteries are expected to last over 5 years in PV systems before normal wear-out causes major capacity loss. In summary, the field results are very similar to the battery capacity values predicted in Figure 1 for the above voltage setpoints.

degradation. The post mortem results from the batteries used in Figure 1 have identified at least two obvious mechanisms for battery capacity loss in PV systems. In the most severe cases where battery capacity is in the 60% range, the battery will be suffering from electrolyte stratification and gas bubble entrapment. In intermediate cases where the battery capacity is around 80%, electrolyte gas bubble entrapment tends to block the electrolyte from circulating to the active material and this results in a temporary reduction in capacity. The other premature capacity loss mechanisms documented in numerous publications include excessive sulfation and degradation of the positive active mass (PAM). The less obvious internal capacity loss mechanisms such as excessive sulfation and degradation of PAM are usually not recoverable with a full recharge like stratification and gas bubble entrapment. It is important to understand that battery sulfation will only become excessive after weeks to months in a discharged condition.

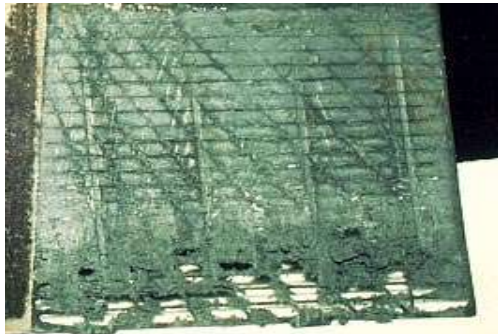
Figure 2 is a photograph of a PV battery that was damaged due to long term stratification causing negative plate deterioration. Note that only the bottom of the plate experienced loss of grid and active material from stratification. The top half of the plate contributed very little capacity to the battery because the electrolyte was at a very low specific gravity. At the bottom of the plate the electrolyte was at an excessively high specific gravity causing the loss of active material. The high acid concentration consumes the bottom of the grid resulting in the loss of active plate material. The operating capacity for this battery was probably about 60% of its

**Figure 2: Electrolyte Stratification
Causing Negative Plate Grid
Deterioration**

initial capacity over most of its life. In a healthy battery, normal wear-out occurs from uniform positive plate grid corrosion and the negative plate remains intact.

Electrolyte stratification is caused when the heavier acid/water mixture falls to the bottom of the battery and the lighter water floats to the top of the battery during recharge. If the gassing rate on recharge is limited by a low regulation voltage and/or is cut short because of cloudy

weather, then the required mixing of the electrolyte will not occur. Recovery requires extended heavy gassing of the battery for hours at voltages at or above 14.4 volts (2.40 vpc).

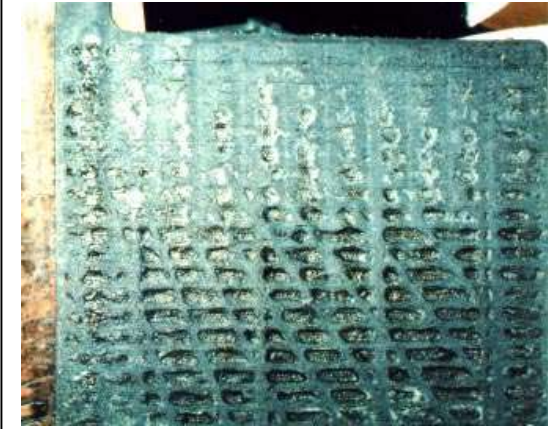
Figure 3 is a photograph of a negative plate that shows signs of gas bubbles for an

Figure 3: Gas Pocket Marks On Negative Plate

extended period. The oval looking pox marks are left in the negative active material because of the differences in plate activity between areas with and without gas bubbles. The battery capacity is usually in the 60 to 80% range and can be easily recovered with heavy gassing. Gas bubble removal requires some vibration or motion of the battery case and/or heavy gassing.

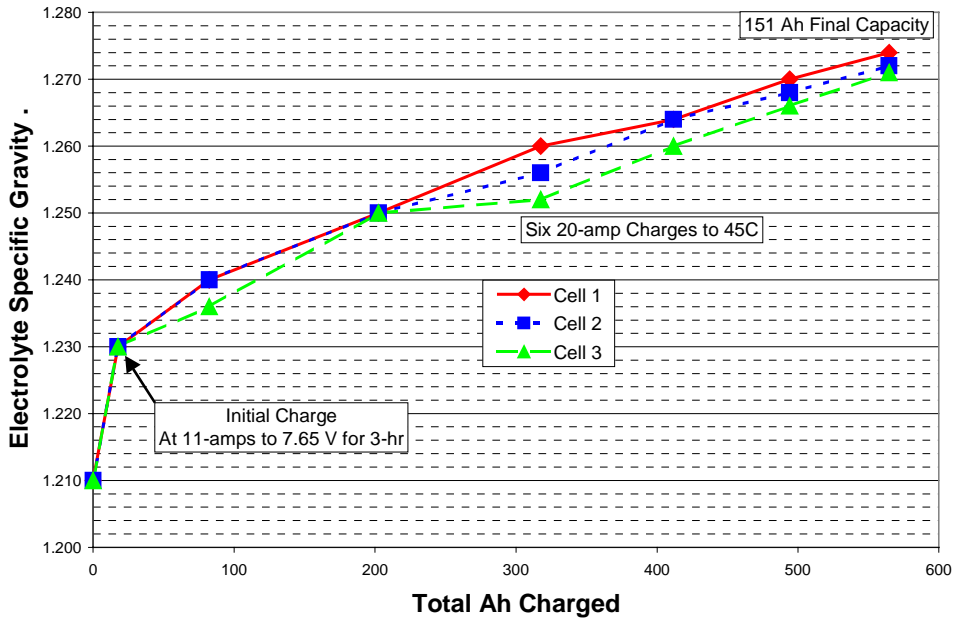
The best indicator that a vented battery is suffering from “hard” sulfation is a battery history of being undercharged and a low specific gravity (<1.250) after a full recharge to at least 15.3 volts (2.55 vpc) for a minimum of 3 hours. Figure 4 shows electrolyte specific gravity plotted vs. the number of Ah recharged into the 6-volt battery at a 20-amp, 10-hour (C/10) rate as per manufacturer’s recovery recommendations. In this case the battery is clearly suffering from “hard” sulfation as indicated by the low battery specific gravity of 1.230 after an equalization charge to 7.65 volts (2.55 vpc) for 3 hours. Each data point after the initial charge to 7.65

volts is a constant current charge at 20-amperes terminated when the battery reaches 45°C. After battery cool down to room temperature, another 20-amp charge is initiated until the specific gravity reached the manufacturers recommended value of 1.277. The result after nearly 600 Ah recharged into the battery was a recovery to normal specific gravity (~1.277) and 80% of the battery's initial capacity after 2 years of normal PV service and 6 months of cycling between 20 and 30% capacity. As indicated in the above section on the Tramway PV lighting systems, 80% of initial capacity is typical of batteries that were cycled under Tramway PV conditions for 2.5 years.

Desulfation Charge For Tramway Golf Cart Battery

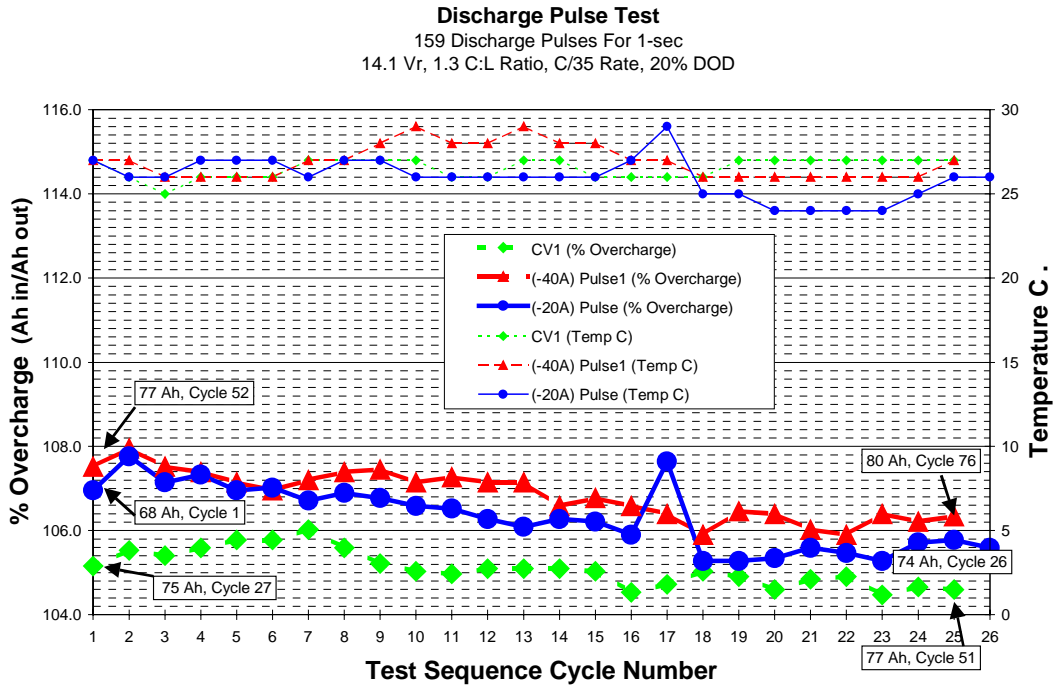
The results in Figure 5 show that 0.16 to 0.32 additional Ah were charged into the battery every cycle over the 2.6-hour charge at regulation voltage. The additional charged Ah translate into a 1 to 2% increase in overcharge during initial testing from about 105%, to 106% and 107% due to the depolarization discharge pulse. The battery manufacturer usually recommends about 110% overcharge for a full charge. Near the end of the test sequence in Figure 6, after about 100 cycles, significant changes occurred in the battery resulting in overcharge increases to 114% from about 107% initially. The overcharge increase also occurred in the baseline constant voltage charge, which again was slightly lower by 1 to 3%. Battery capacity measurements after a complete 12-hour finish-charge and the end of each test sequence do not show a clear trend toward improvement. Only the initial tests using both constant voltage and discharge-pulse charging show small increases of 2 to 6 Ah in battery capacity. At the end of the 7-month test sequence and 175 cycles, battery capacity was clearly dropping from 80 Ah to about 67 Ah in both constant voltage and discharge-pulse charging. The capacity loss in Figure 6 began to occur after 100 cycles. At this time it is not known if the increase in overcharge to 114% from 107% is due to the depolarization discharge pulses or to battery aging characteristics. Historically this battery did not demonstrate an increase in overcharge unless it was left in a discharged condition. No deficit charge cycling was conducted on this battery. More testing would be required to better establish the cause of the increase in overcharge over time and establish the value of this charge algorithm in life-cycle battery tests and fielded PV systems.
