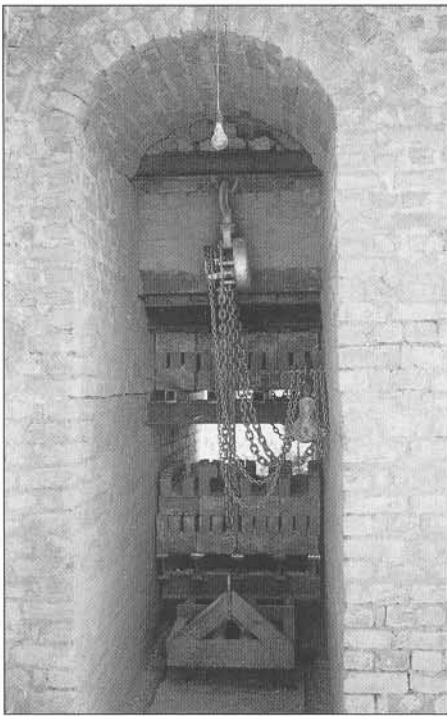
Fig. 4: Shaft 1: Chain pulley unloading arrangement

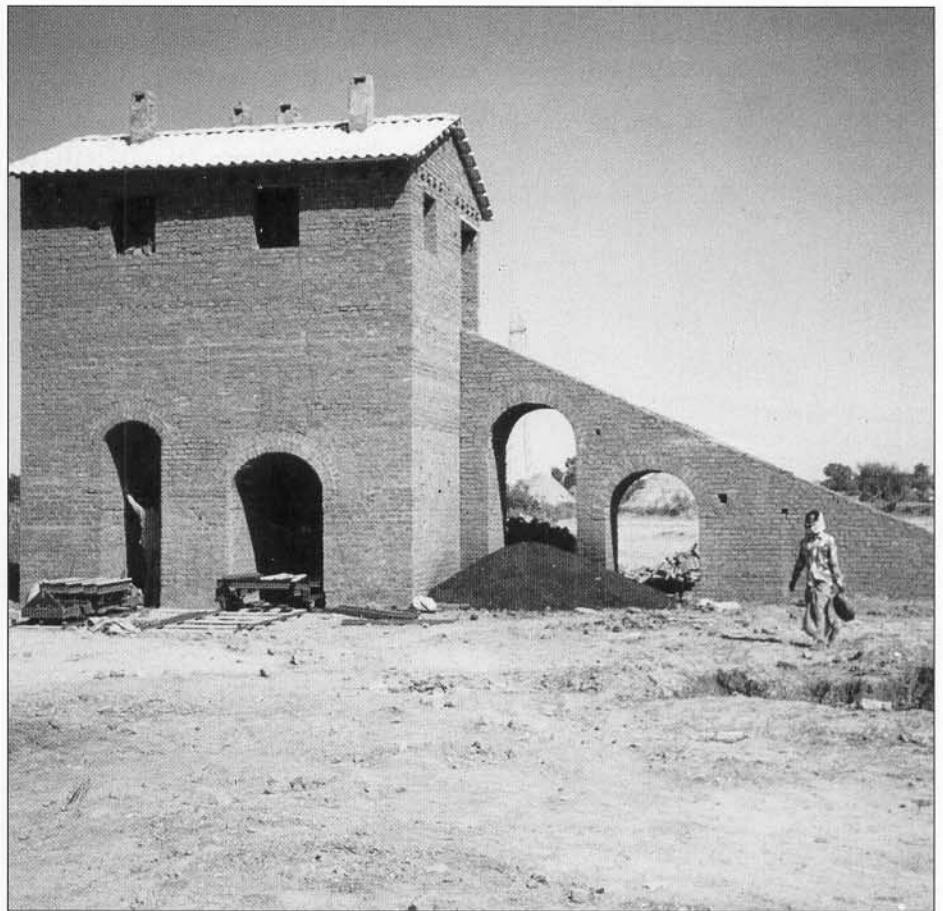
Fig. 7: Kiln after completion of construction before modification

These modification were incorporated in the kiln during October - November 1996 within the idle period of shut down due to rainy season (Fig. 7 and 8).

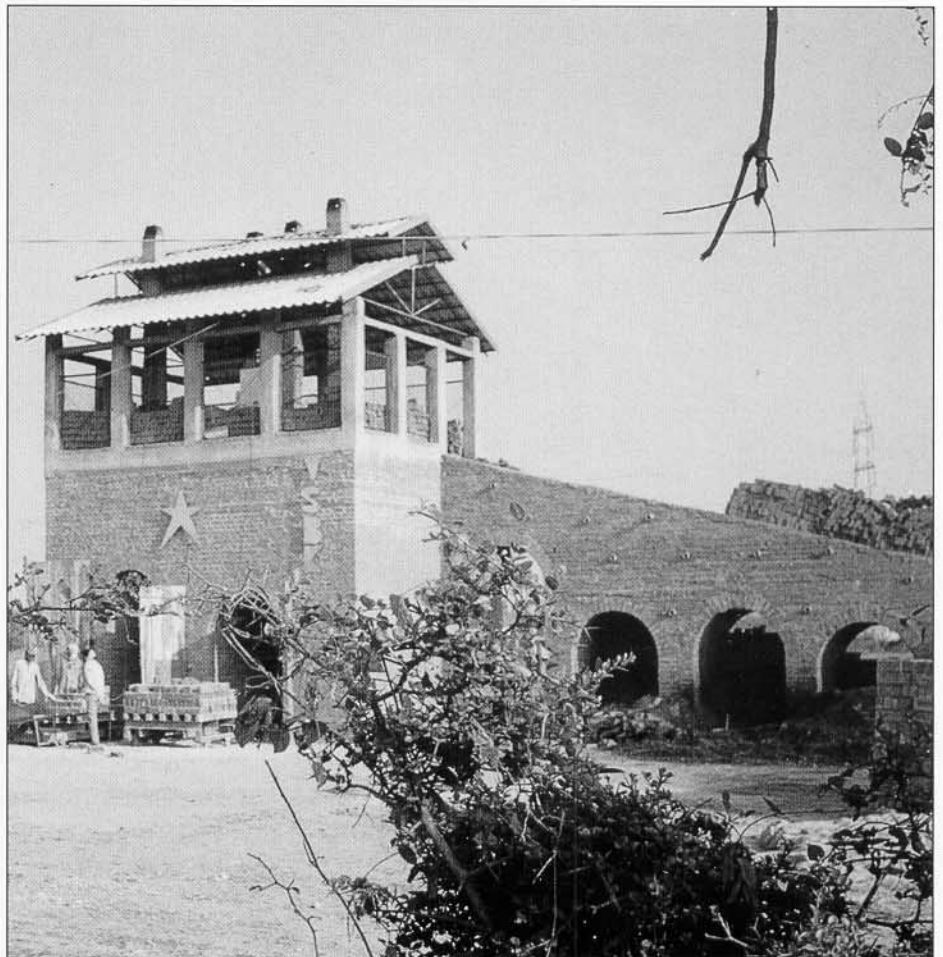
Fig. 8: Kiln after modification

- Open out the loading platform by replacing the walls with columns and grills,
- Increase height of shafts by one batch from 8 to 9,
- Increase the height of stack by about 1 metre,
- Increase the gap in roof monitor from 350mm to 700mm,
- Provide flues and dampers at two levels at the top of the shaft,
