Building to Resist the Effect of Wind, Volume 3:
A Guide for Improved Masonry and Timber
Connections in Buildings

VOLUME 3. A Guide for Improved Masonry
and Timber Connections
in Buildings

NBS BUILDING SCIENCE SERIES 100-3

This report investigates the use of connectors for masonry and timber elements in low-rise buildings. Connector characteristics and construction details that improve a building's response to extreme wind effects are given primary emphasis. Recommendations include improvements through better utilization of connector technology showing good feasibility of introduction in developing countries. The building systems considered in this study fall within the low to moderate cost category.

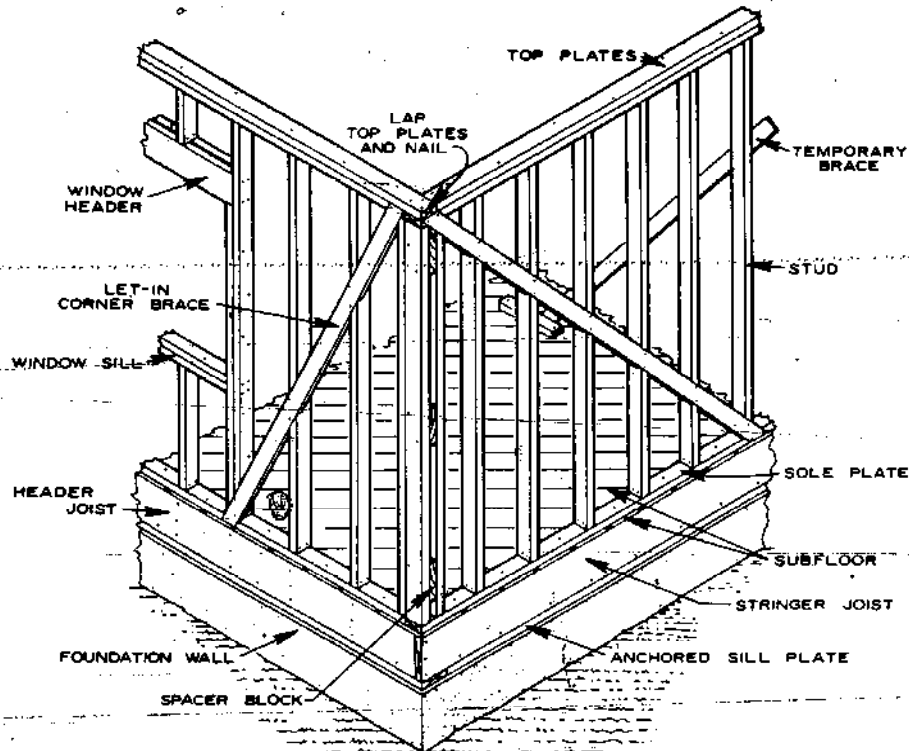
FIGURE 5 TIMBER WALL CONSTRUCTION.

Figure 5 shows a partial view of a timber "stud" wall system. The studs or "verticals" transmit gravity loads and the vertical component of wind-induced loads which may be reversible (bearing or uplift). In addition, the studs provide flexural resistance against direct horizontal wind pressure or suction. The diagonals stiffen the walls in their own planes and increase the capability of the system to resist lateral loads. The specific fastener details for the stud wall system are discussed in section 3.

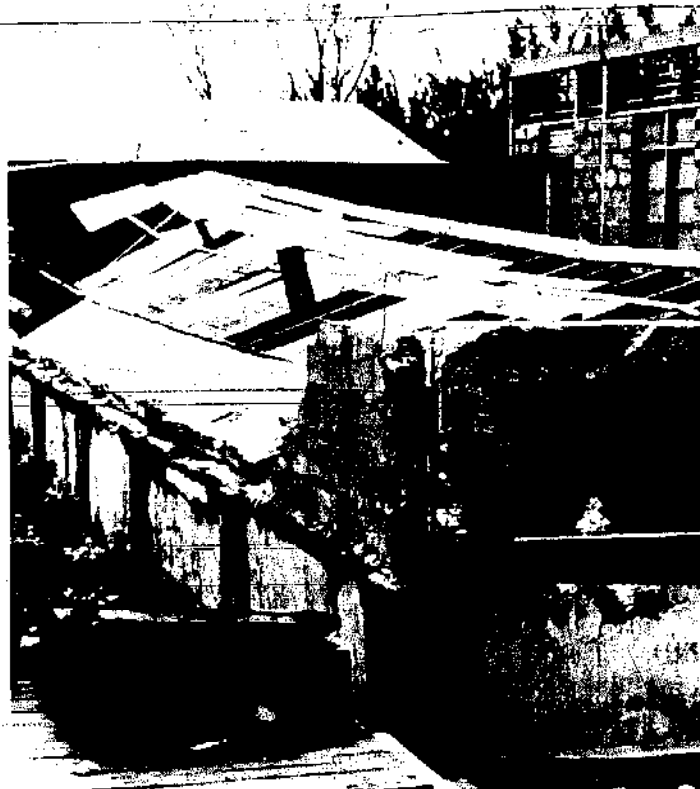
FIGURE 8 COLLAPSE OF ONE-STORY BUILDING CAUSED BY THE NOVEMBER 1974 TYPHOON IN THE PHILIPPINES.

Figures 8 to 17 exhibit buildings damaged or destroyed by recent hurricanes and typhoons. The buildings shown in figures 8 to 10 belong to a group of one-story structures in Northern Luzon, the Philippines, which either sustained severe damage or collapsed as a result of the November 1974 typhoon. These structures consisted of masonry walls and wood posts, a pitched roof system of wood trusses, purlins and corrugated iron cover, and a continuous foundation wall of cast concrete.

Figure 10 exhibits a typical failure of the fasteners connecting the purlins to the top chords of the trusses. Most of the roofing was "peeled off" in this manner. Portions of the corrugated iron roofing found on the ground contained the purlins with their metal wire attachments still in place (fig. 50). Instability of the trusses, few of which were still standing, was attributed to the loss of purlins and the absence of other longitudinal bracing between the trusses. The collapse of the masonry walls as shown in figure 8 was likewise attributed to the loss of lateral support at the roof level. However, the extent and severity of wall damage is also attributed to the absence of connections between abutting walls and the ineffectiveness of the vertical anchorage at the base. As indicated in figure 9, the only anchorage consisted of steel plates bolted to the wood posts. Close inspection revealed severe corrosion of these plates, especially at the ruptured section through the bolt-holes (fig. 9). The masonry walls in these buildings were nonload-bearing as they were stopped short of the roof to provide openings at the top (fig. 8). Thus the wood posts were the only vertical load-bearing elements and with the loss of the roof many of the corner posts were tipped over (fig. 8).

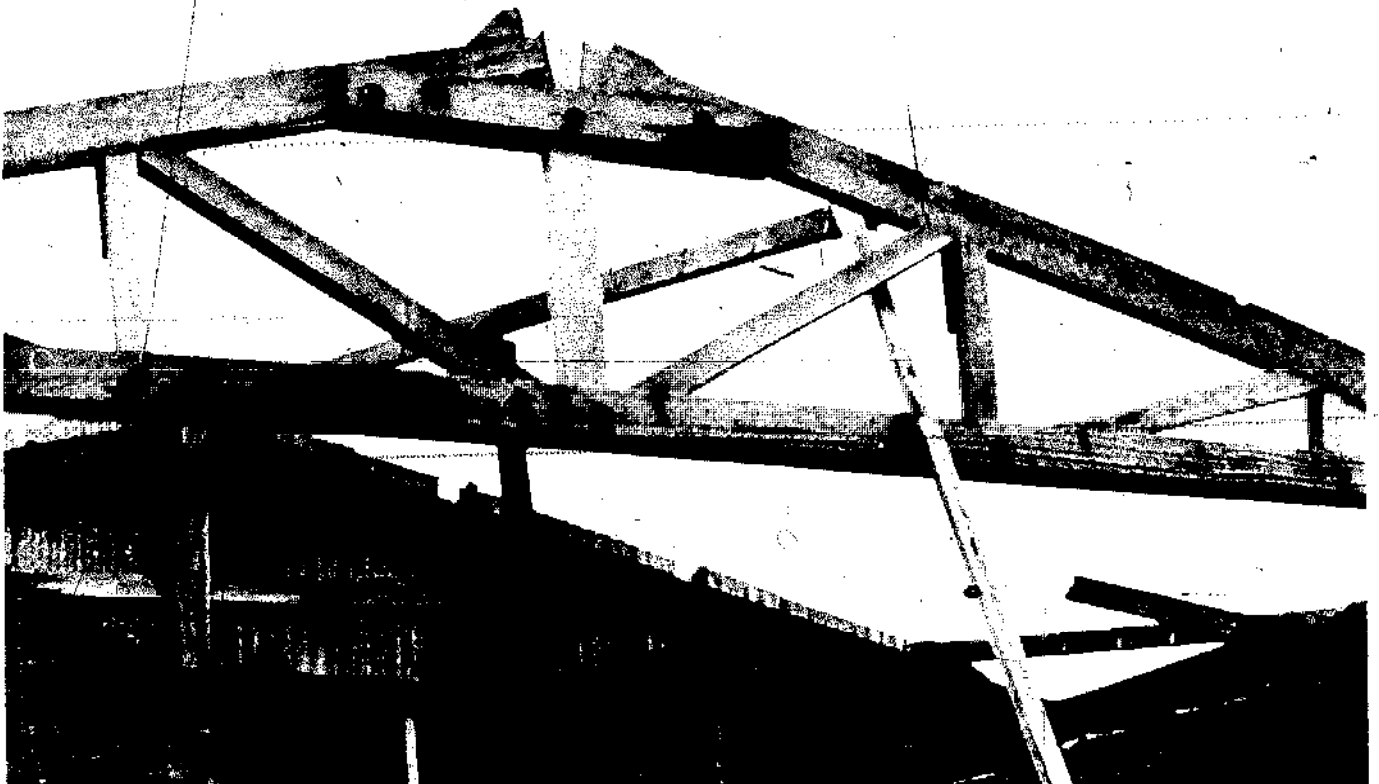
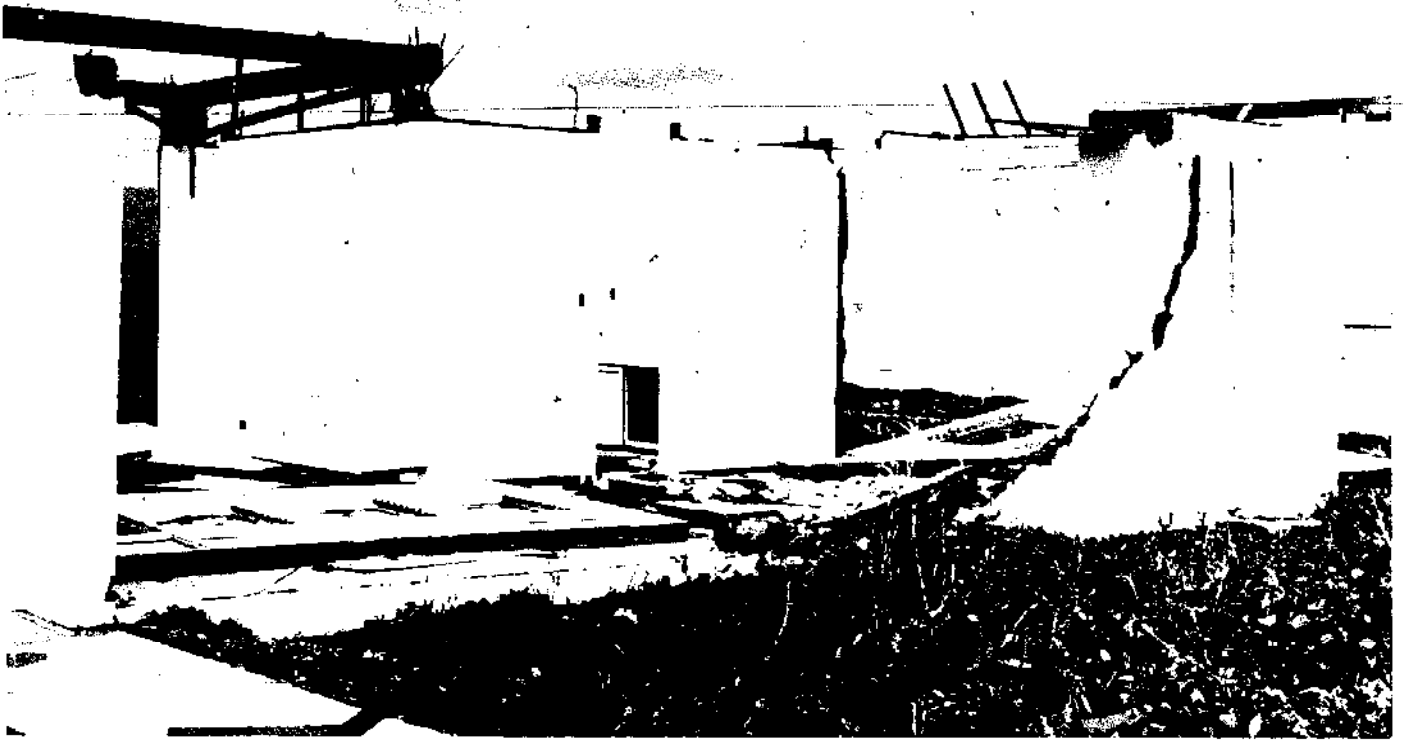
FIGURE 11 SINGLE FAMILY HOUSES DAMAGED OR DESTROYED BY TYPHOON IN NOVEMBER 1970, IN CENTRAL LUZON, THE PHILIPPINES.

Figures 11 to 13 show single family housing units of concrete masonry bearing wall construction, located in Central Luzon, the Philippines, that were damaged or destroyed by the November, 1970 typhoon. An inherent weakness of these systems is the absence of peripheral support of the masonry walls at the top because of a local preference for large openings at these locations. This practice reduces the effectiveness of the roof to function as a diaphragm and makes it more susceptible to failure by wind suction or uplift. As indicated in figure 11, most of the roofs of these units were removed by the storm. Inspection of figures 12 and 13 indicates good quality workmanship was used in constructing the masonry walls which contained vertical reinforcement in grouted cores. Note that the nails between the top window frame insert and the wall below or the peripheral wood joist above were not effective in preventing the

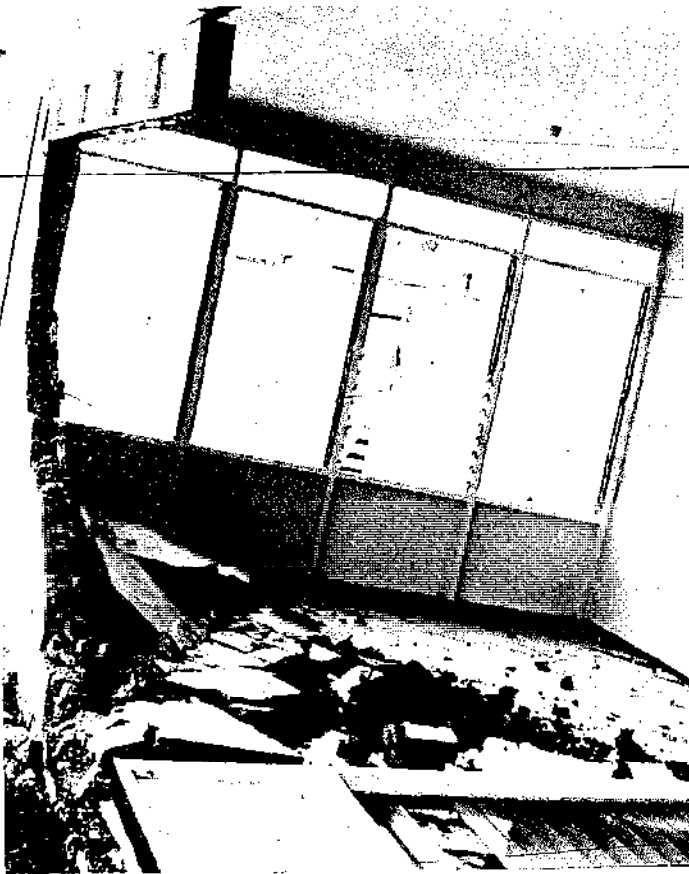
FIGURE 14 RESIDENTIAL BUILDING IN DARWIN, AUSTRALIA, DESTROYED BY THE DECEMBER 1974 CYCLONE.

Figures 14 to 17 exhibit structures consisting of different types of masonry wall systems that sustained severe damage or were destroyed by the December 1974 cyclone in Darwin, Australia. These structures represented engineered masonry construction with respect to the quality of workmanship and adherence to Australian masonry codes and standards (which are comparable to those in the United States). The Darwin experience demonstrated that compliance with current standards does not necessarily produce a structure capable of resisting the estimated 65 m/s (150 mph) winds experienced during this storm. However, it does indicate the need to reexamine the existing provisions with the objective of developing improved design criteria, connection details, and construction practices in order to mitigate the extent of damage associated with extreme winds.

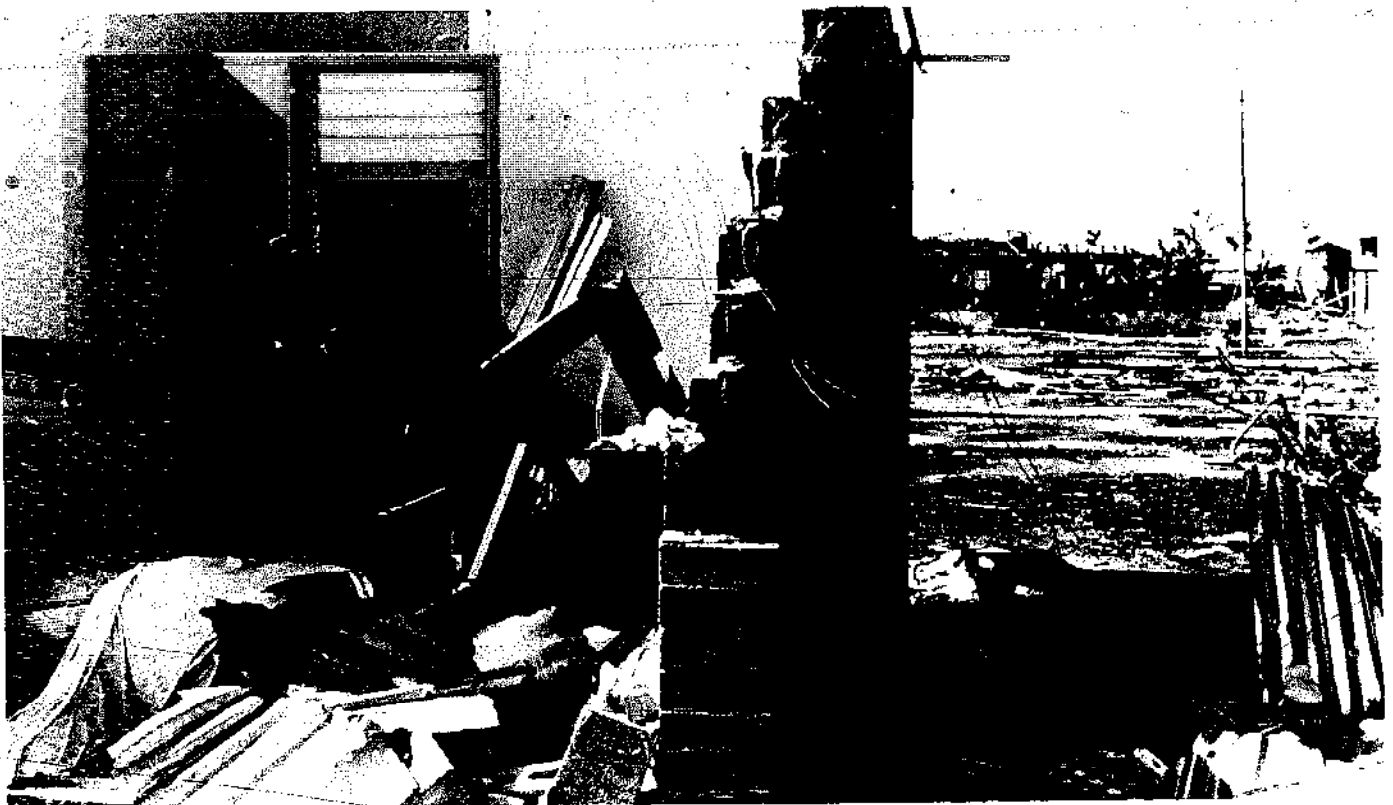
FIGURE 15 BUILDING OF CAVITY WALL CONSTRUCTION IN DARWIN, AUSTRALIA, PARTIALLY DESTROYED BY THE DECEMBER 1974 CYCLONE.

A damage study of the Darwin structures reveals some features worthy of note. In figure 15, it appears that failure occurred at the fourth bed joint from the top, in the inner concrete masonry wythe of the double-wythe cavity wall. Since the inner wythe is the loadbearing component, its failure was probably caused by an outward thrust of the roof under the action of wind. The tilted position of the inner wythe with its top leaning against the brick facing indicates the absence of ties between the wythes near the roof level. The masonry wall in figure 14 consists of two concrete block wythes with a cavity in between. The condition of the reinforcement demonstrates the ineffectiveness of the light-gage ties in assisting the integral functioning of the two wythes in out-of-plane flexure.

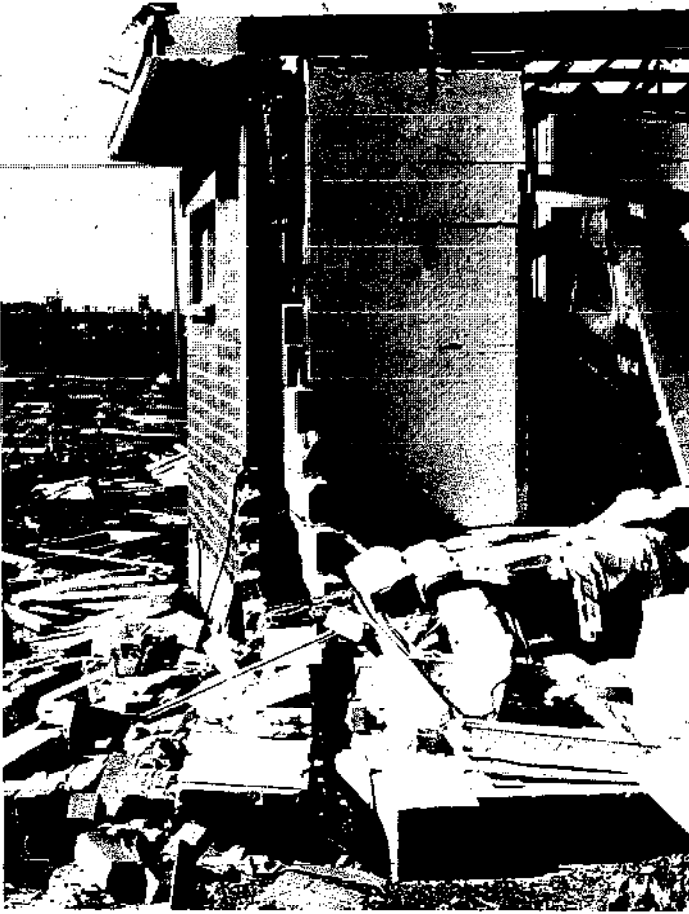
FIGURE 16 BUILDING IN DARWIN, AUSTRALIA SHOWING PARTIAL COLLAPSE OF ROOF AND MASONRY INFILL WALLS CAUSED BY THE DECEMBER 1974 CYCLONE.

Figure 16 shows an infill wall construction with a steel frame and concrete masonry filler walls. There is no visual evidence of any reinforcement having been used in the filler walls. Note the severity of vertical cracking through the wall on the right and also the separation between the steel column and the wall at the left. It is not possible to establish by examination of the figure whether there were any connectors between the steel columns and the filler walls. Figure 17 shows the portion of a concrete masonry wall under the sill of a large window opening that has failed. Note that the top course was connected to the window frame with anchor straps embedded into the grouted cores. It is likely that failure was caused by the movement of the window frame, prying the top course loose from the rest of the wall.

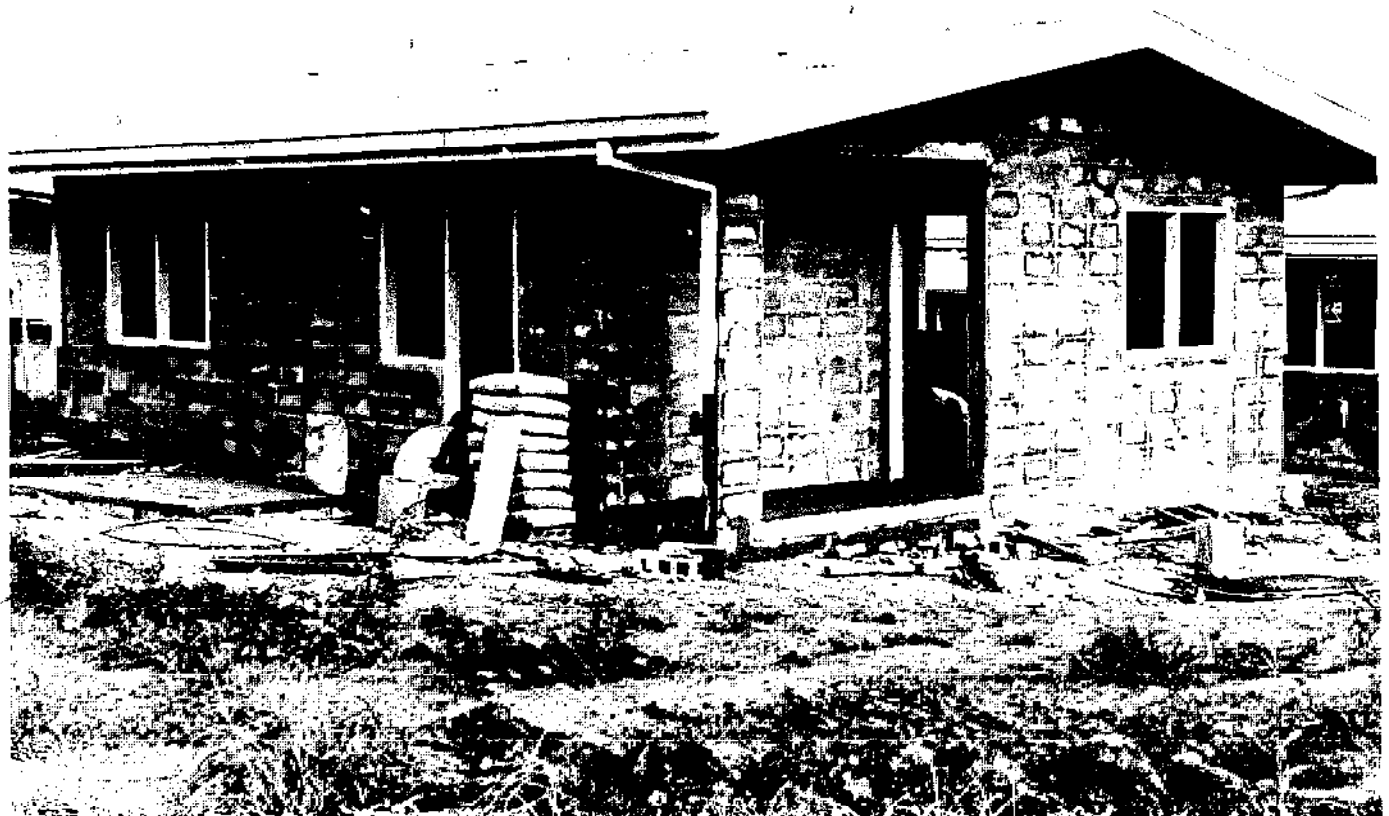
FIGURE 18 SINGLE FAMILY MASONRY HOUSE UNDER CONSTRUCTION IN CENTRAL
LUZON, THE PHILIPPINES.

Figures 18 and 19 show two different stages of construction of a single family house located in Central Luzon, the Philippines. The walls are built with 3-core concrete block units (some of which may be seen lying on the ground in fig. 18). The units are laid in stacked bond to permit placement of reinforcement through the vertically aligned cores. On the basis of figure 19 the quality of masonry construction is deemed inferior by existing masonry standards. Some of the deficiencies noted are: (1) use of defective units, (2) partially filled and non-uniform mortar joints, (3) insufficient horizontal reinforcement for stacked bond construction, and (4) insufficient lintel reinforcement above the openings. It should be pointed out, however, that this system utilizes a peripheral concrete bond beam cast directly above the lintel course (see fig. 18). From the standpoint of overall structural integrity in a severe wind environment, attention is drawn to the practice of using large roof overhangs which are particularly susceptible to wind damage as they are subjected to a positive pressure from below and suction from above [2]. A potentially critical condition also exists in the masonry column supporting a larger overhang at the corner of the landing. Unless substantial top and bottom anchorage and vertical reinforcement is supplied in the column, which is not likely to be the case, given the limited available core space in the single unit section, there is a high probability that the column will fail under the impact of windborne missiles and/or uplift forces exerted by the roof in a severe windstorm.

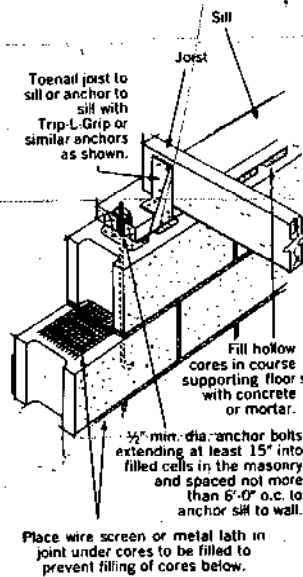
FIGURE 30 APPLICATION OF ANCHOR BOLT FOR MASONRY CONNECTION: (a) CONNECTION OF SILL PLATE TO CONCRETE MASONRY BEARING WALL; (b) CONNECTION OF CONCRETE MASONRY WALL TO WOOD STUD WALL.

two anchor bolt applications: (a) anchorage of sill to masonry wall and (b) anchorage of stud wall to masonry wall. Also consult figures 55 and 56 which illustrate the use of anchor bolts to connect a stud wall system to cast concrete slab footings and concrete masonry foundation walls.

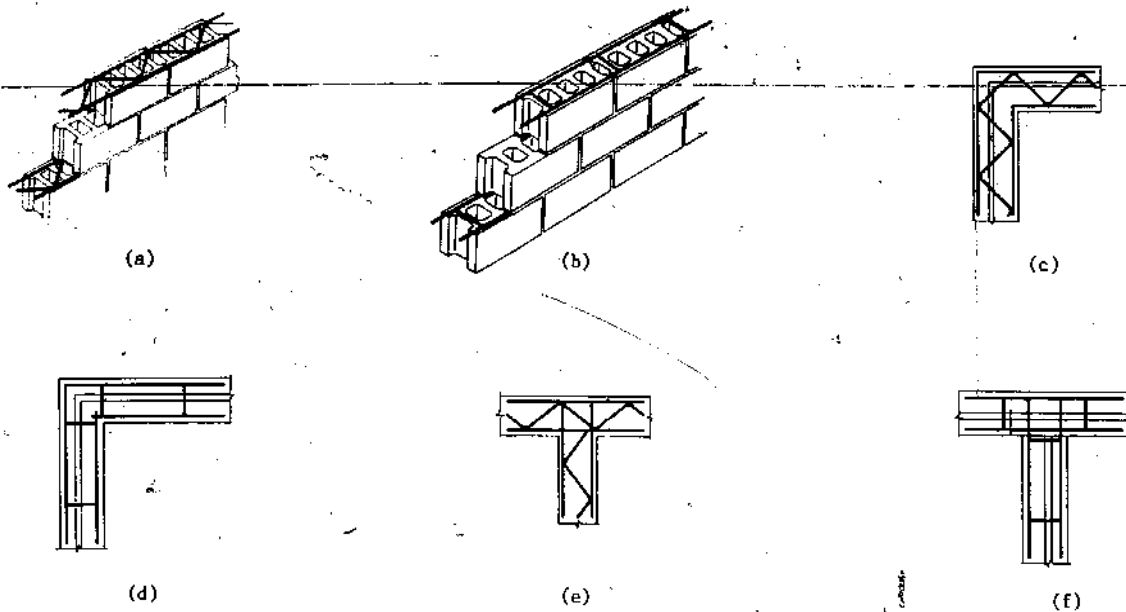
FIGURE 31 JOINT REINFORCEMENT IN MASONRY WALLS: (a) TRUSS; (b) LADDER; (c) AND (d) PREFABRICATED CORNER SECTION; (e) AND (f) PREFABRICATED TEE SECTION.

Figure 31 shows reinforcement designed for placement in the horizontal joints of masonry walls. The two common shapes are the truss and the ladder shown in (a) and (b), respectively. This reinforcement is fabricated from light-gage, cold-drawn steel and consists of two longitudinal rods welded together by cross rods. Joint reinforcement is used as a means to prevent or control cracking in masonry walls and to improve their tensile strength in horizontal flexure.

The use of joint reinforcement is strongly recommended in walls of stacked bond construction which are prone to develop cracking in service along the vertically aligned mortar joints. A good practice is to use them in alternate courses in stacked bond construction and in every third course in running bond construction. Special prefabricated units are also available for continuous reinforcement around corners as in figure 31(c) and (d), and for tying abutting walls and partitions as in figures 31(e) and (f).

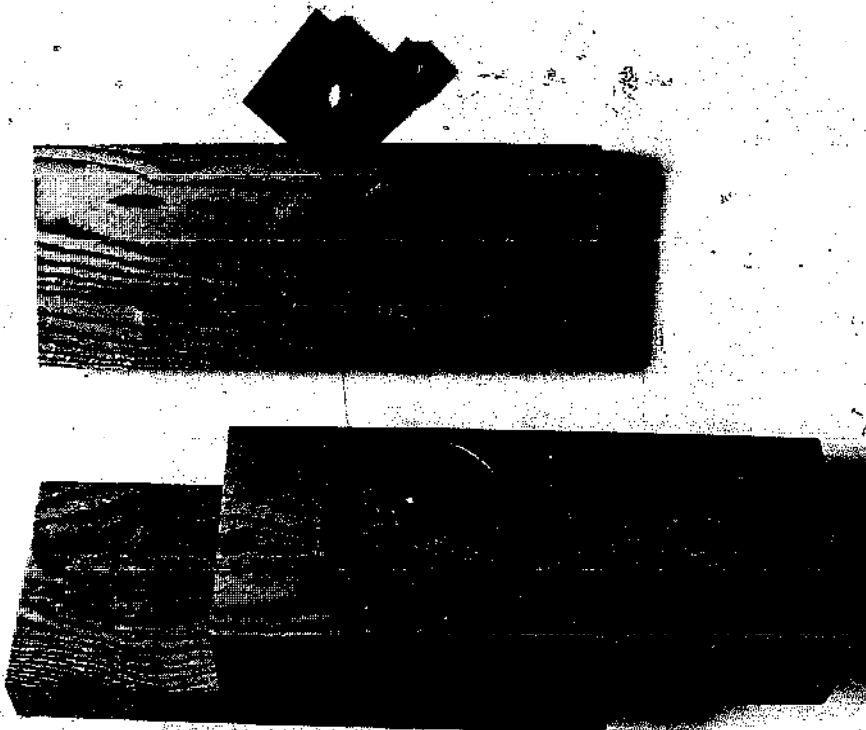
FIGURE 34 JOINT WITH SPLIT-RING CONNECTOR SHOWING CONNECTOR, PRECUT GROOVE, BOLT, WASHER, AND NUT.

Split rings and toothed rings are used for wood-to-wood joints, and shear plates are used for wood-to-steel joints, and sometimes for wood-to-wood joints. Proper joint design procedures and loads can be found in ref. [47].

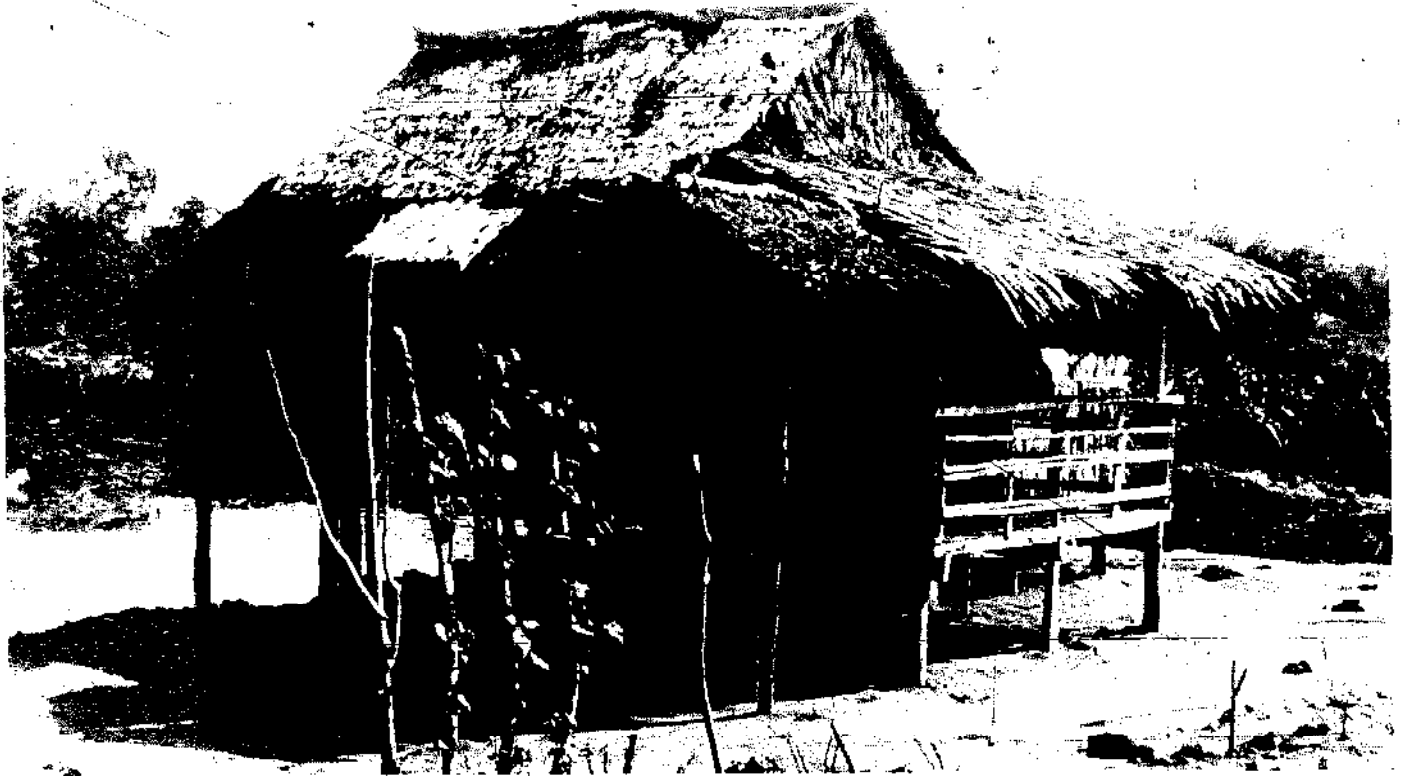
FIGURE 39 POLE-TYPE CONSTRUCTION.

This type of construction is well suited to high wind areas because the major structural member, the pole, serves as the connecting link between all other structural members. If the poles are set 1.2 m (4 ft) or more into the ground, they serve as anchors for the building. For long life, all poles must be pressure treated for resistance to decay and insect attack.

- (1) Pole-type construction in which poles are set into the ground to serve as foundation and extend to the roof (fig. 39).

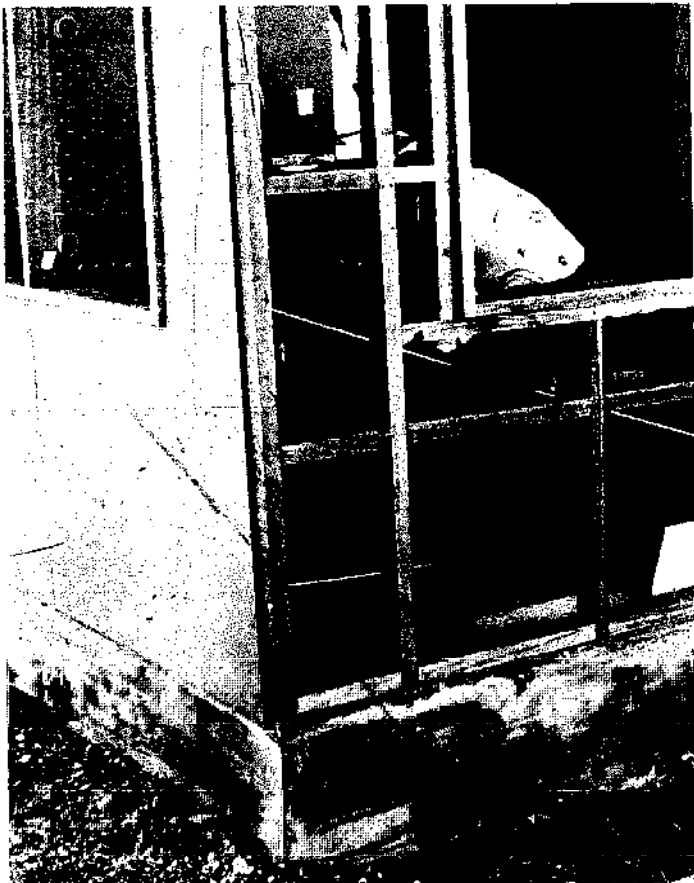
FIGURE 44 COVERING MATERIAL ON THE OUTSIDE PROTECTS FRAMING AND CONNECTORS.

Covering material applied on the outside of the framing (fig. 44) protects the wall framing and connectors from rain. Walls with the covering set into the framing have a greater potential for trapping water, and thus promoting decay. Anchor bolts on the outside of the wall are particularly susceptible to trapping water (fig. 45). They can easily be placed on the inside for protection. The type of sill plate shown in figure 45 also traps water. The sill plate should at least be sloped to the outside so water will drain from it, and the joint with panel materials should be caulked.

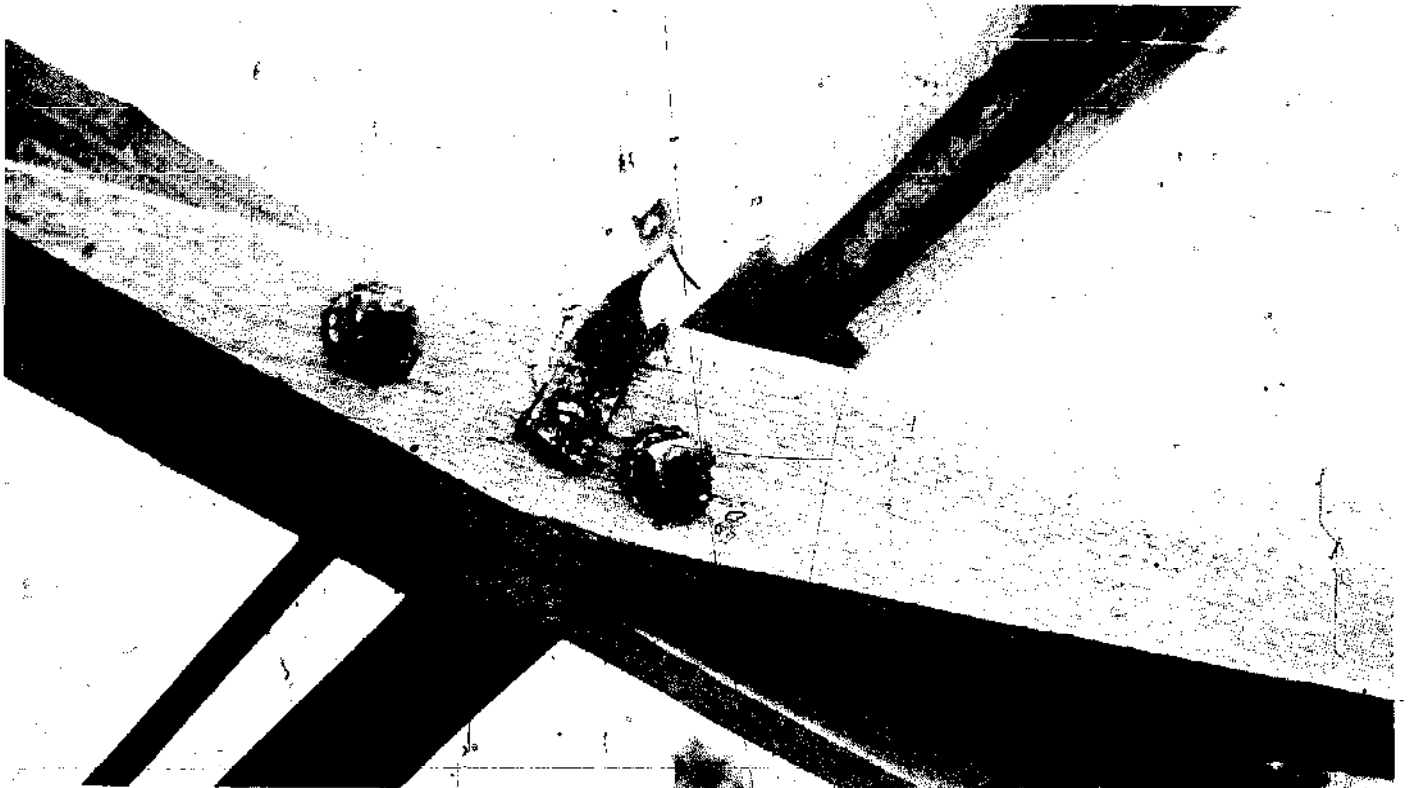
FIGURE 46 METAL STRAP ON ONLY ONE SIDE OF FRAMING FAILED TO RESIST BENDING LOAD.

One method of tying roof framing to a masonry wall is to cast reinforced concrete columns at all corners and at intermediate locations on long walls. Reinforcement is tied to the foundation and extends above the columns so that it can be attached to a wood beam which extends completely around the perimeter of the house on top of the masonry wall. Trusses are sometimes anchored to this beam by metal straps nailed to both members. The metal strap has a 90° twist at its center which weakens it and allows the nails to be pulled out when anything but a direct uplift force is exerted on the strap (fig. 46).

A sheet metal connector that can be nailed to both sides of the rafter and beam would prevent the type of failure caused by rotation in the single, heavy strap.
