COUNTERING SHRINKAGE CRACKING IN RENDERS

3rd Year Undergraduate Project, 2001-2002,
School of Engineering, University of Warwick

Summary

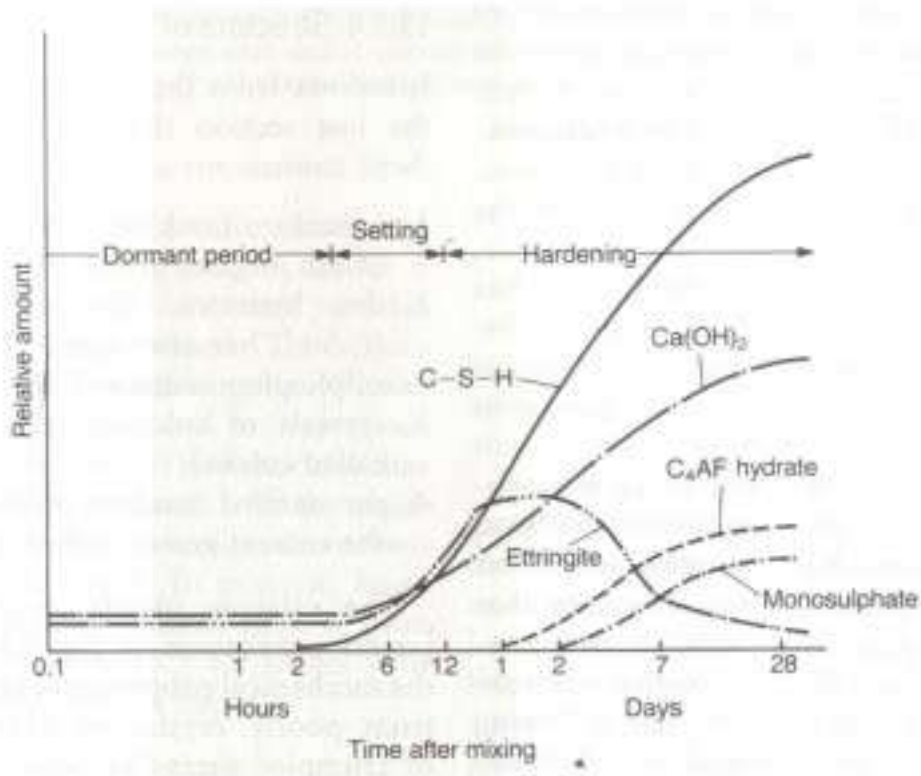
Figure 4: Typical Hydration product development in Portland cement paste (Illston 1994)

However, this formation of ettringite does not cause expansion as it will crystallise out, this can be seen in figure 4 section 2.4., which details the products of hydration over time. The formation of ettringite will lead to shrinkage compensation if the ettringite is formed after setting, at a stage when the paste has already attained certain rigidity. There are shrinkage-compensated cements available, which will reduce shrinkage in concrete through ettringite formation.

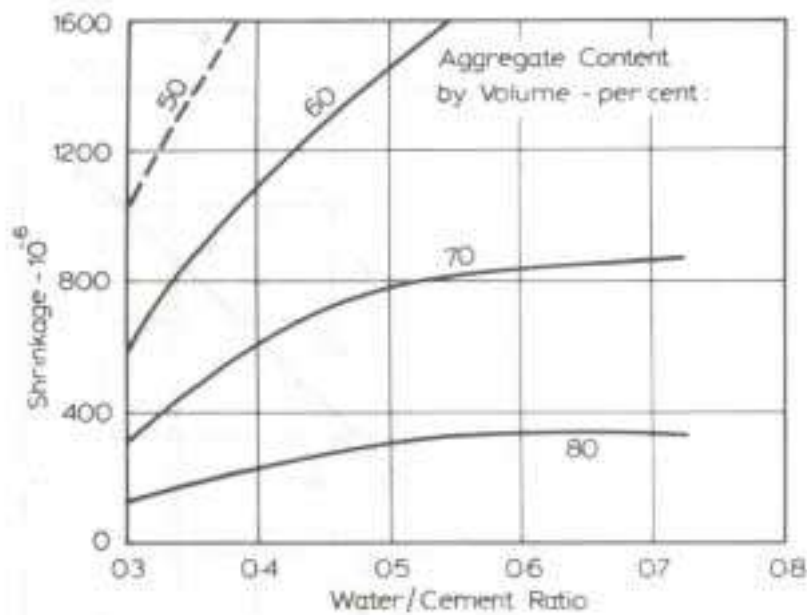
Figure 7: Influence of water/cement ratio and aggregate content on shrinkage (from Neville 1995)

The shrinkage of cement or mortar is larger the higher the water/cement ratio as this determines the amount of evaporable water in the cement paste and the rate at which it can move to the surface. The amount of shrinkage is not equal to the volume of water removed as it is also influenced by other factors such as gel particle size. The affect of aggregate leads to less shrinkage in concrete in comparison with mortar, which does not contain aggregate. Also the type of water removed has an affect as discussed earlier, emptying of the capillaries results in water loss with no shrinkage, but once capillary water is lost, the removal of adsorbed water takes place and causes shrinkage. When no moisture movement to or from the cement paste is permitted, shrinkage occurs due to withdrawal of water from the capillary pores by the hydration of the hitherto unhydrated cement called self desiccation. This shrinkage is restrained by the rigid skeleton of the already hydrated cement paste and also by the aggregate particles.

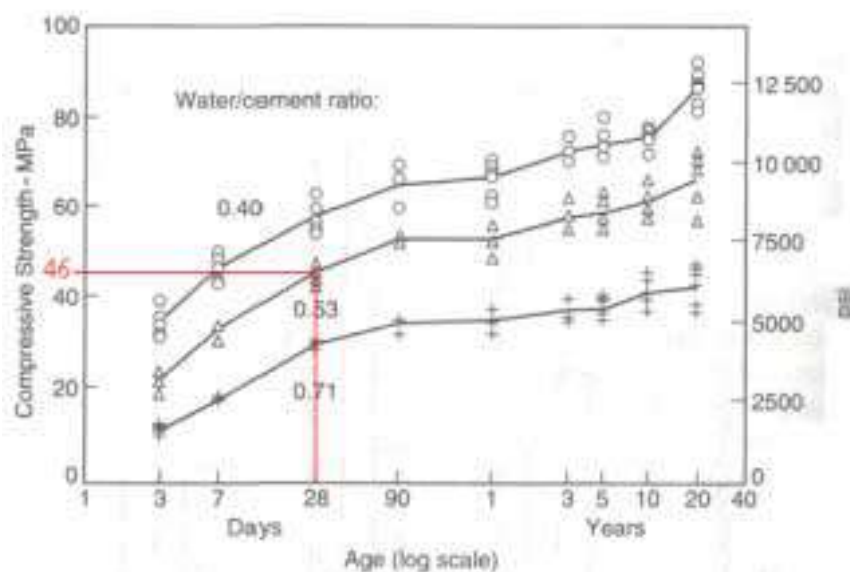
The strength of cement paste is governed by its porosity, which depends on the water cement ratio and degree of hydration. The higher the water content the greater the porosity and volume of voids, which leads to a weak mortar. Figure 8 below shows the effect of age and water content on the strength of the mortar.

Figure 8: Effect of age and water/cement ratio on concrete strength (Neville 1995)

Using this formula with a value of 46 Mpa for compressive strength taken from the graph in figure 8 the tensile strength of the plain mortar samples can be calculated to be 3.85 Mpa ($3.85 \times 10^6 \text{ N/m}^2$). Values for tensile strength will be used in section 5 in order to calculate an expected relationship between crack width and number of cracks for the purposes of comparing the theoretical predictions with actual results.

The data from this graph can be used to make the figures for tensile and compressive strength attained in section 3.3.1.2. more accurate. The graph in figure 8 shows data for samples, which have been moist, cured the entire time. Due to time restrictions the samples used were only cured for seven days and then left to dry in air for another 21

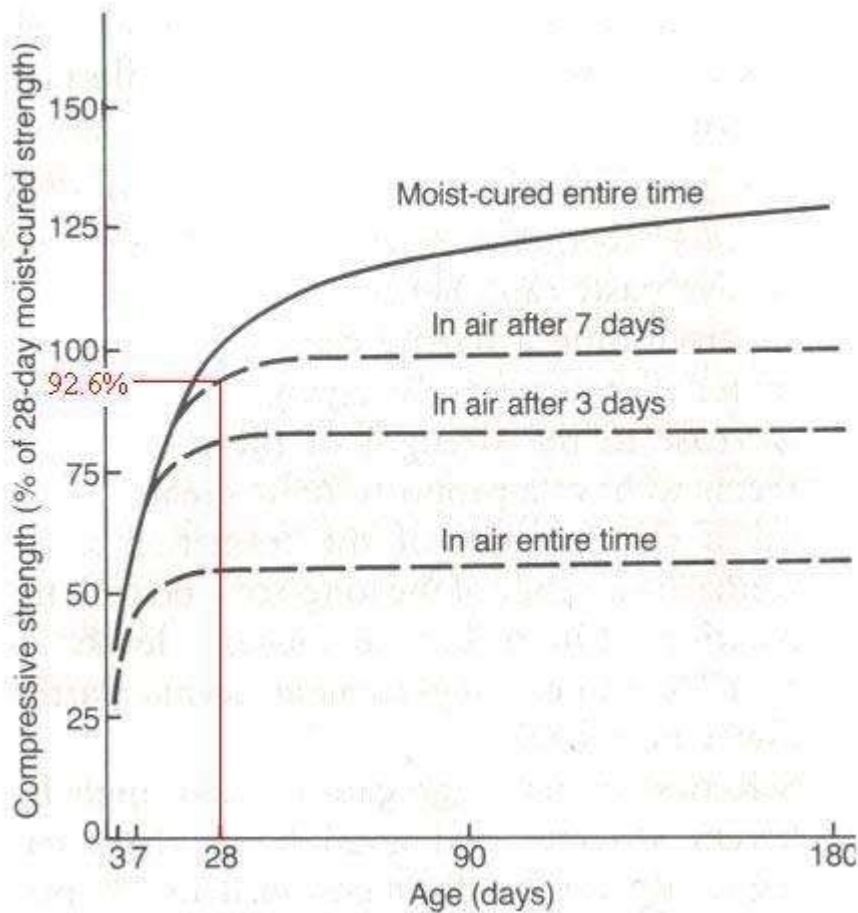
water completely or leaving it in a sealed environment to reduce evaporation and maintain high humidity in the air surrounding the specimen. Some form of curing i.e. preventing water loss from the concrete surface is not only important to maintain hydration and therefore strength gain, water loss also leads to plastic shrinkage and increased permeability (due to increased porosity) – which is a problem when the material is required for waterproofing. Figure 9 below illustrates the influence of curing on concrete strength.

Figure 9: Influence of curing conditions on concrete strength (From Illston 1994)

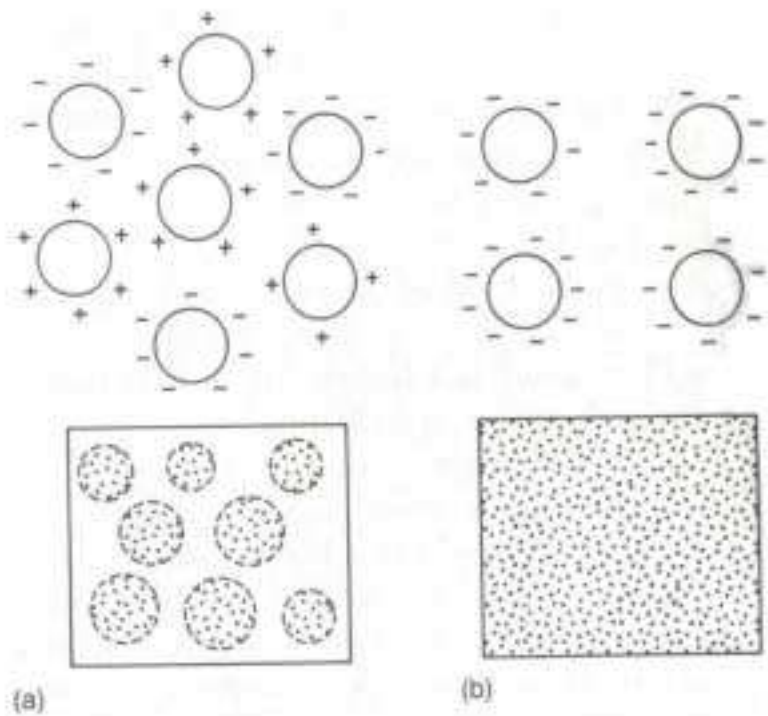
Figure 10: Dispersing action of plasticising admixtures (From Illston 1994)

- (a) flocculated particles
- (b) dispersed particles after admixture addition

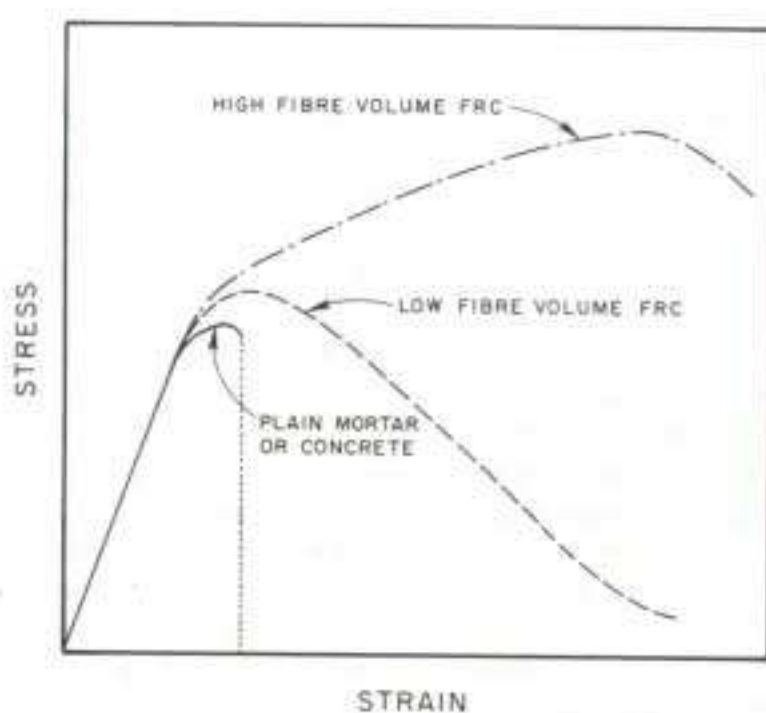
In application (b) and (c), the main role of the fibres is to control the cracking of the composite. The effect of fibres in fibre reinforced concrete is illustrated in the schematic (figure 11) below. The fibres improve the 'ductility' of the material, i.e. its energy absorption capacity.

Figure 11: Typical stress-strain curves for low fibre volume and high fibre volume FRC
(From Bentur 1990)

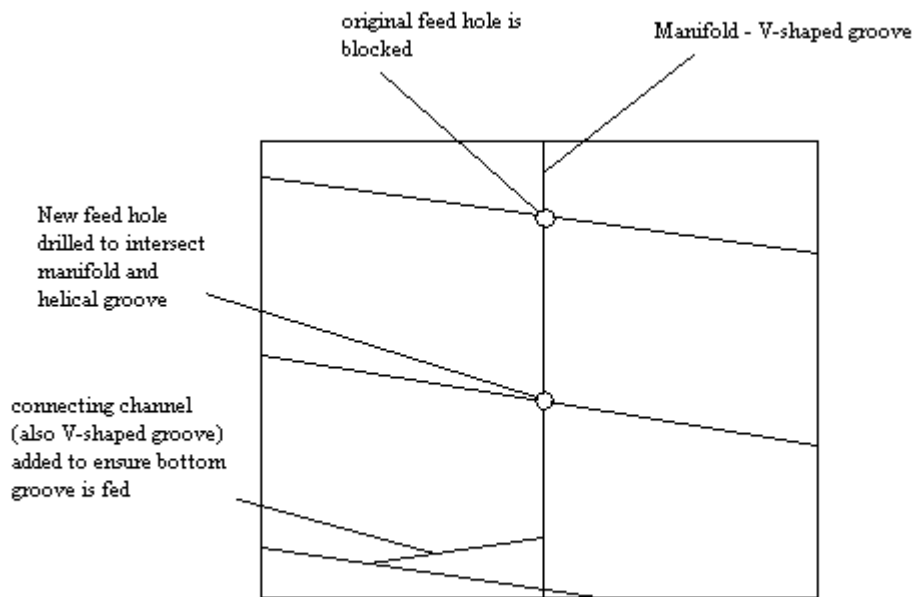
Two manifolds diametrically opposite each other were included to run the whole length of the pipe, the original feed hole was blocked and a new hole drilled in the middle at a point where a manifold intersected the groove. The point at which this manifold intersected the last section of the channel was too near the end of the pipe. This was a problem as the ends were to be sealed due to the likelihood of water leaking from the ends, therefore a connecting channel was also included in the same manner the manifolds had been. Two bleed holes were then drilled into the pipe wall diametrically opposite the feed-hole intersecting the channel (therefore intersecting the second manifold). These were to ensure that air was pushed out of the channel as the water flowed around it, and would be immediately blocked as water came through.

Figure 18: The test rig once modified to improve flow, the two bleed holes are not visible as they are on the other side, they also intersect with the channel.

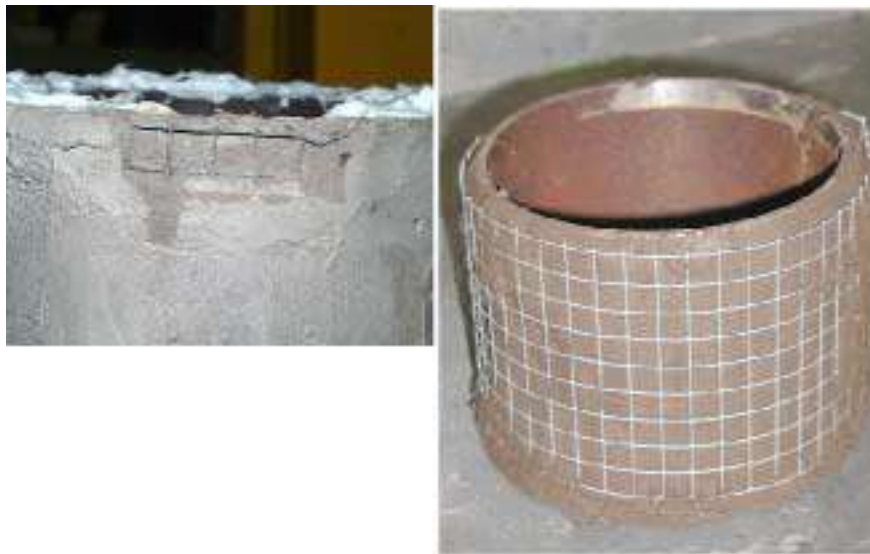
After these rigs had been tested the mortar was chipped off, at this point the newly designed rigs had also become available. With eight rigs, it was possible to test four variations of render with two rigs to each render. The renders were applied as described in section 5, the most difficult to apply being the wire mesh as it had to be held onto the outside of wet mortar ensuring no gaps between mesh and mortar:

Figure 20: making a wire mesh reinforced render, (on right – applying mesh into wet mortar, on left – mortar chipped away after testing to reveal mesh).

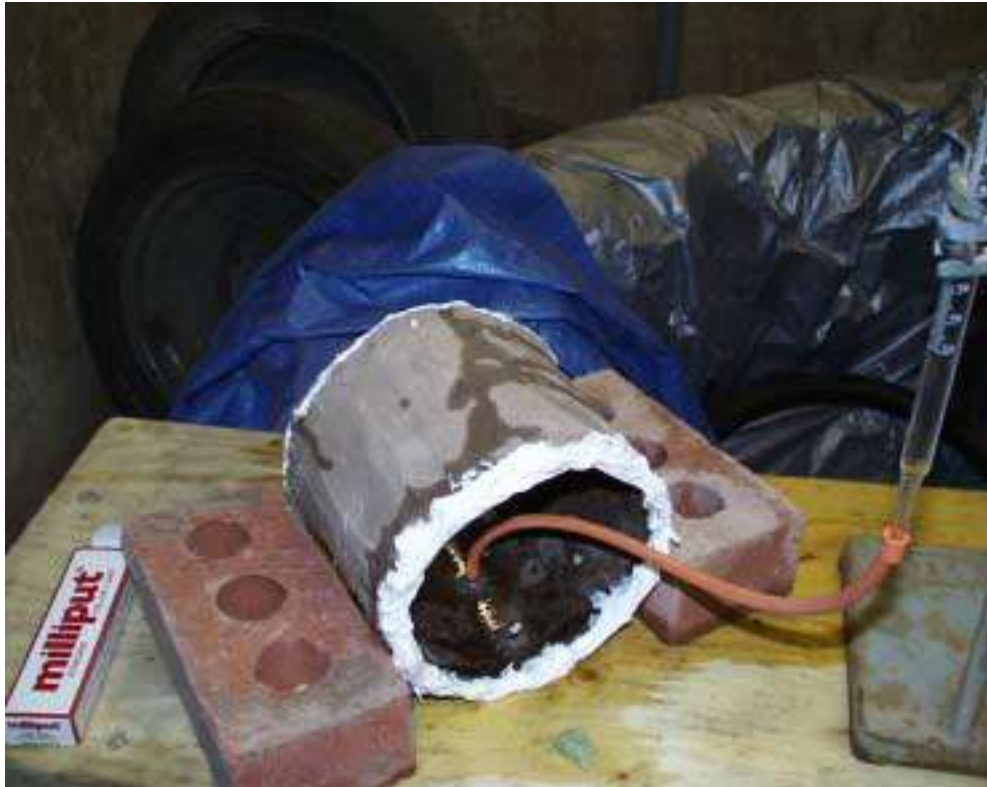
Figure 21: set up of the rig showing pipe connecting to channel and pipette

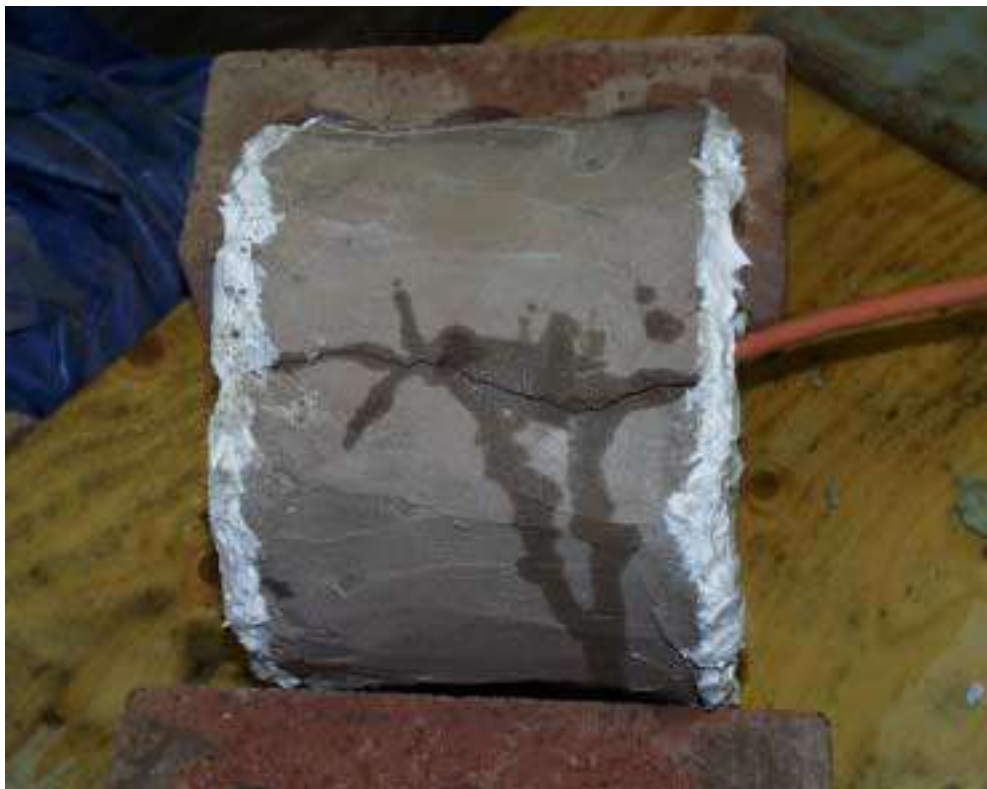
Figure 22: Leakage through a crack

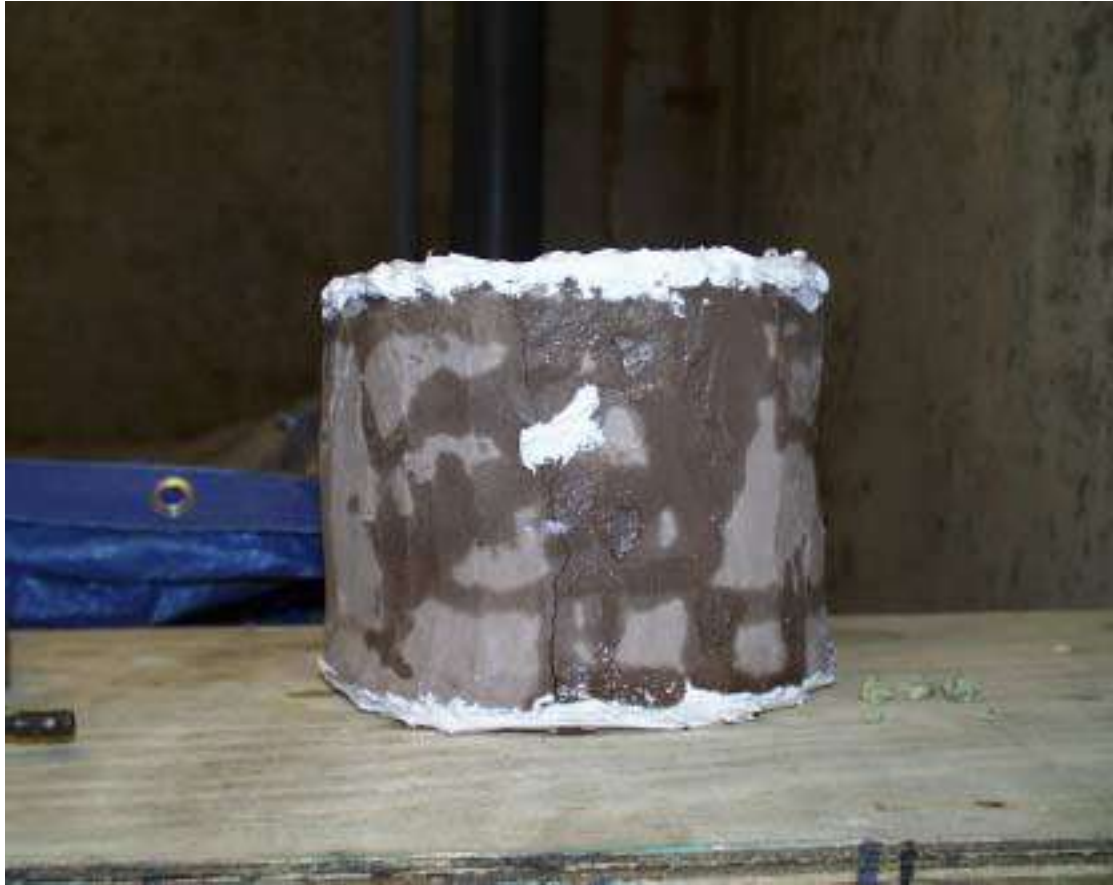
This had to be overcome by observing leaks, marking them and applying greater quantities of sealant. In the case of the wire mesh samples this was done twice as the end leakage was excessive in these samples. Therefore, in the results there are three different flow rates for the mesh samples, the smallest being that with all end effects removed. This was also done once for the Rockfast sample, giving two flow rates for Rockfast.

Figure 23: A sample with end leakage

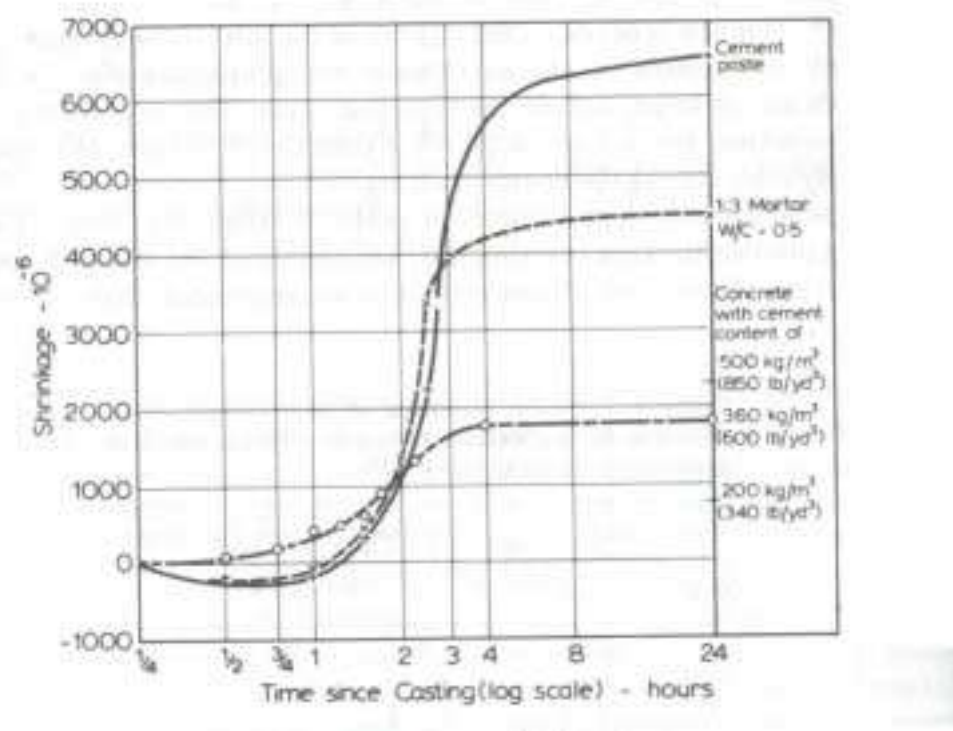
Figure A1.1.: Influence of cement content of the mix on early shrinkage (Neville 1995)

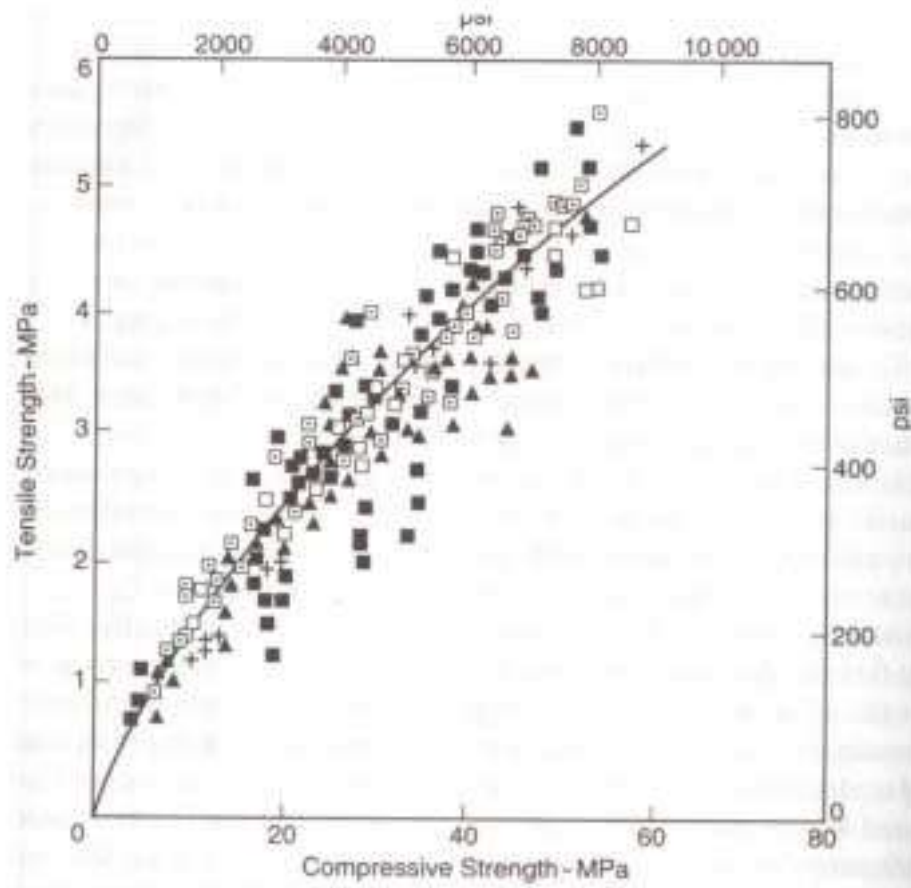
Figure A1.2.: The relationship between tensile and compressive strength (Neville 1995)

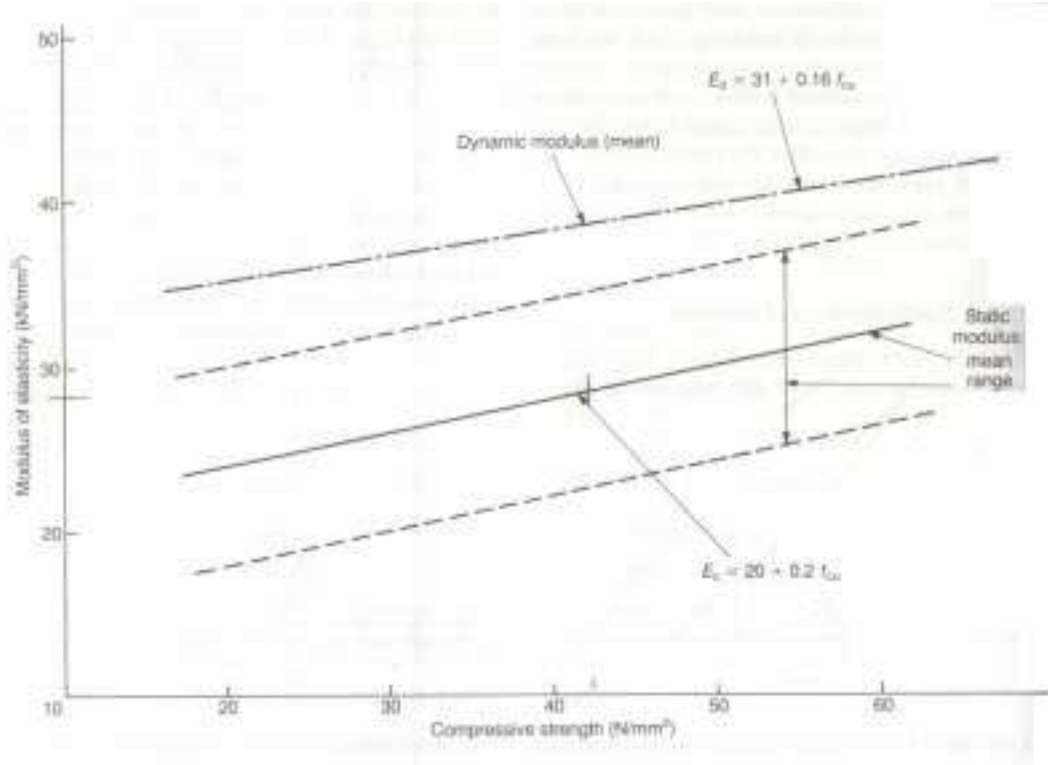
Figure A1.3.: The relationship between compressive strength and Modulus of elasticity (Illston 1994)

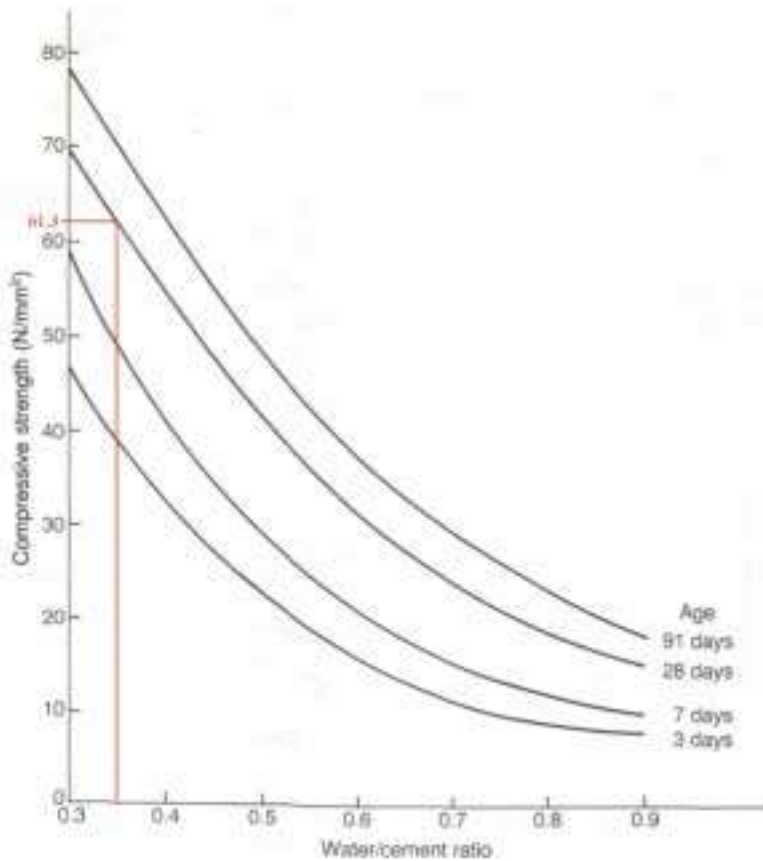
Figure A1.4 Relationship between water/cement ratio and strength (Illston 1994)
