Community Water Supply: The Handpump Option

By: Saul Arlosoroff, Gerhard Tschannerl, David Grey,
William Journey, Andrew Karp, Otto Langeneffer & Robert
Roche

Published by: The International Bank for Reconstruction and Development/
THE WORLD BANK
1818 H Street NW
Washington D.C. 20433
U.S.A.

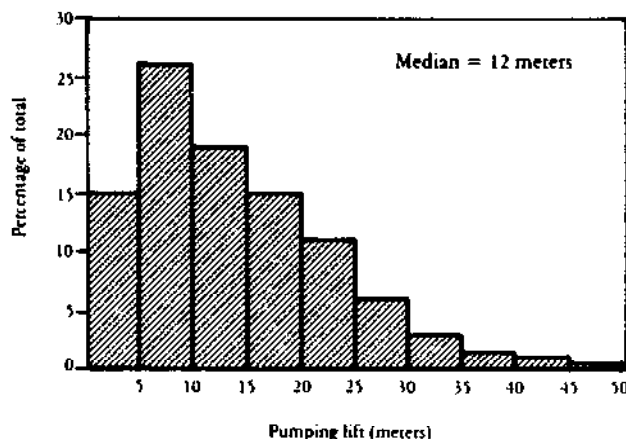
Figure 2.1 Pumping Lift Frequency Distribution in Field Trials

In the Project field trials, efforts were made to site wells where groundwater was as deep as possible — the aim being to develop handpumps suitable for deepwell applications. However, as the diagram shows, 75% of the wells involved pumping lifts of less than 20 meters, and 85% were less than 25 meters. It seems likely that these figures are a good reflection of the global situation in terms of groundwater depth.

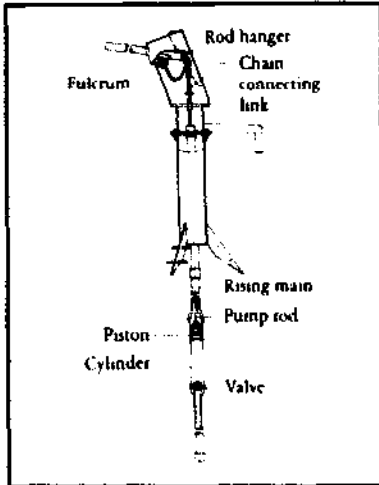
In deepwell pumps, the cylinder is immersed below the water level. They are suitable for lifts down to 45 meters or more, depending on the effort that users

are willing to apply for progressively less water as depth increases. The submerged cylinder eliminates the need for priming, but means that repairs or maintenance involve removal of components from down the well.

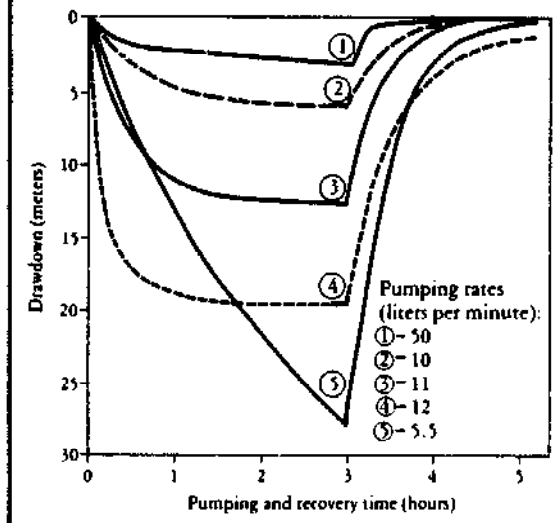
Figure 4.2A Drawdown and Recovery of Five Handpumped Wells in Southern Ghana

such as permeability are often more important than the pumping rate in determining drawdown, as evidenced by Curve 1, where the well with the highest pumping rate has the least drawdown.

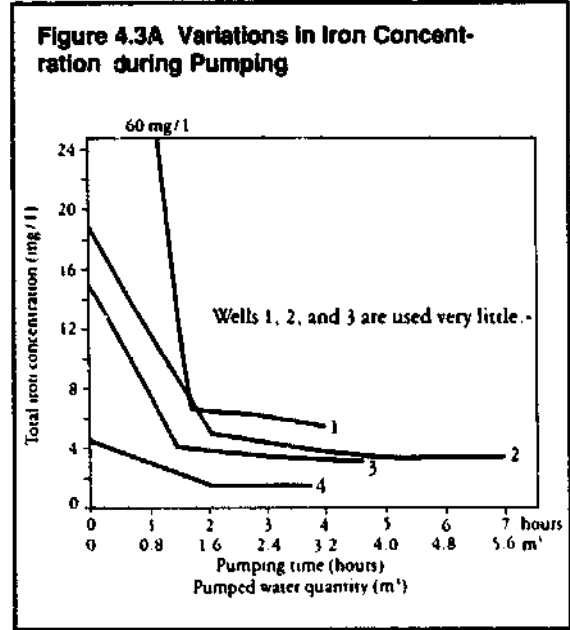
The issue of taste is important. Overnight build-up of iron concentrations in wells with corroding rods or rising mains can be very high. Figure 4.3A shows the result of pumping tests on wells in southern Ghana where the galvanized pumprods of the Moyno

handpump were being attacked by corrosive groundwater. Natural groundwater iron content measured in wells equipped with corrosion-resistant handpumps in the West African field trial areas has generally been found to be less than 1 mg/l. The very high initial iron concentrations in the illustrated wells fell away rapidly as pumping progressed, reaching stable low levels within two hours in most cases. However, measurements in one well just three days after the test revealed that the initial iron concentration was as high as before the test, proving that accumulation of corrosion products from the pump was the major cause of high iron content.

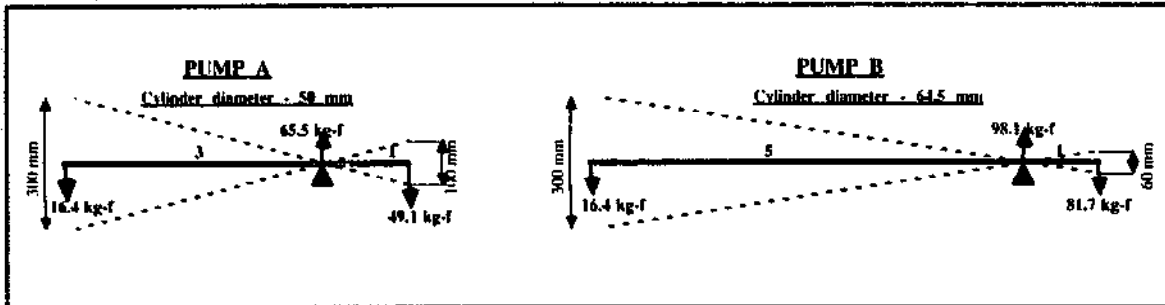
Box 4.4 Effects of Handle Design and Cylinder Size on Pumprod Stresses

Field trial observations have shown that users of lever-action handpumps tend to move the handle end by the same amount irrespective of the total stroke length available. This constant travel distance (usually in the range of 300 to 400mm) is maintained as long as the operating force is within acceptable limits. This finding has considerable significance for handpump designers.

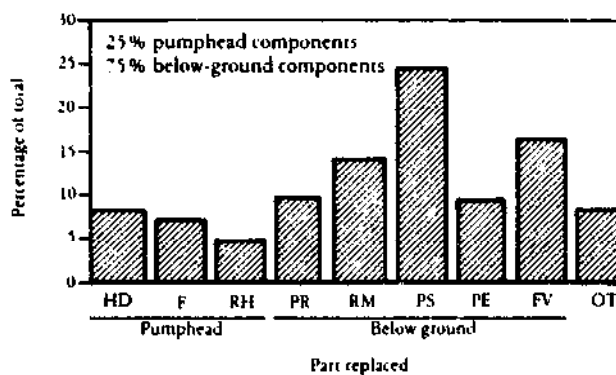
Repairs by Part Type

HD = Handle RH = Rod hanger RM = Rising main PE = Pumping element OT = Other
F = Fulcrum PR = Pump rod PS = Piston seal FV = Foot valve

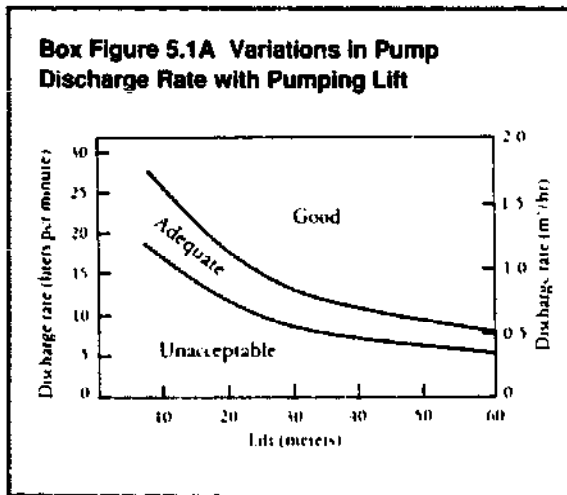
Box Figure 5.1A Variations in Pump Discharge Rate with Pumping Lift

lift of 7 meters and increasing to 75 watts at a lift of 45 meters or more. Adults will usually apply over 100 watts (and sometimes over 150 watts) at high lifts in order to increase the discharge rate. A representative range of mechanical efficiencies has been used — from 45% at 7 meters to 70% at 45 meters. "Good"

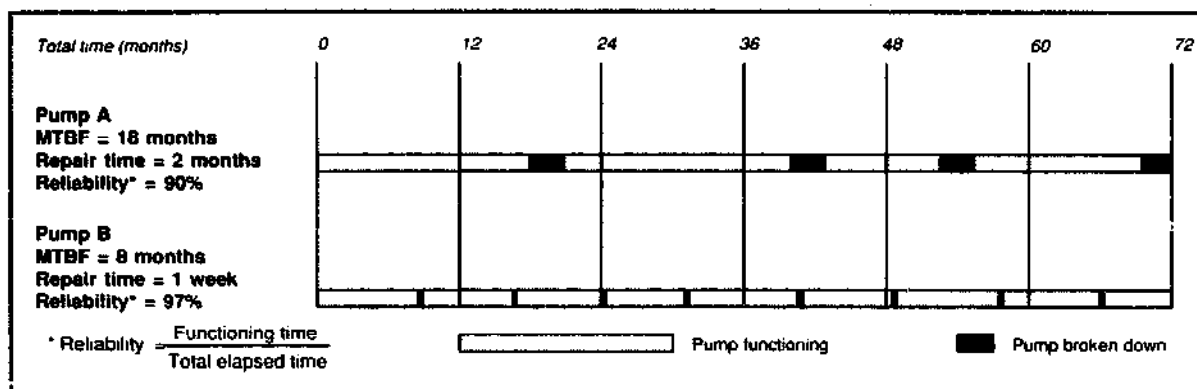
Box 5.2 Definitions of Reliability

The "reliability" of mechanical equipment is commonly measured in terms of the "mean time before failure" (MTBF). Thus, Pump A which has a MTBF of 18 months would be judged to be more "reliable" than Pump B for which the MTBF is 8 months.

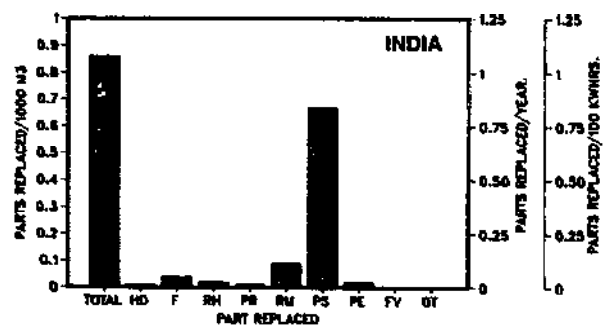
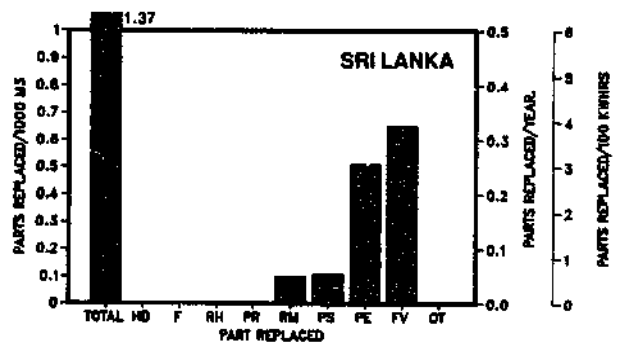
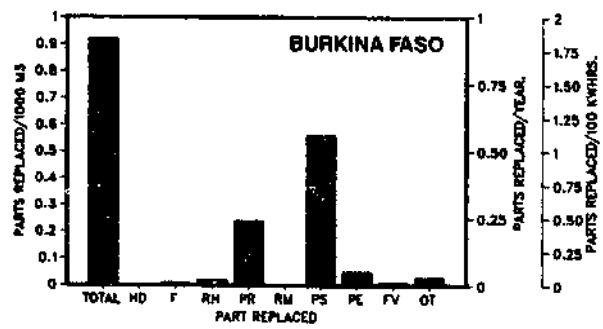
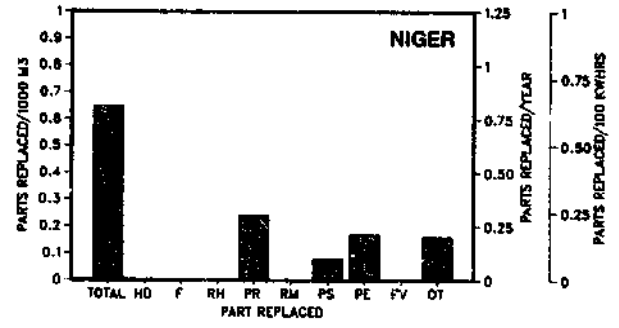
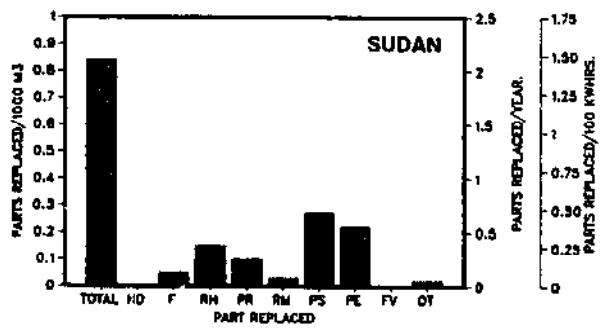
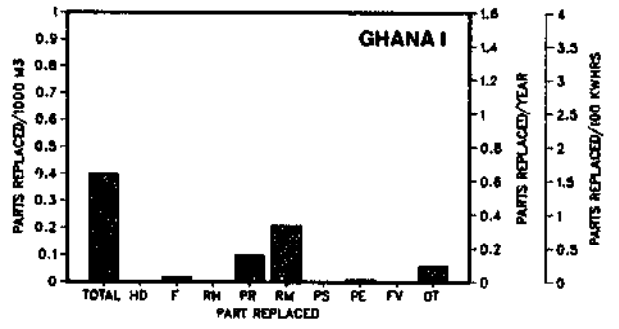
INDIA MARK II: CAUSES OF ESSENTIAL INTERVENTIONS

HD-Handle RH-Rod hanger RM-Rising main PE-Pumping element
 F-Fulcrum PR-Pump rod PS-Piston seal FV-Foot valve OT-Other
