Handpumps Testing and Development: Progress Report
on Field and Laboratory Testing

Rural Water Supply Handpumps Project

Saul Arlosoroff, David Grey, William Journey,
Andrew Karp, Otto Langenegger, Leif Rosenhall,
and Gerhard Tschannerl

UNDP Project Management Report Number 4

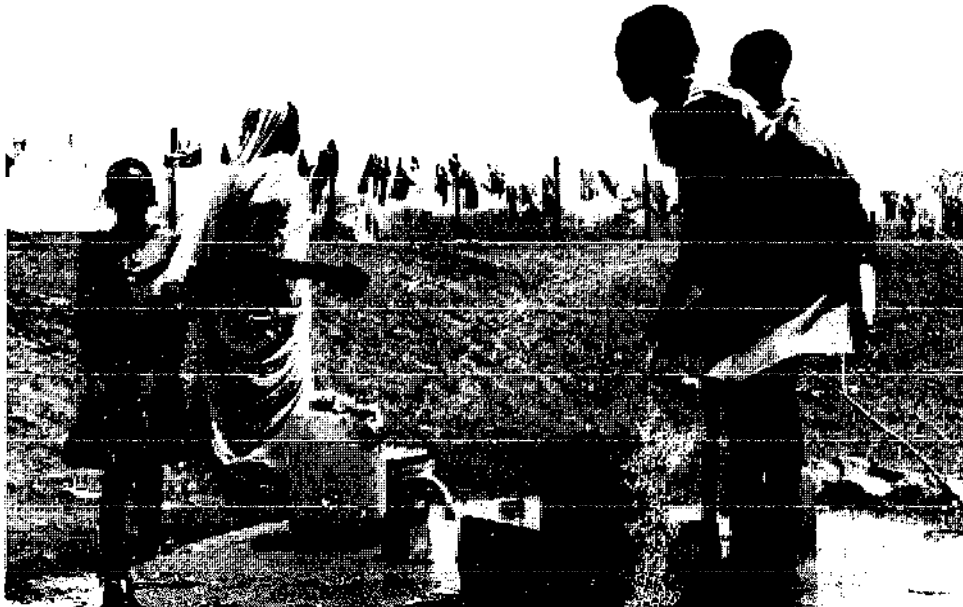
FIGURE 2-1 BLAIR PUMPS IN THE SUDAN

This direct action handpump was developed and manufactured in Zimbabwe. It is operated by moving the entire "walking stick" shaped discharge pipe up and down. To the left a second Blair pump is shown which was installed on the same wide diameter well; it is in its descended position where the discharge pipe rests when not in use.

Five Blair pumps were installed (2 on a dug well and 3 on a hafir outlet well) in March 1983. Thirty-four Deplechin Duba Tropic II handpumps, donated by the EEC, were received in Kadugli in mid-1983 and one was installed. Limited monitoring was carried out during the remainder of 1983 and early 1984. With the arrival of the new CME a firm monitoring plan has been proposed and new pumps are being installed. Photos of Blair and India Mark II handpumps are shown in Figures 2-1 and 2-2.

The Blair pumps (3 on a hafir outlet with a water level of 3-4 m and 2 on a dug well with a water level of 6-7 m) were installed in March 1983 and were working satisfactorily when visited by the RPO in April 1983. However, their acceptability was questionable due to relatively low yield and the problem of filling narrow-necked containers (plastic jerricans are the most commonly used containers in South Kordofan) with the Blair's moving rising-main. When next visited after the rains in October, one of the pumps at each site was not working due to broken head blocks and the users of the dug well were drawing water with buckets through a manhole.

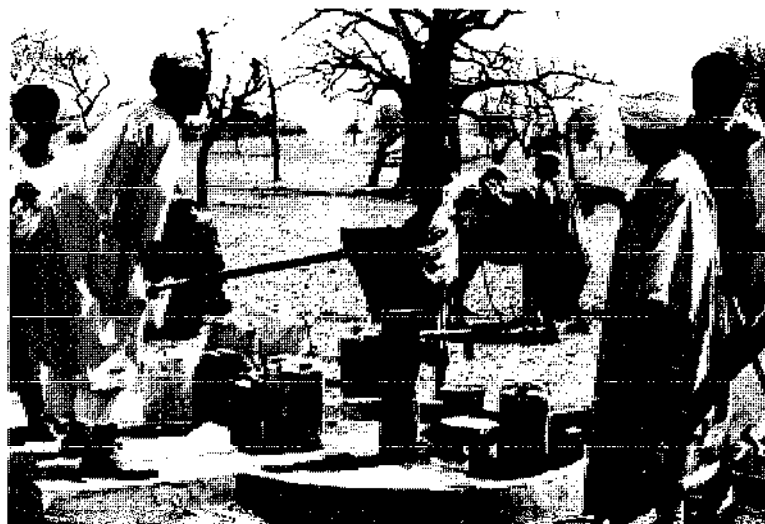
FIGURE 2-2 INDIA MARK II HANDPUMP IN THE SUDAN

Following the installation of over 400,000 India Mark II pumps in India, UNICEF has begun to incorporate this sturdy pump in its projects in Africa.

The India Mark II pumps are popular, are being worked very hard and, in general, are performing well. However, a considerable percentage of those pumps visited in the field had problems, some of which were serious. Many cases were seen of wearing or even completely collapsed handle bearings, with resulting consequences including severely worn pump rods, pump rod guide bushings, handle levers, and handle quadrants as well as "peeled back" pumphead cases (see Figure 2-3). All of these problems are due to lateral handle movement resulting from worn bearings. It is likely that the cause of this bearing wear is the regular removal of the axle pin and its replacement (by hammering) through the bearings every time the pump is dismantled. This procedure is prescribed in the India Mark II installation and maintenance manual. However, it is not necessary to remove the axle pin -- except when the handle, bearings or pin itself need replacement -- and doing so will greatly reduce bearing life and accelerate pumphead destruction. Steps are being taken to have the manuals modified to reflect this very important point.

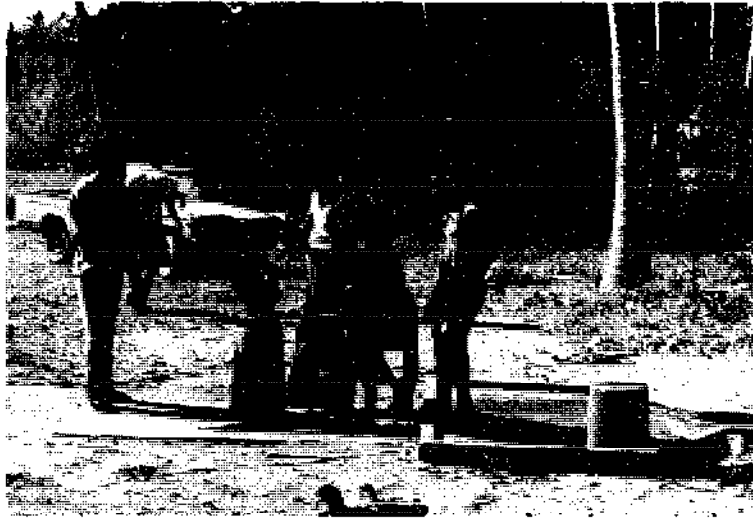
FIGURE 2-7 KENYAN-MADE MODIFIED INDIA MARK II PUMP

This Kenyan-made pump has two notable modifications from the standard India Mark II design. First, the pedestal is made of concrete instead of steel, in order to reduce the cost. Second, the discharge spout has been elongated in order to move water away from the pump. This helps keep the pump operating area dry and to minimize the possibility of sullage water entering the well.

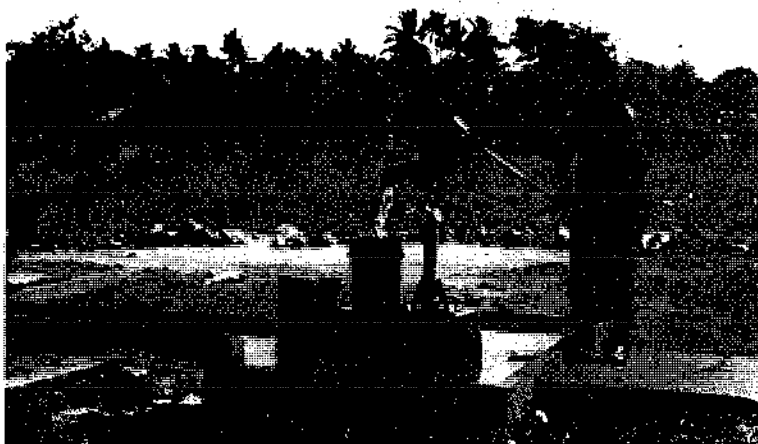
FIGURE 2-8 NIRA HANDPUMP IN KENYA

The pump is made in Finland and has undergone several design modifications in recent years. This recent model is included in the field trials of handpumps in Kenya.

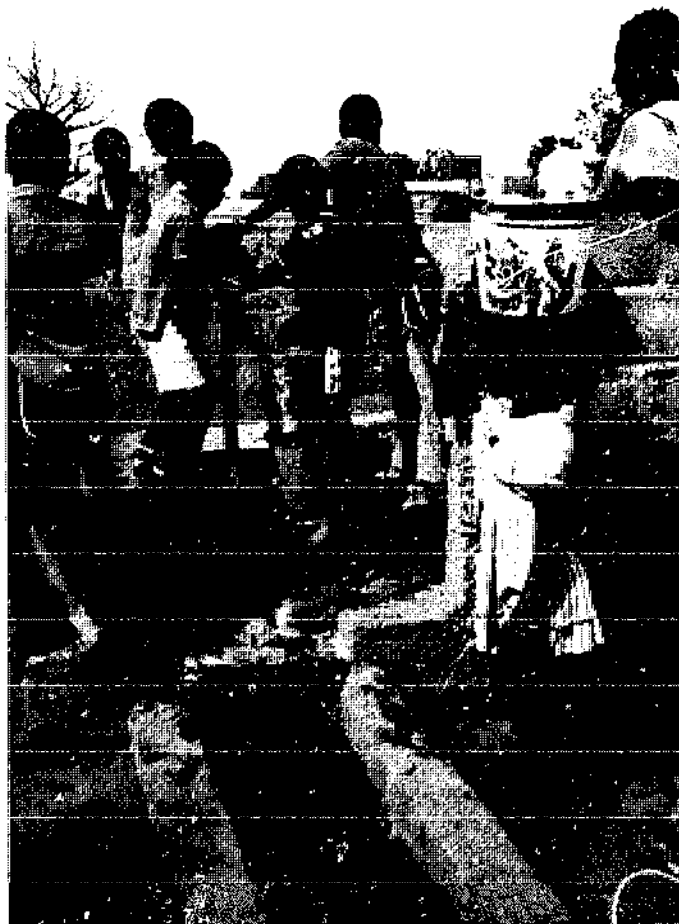
FIGURE 3-18 VERGNET FOOT-PUMP IN MALI

This French-made foot-operated pump is popular in some parts of Western Africa, where more than 14,000 have been installed. In the photo two youngsters are jointly operating the pump, with each placing one foot on the pedal. They have placed stones next to the pump on which each places his other foot.

Maintenance structure: The handpumps (Figure 3-18) are repaired and maintained by village and local mechanics. The maintenance costs are borne by the villagers, who also contribute to the purchase and installation of the pumps.

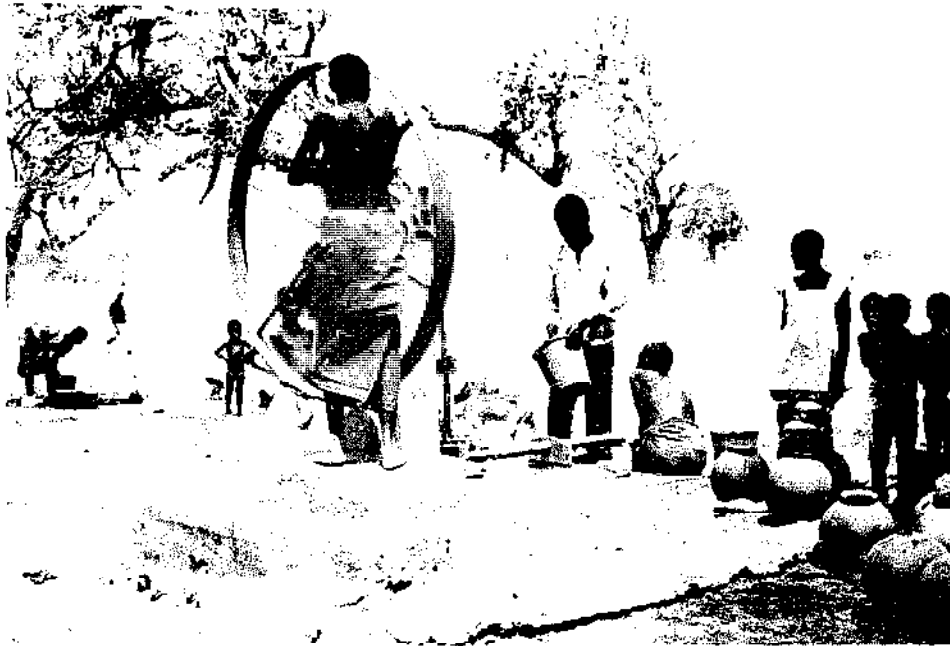
FIGURE 3-19 VOLANTA PUMP IN BURKINA

This deep set handpump is a candidate for VLOM classification. It is manufactured in both Burkina and The Netherlands and uses a rotary handle to drive a piston assembly. Its rising main is of a sufficient diameter so that the piston assembly can be pulled up through it for maintenance, without the need for special hoisting equipment. The Volanta pump in the photo has been equipped by the Project with a water meter in order to indicate the amount of use it receives.

The types of pumps used account for the different approaches that the projects in Burkina have adopted in maintaining handpumps. The FED project uses the Vergnet as their standard pump and the Dutch project uses the Volanta pump, both of which are suitable for village-level maintenance. On the other hand, the pumps installed in the USAID (Moyno) and UNICEF (India Mark II) projects are not as suitable for village repair as are BOM pumps, at least in the below-ground structure. One of Volanta pumps tested in Burkina is shown in Figure 3-19.

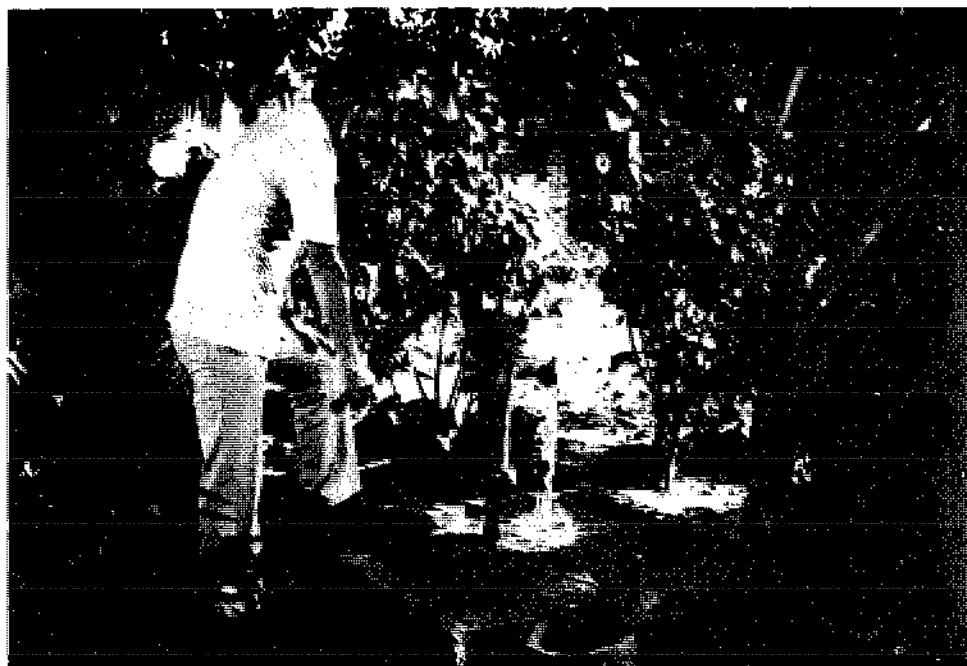
FIGURE 5-1 BANGLADESH NEW NO. 6 PUMP

Over 500,000 suction pumps have been installed in Bangladesh over the past ten years, most of which are of the New No. 6 type. It is robust, and the fact that all the moving parts except for the foot valve are located above-ground makes the pump easy to repair. But suction pumps used for domestic water supply have the general disadvantage that they often need priming (i.e. filling from the top before water can be pumped), which can introduce contamination into the well. An additional problem with the use of suction pumps in Bangladesh is that ground water levels have been decreasing over the years, and are more than eight meters below the surface (the approximate limit for suction pumps) at 15 to 20 percent of all possible tubewell sites in the country, at least in the dry season. For this reason a non-suction, direct action pump, known as the TARA, has been developed and is now being tested.

* The New No. 6 pump is a suction pump which is the national standard pump in Bangladesh, although development of a more widely applicable non-suction low lift pump is being encouraged by the Project. The New No. 6 pump is itself an improvement made in the late 1970's to the old Maya No. 6 pump (In Bangladesh, No. 6 designates a 3-1/2 inch cylinder diameter, about 90 mm). The laboratory test results are given in UNDP Project Management Report No. 3.

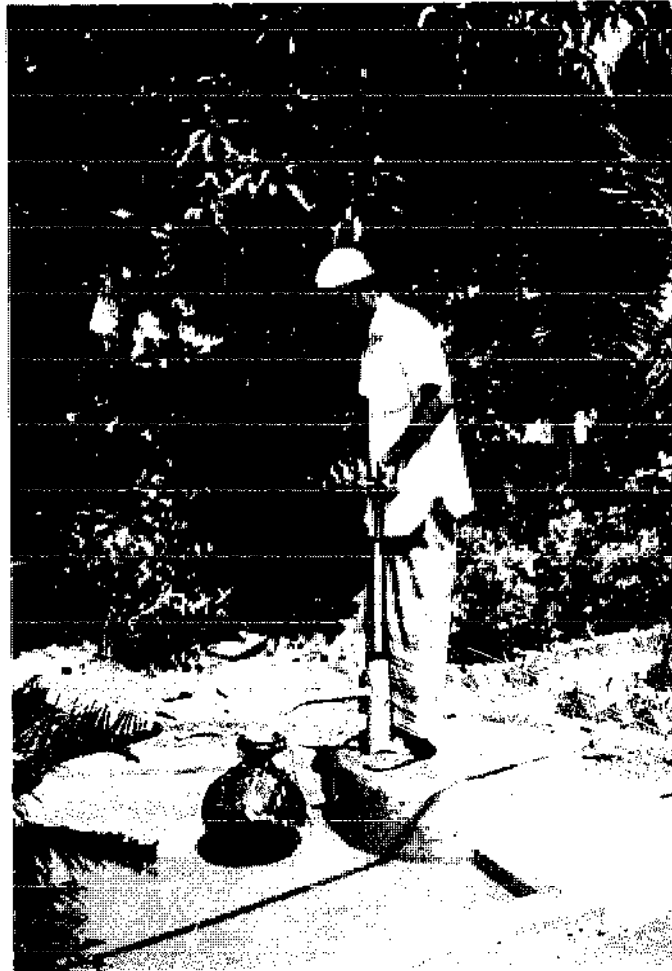
FIGURE 5-2 TARA HANDPUMP

A first generation prototype TARA pump is being demonstrated in Bangladesh at the time of its introduction in 1982. This direct action pump has a high potential for providing the technology component of a low cost, easily maintainable system.

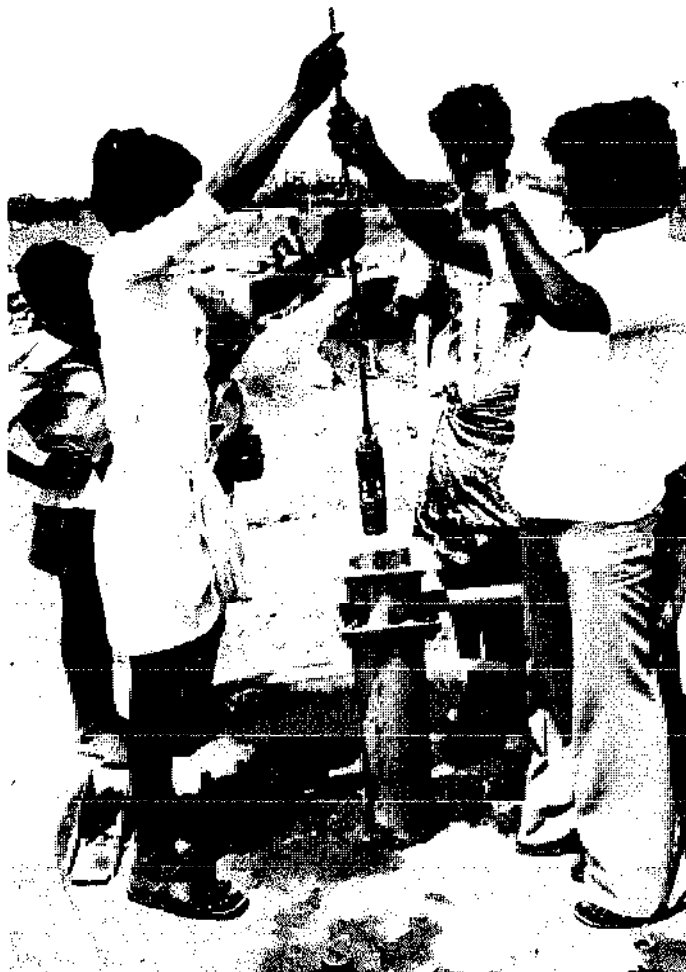
FIGURE 5-4 THE PROTOTYPE MODIFIED VLOM INDIA MARK II HANDPUMP

A VLOM version of the standard India Mark II pump is being developed and field tested in India which permits the extraction of the piston and, if desired, also the foot valve through an open cylinder. The last segment of the pump rod with attached piston and foot valve was extracted in less than an hour. The foot valve was connected to the piston for extraction by lowering the piston to the top of the check valve and rotating the pump rod clockwise.

The second foot valve option is a "snap-in" arrangement. It consists of the standard India Mark II foot valve in a modified cage arrangement with a double convex tapered spigot below the follower plate of the foot valve. The double convex tapered spigot inserts into a PVC or polyethylene (PE) receiver ring with an interference fit, holding the foot valve in place against the upthrust of hydraulic friction and effecting a static seal. The interference fit requires a pressure of approximately 15 to 20 kg-f (33 to 44 pounds) to make it snap into place. The snap-in foot valve has a shaft extending from the upper cage to open the piston valve when the two are joined for extraction. This allows the column of water resting on the piston to drain through the piston and around the foot valve when it is pulled out of the receiver, so that maintenance personnel need only lift the weight of the pump rod and pumping elements (at a 40 meter setting, the weight is about 36 kg-f).

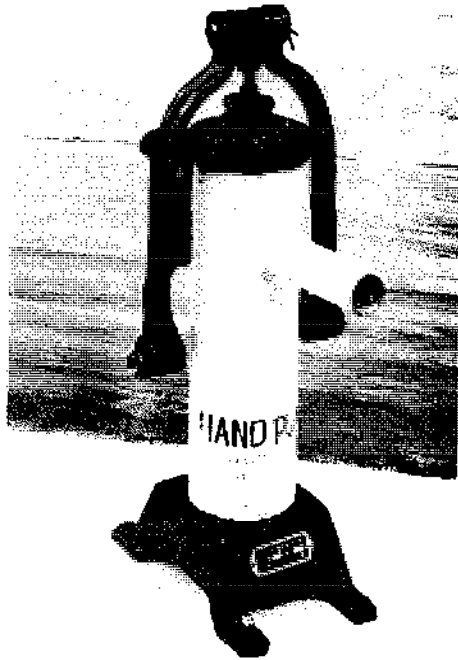
Model SY-81
Type: Single Piston
Flow: 3 m³/hour
Suction: 6 m
Total lift: 8 m
Operation: One person press
Producer: Dayu County
Farm Machinery Plant,
Jiangxi Province, China

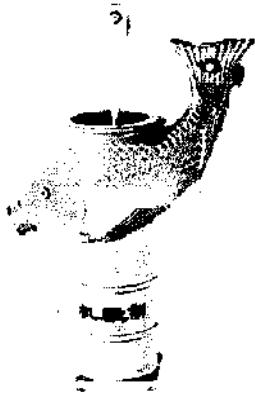
Model: J-8.5
Type: Single piston
Flow: 1.3-1.6 m³/hour
Suction: 7 m
Total lift: 7 m
Operation: One person press
Producer: Longhai County
Farm Machinery Institute,
Fujian Province, China

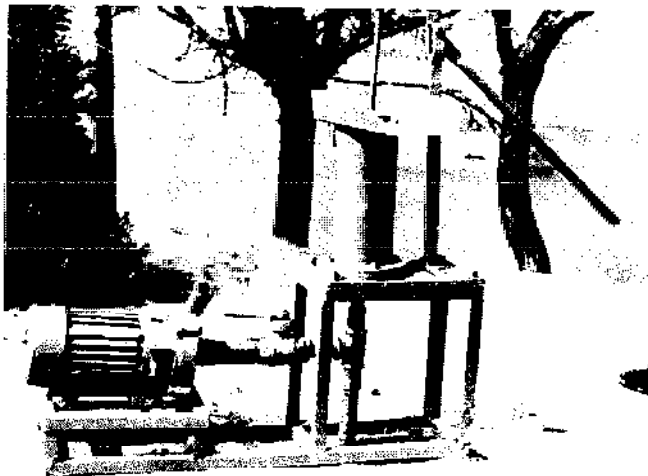
Model: SJ-100
Type: Single piston
Flow: 2 m³/hour
Suction: 7 m
Total lift:
Operation: One person press
Producer: Dongming County
Farm Machinery Plant,
Shandong Province, China

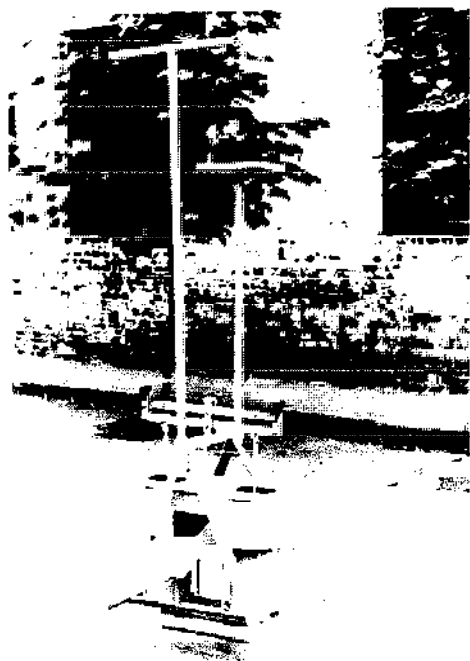
Model: Peijiang
Type: Double piston
Flow: 16 m³/hour
Suction: 6 m
Total lift:
Operation: One person pedal
Producer: Suining County
Farm Machinery Plant,
Sichuan Province, China

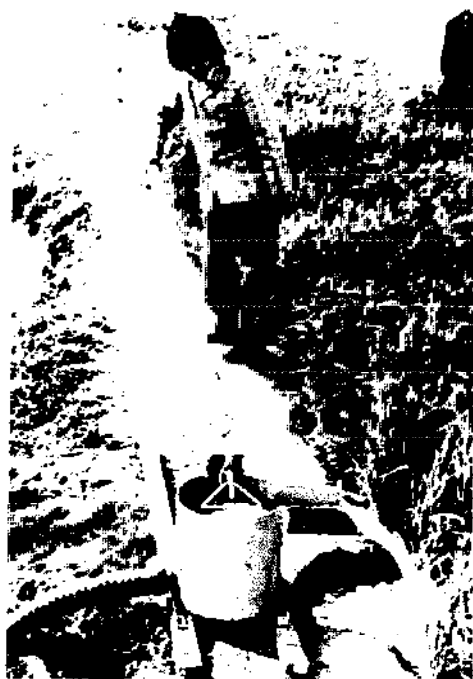
Model: Gene
Type: Diaphragm
Flow: 5-8 m³/hour
Suction: 5 m
Total lift:
Operation: One person press
Producer: Shandong Water
and Electricity Equipment
Plant (Qufu), Shandong
Province, China
